Seismic damage assessment of school buildings after 2012 Emilia Romagna earthquake

Antonio Formisano*

SUMMARY – In the paper the usability checks performed on precast RC gyms and masonry school buildings, located in the Municipalities of San Pietro in Casale (BO), Bomporto (MO) and Bondeno (FE) after the seismic events occurred on 2012 May 20th and 29th, are reported and discussed. First, the main features of surveyed buildings have been identified. Later on, on the basis of the detected damages, their seismic deficiencies have been recognized. Finally, the indication of some appropriate simple interventions for retrofitting studied buildings has been given.

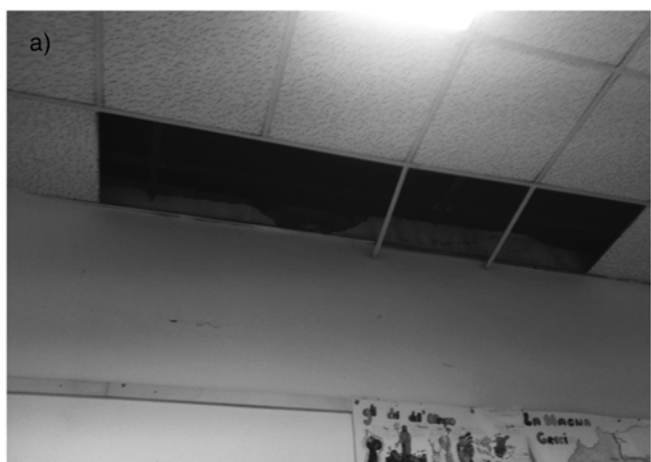
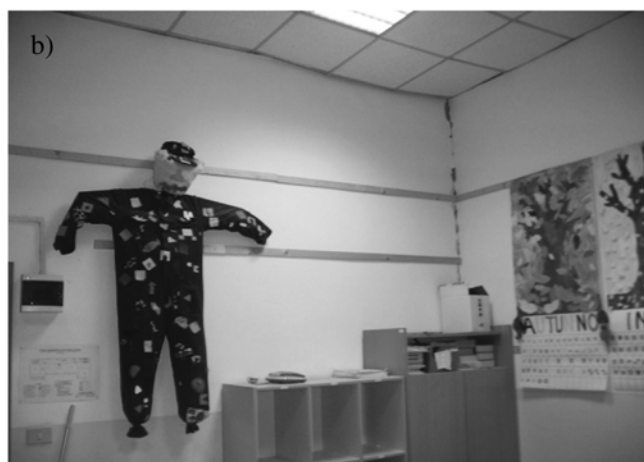
The building has shown few damages in the external part of the load bearing vertical structure. Instead, inside, at the first level, vertical cracks between masonry walls and internal ones, together with damages and failures of some ceiling panels, are noticed (Fig. 2).

Fig. 2. Failure of ceiling panels (a) and vertical crack between masonry wall and internal one (b).
Crollo di pannelli del controsoffitto (a) e fessure verticali tra parete in muratura e divisorio interno (b).

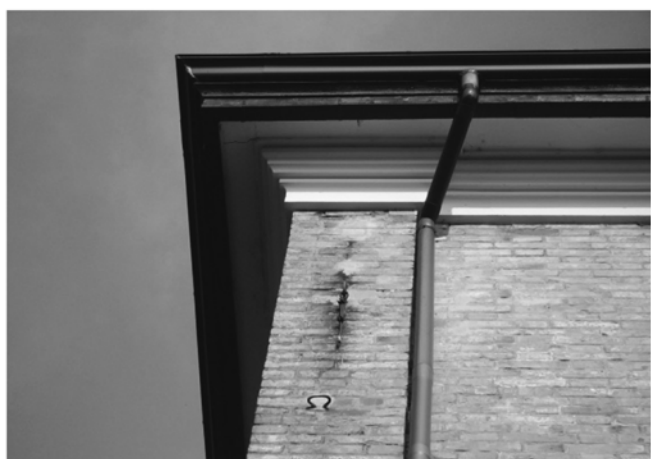
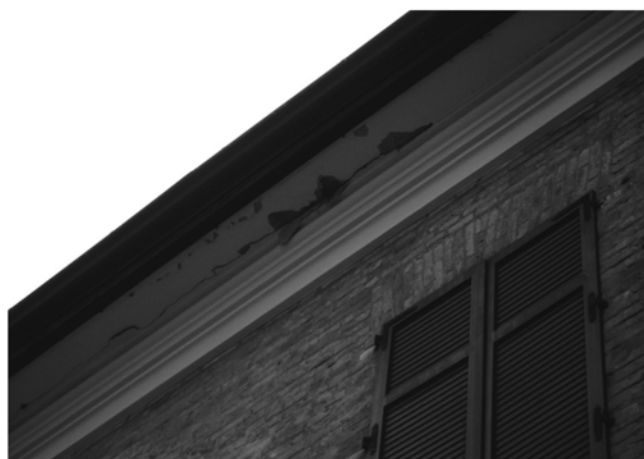
On the façade, some horizontal cracks long the intersection zone between masonry wall and cornice roof have been recorded (Fig. 3).

Fig. 3. Horizontal cracks along the roof cornice.
Fessure orizzontali lungo la cornice del tetto.

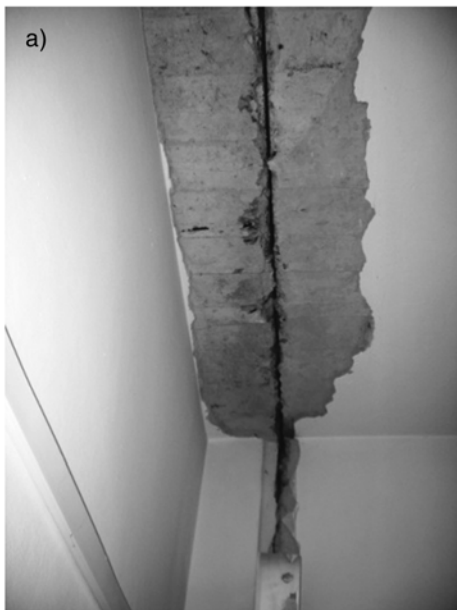
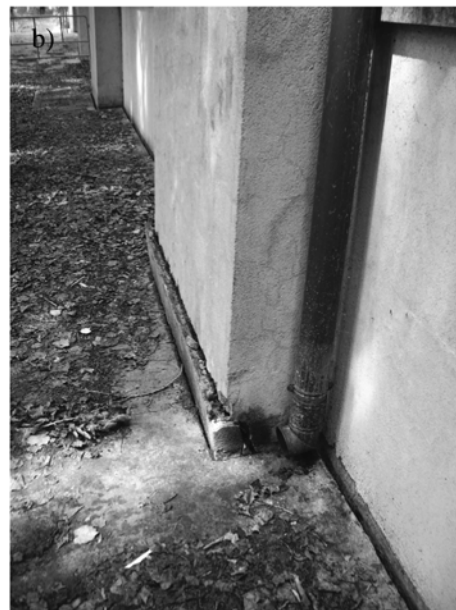
Fig. 5. Vertical crack corresponding to the joint zone (a) and a slight foundation subsidence at the building base (b).
Fessure verticali in corrispondenza del giunto (a) e leggero cedimento della fondazione (b).

A significant damage has been detected in the contact zone among buildings, since the "rules of art" have not been followed in the joint design and hammering of two structural parts have produced the detachment of large parts of plaster (Fig. 5a). One of the two buildings has shown a foundation relative displacement which has produced both displacement and rotation of the precast panel used to close the ventilation space around the building (Fig. 5b).

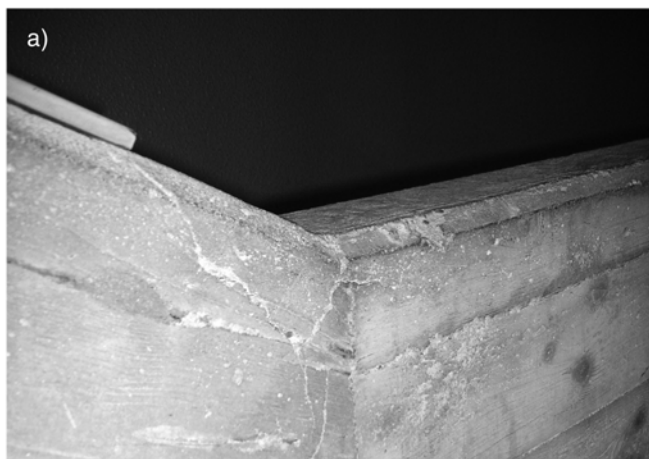
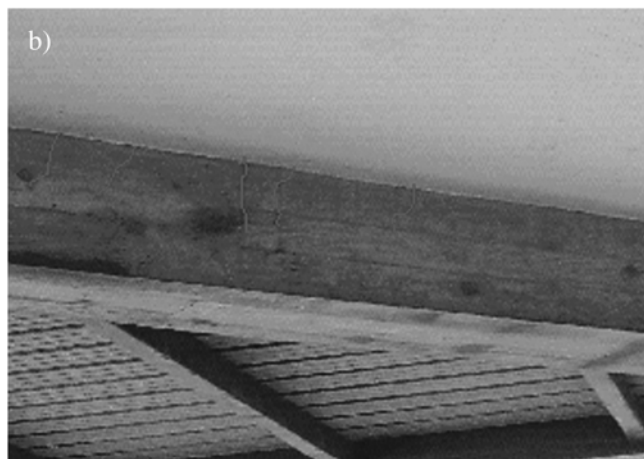
Inside the building, some damages in the staircase (Fig. 6a) and in a ground storey beam (Fig. 6b) have been detected, the latter showing few but diffused cracks due to vertical seismic accelerations. Other non-structural damages are cracks into plaster in the

Fig. 6. Cracks in the staircase beam (a) and in a ground storey beam external to the school (b).
Fessure in una trave delle scale (a) e in una trave a piano terra esterna all'edificio (b)

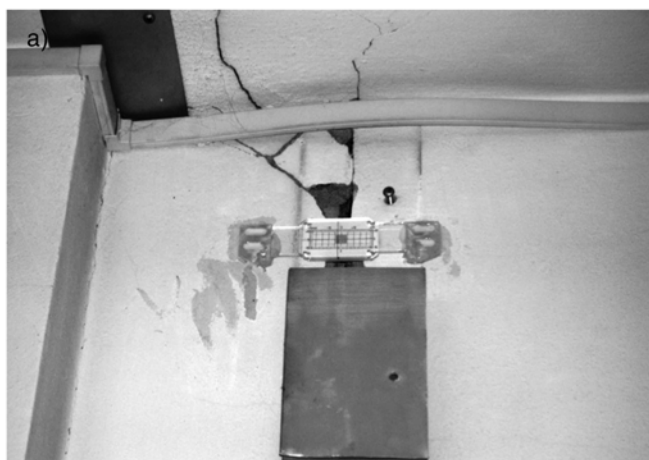
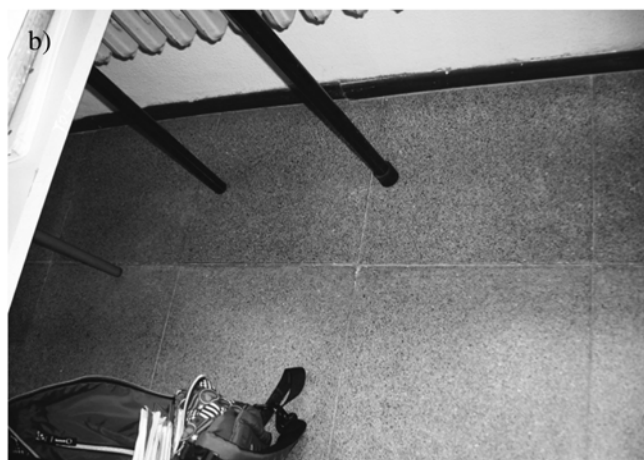
area close to the joint (Fig. 7a), as well as a horizontal crack on the pavement of a first level classroom (Fig. 7b).

Fig. 7. Non structural damages: plaster cracks (a) and a pavement horizontal crack (b).
Danni non strutturali: fessure nel rivestimento (a) e una fessura orizzontale nel pavimento (b).

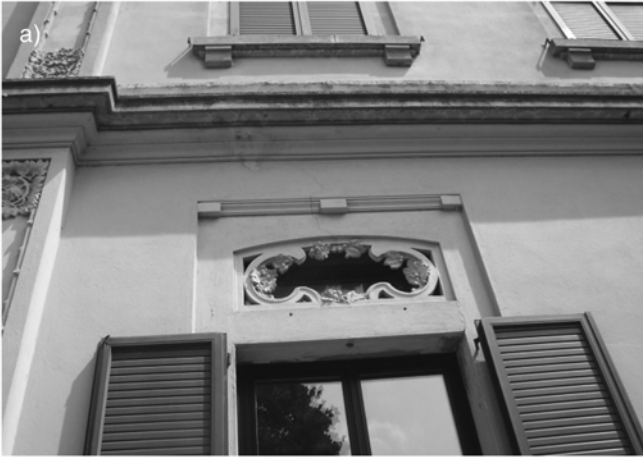
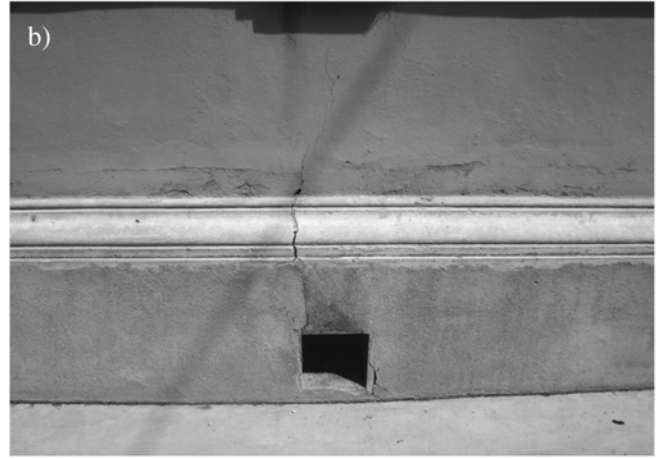
Vertical cracks into door architraves and diagonal cracks in the masonry spandrels above the same doors have been recorded inside and outside the building (Fig. 9). In addition, horizontal cracks between masonry walls and floors due to the deficient connection grade among them has been noticed.

Fig. 9. Vertical cracks into architraves (a) and at the building base (b).
Fessure in architravi (a) e base dell'edificio (b).

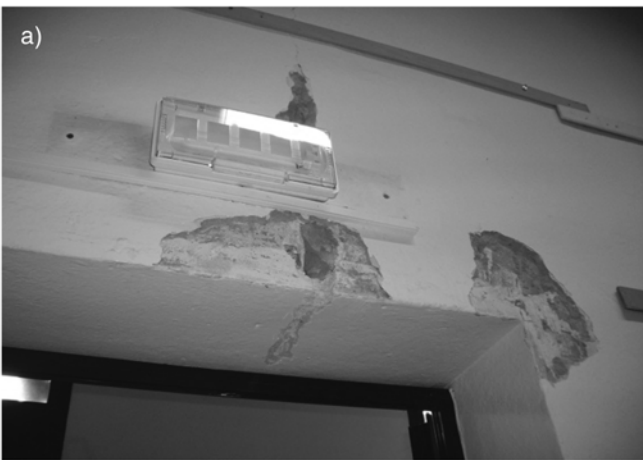
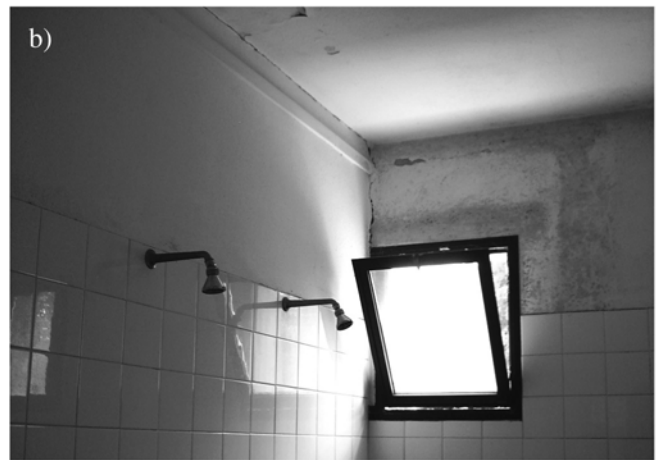
Also in this case, slight damages consisting of cracks into architraves and masonry spandrels have been detected (Fig. 10a). Moreover, horizontal cracks between

Fig. 10. Architrave (a) and wall-floor (b) cracks.
Fessure in architravi (a) e tra pareti e solette (b).

masonry walls and intermediate floors have been seen (Fig. 10b).

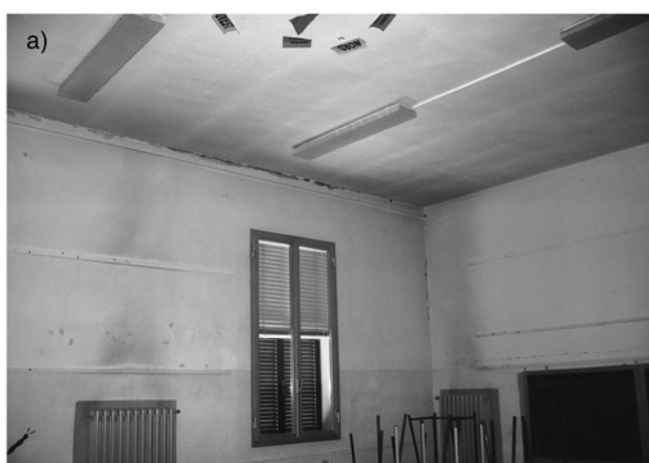
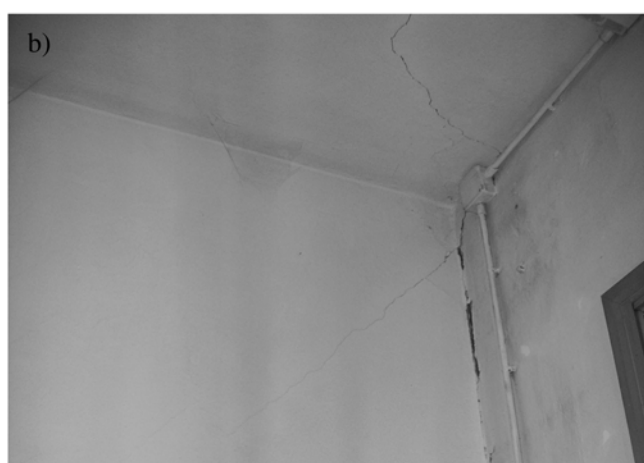
Medium-heavy damages have been detected, they being represented by the floor-wall detachment due to the scarce link level among these parts (Fig. 13a), cracks into the vault key, horizontal cracks into floors and diagonal cracks into walls (Fig. 13b).

Fig. 13. Masonry structural unit of the school building "Menotti": wall-floor horizontal crack (a) and diagonal cracks into wall and floor (b).

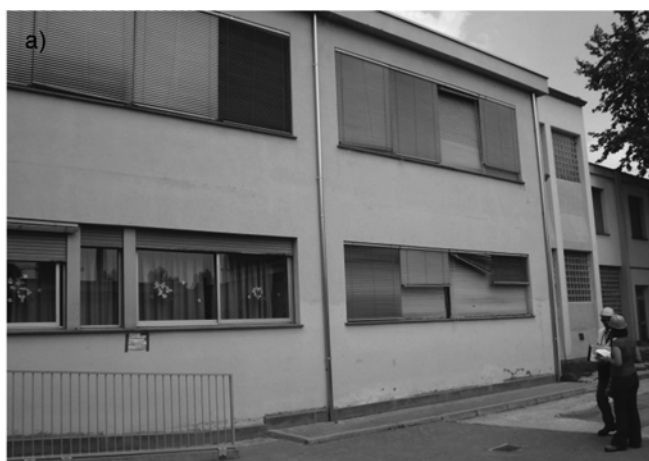
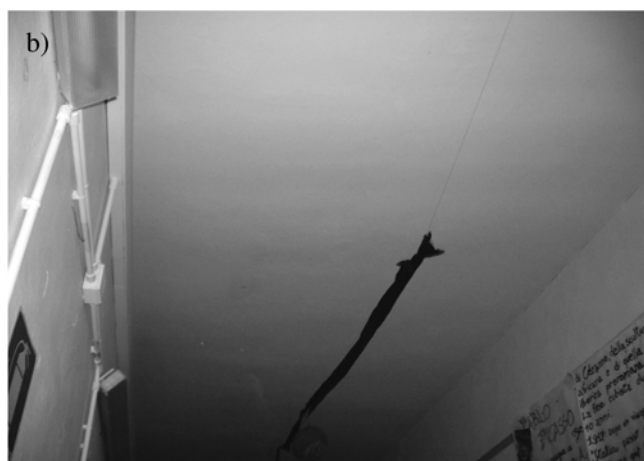
The building has suffered slight damages to non-structural parts, such as internal walls, plaster and ceiling panels (Fig. 14b). Even if a rather good building seismic response has been recorded, lack of transverse connections among frames makes the building very vulnerable towards earthquakes. The last structural unit, erected in 90's to host the school refectory, has a r.c. structure with frames in one direction only (Fig. 15a).

Fig. 14. The central r.c. structural unit of the school building "Menotti": external view (a) and ceiling damages (b).

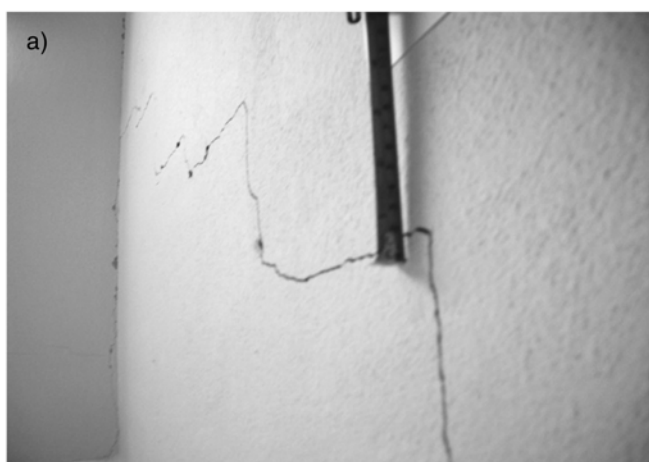
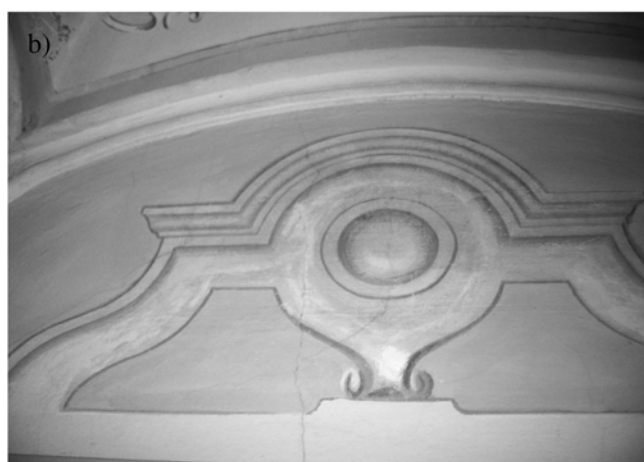
In the building few damages among walls and not significant floor-wall cracks have been recorded. Diagonal cracks into masonry piers and horizontal cracks in vaults are very diffused (Fig. 18).

Fig. 18. Details of some cracks detected in the “Sorelle Luppi” school building.
Dettagli di fessure osservate nella scuola «Sorelle Luppi»

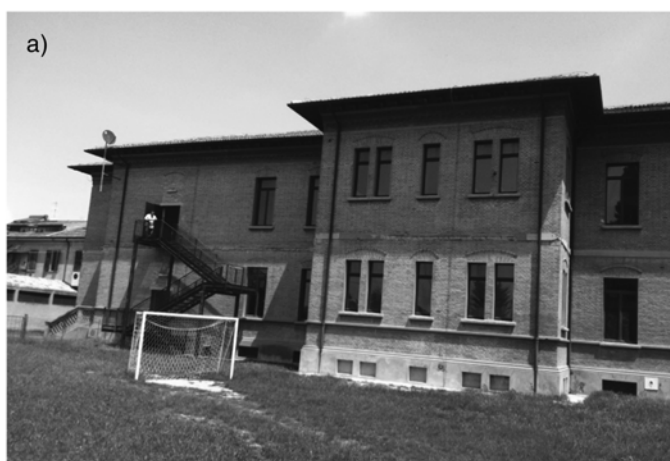
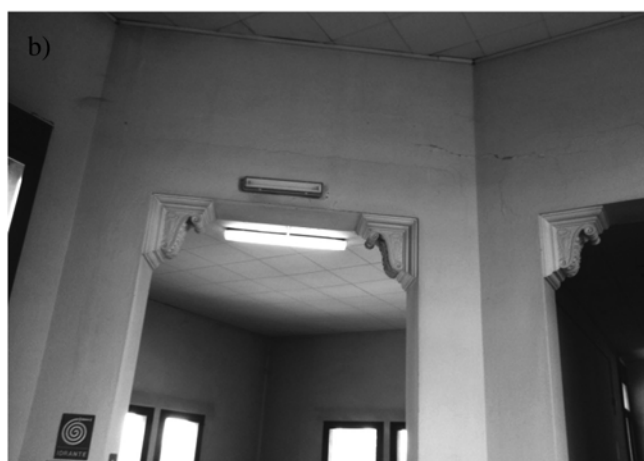
Slight structural damages, namely vertical cracks in door and window architraves (Fig. 19b), horizontal cracks at the floor-wall intersections and diagonal and vertical cracks into masonry walls (Fig. 20), have been noticed. However, a very heavy damage has been detected at the intersection of two masonry walls, which were completely separated (Fig. 21a).

Fig. 19. The primary school “Battisti”: external view (a) and architrave cracks (b).
La scuola elementare «Battisti»: esterno (a) e fessure di un architrave (b).

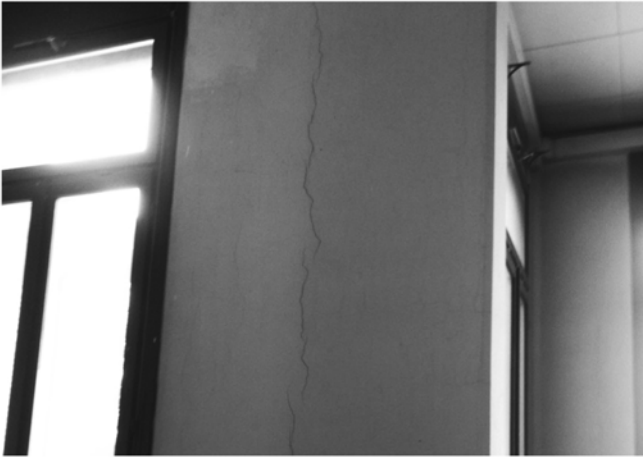
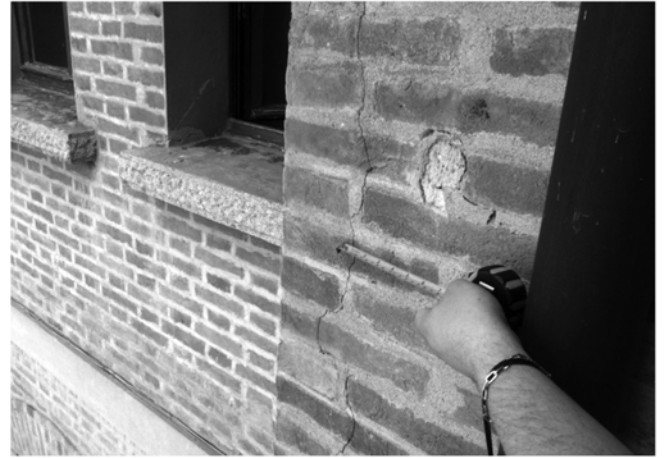
Fig. 20. Vertical cracks in masonry piers of the primary school “Battisti”.
Fessure verticali in maschi murari della scuola elementare «Battisti».

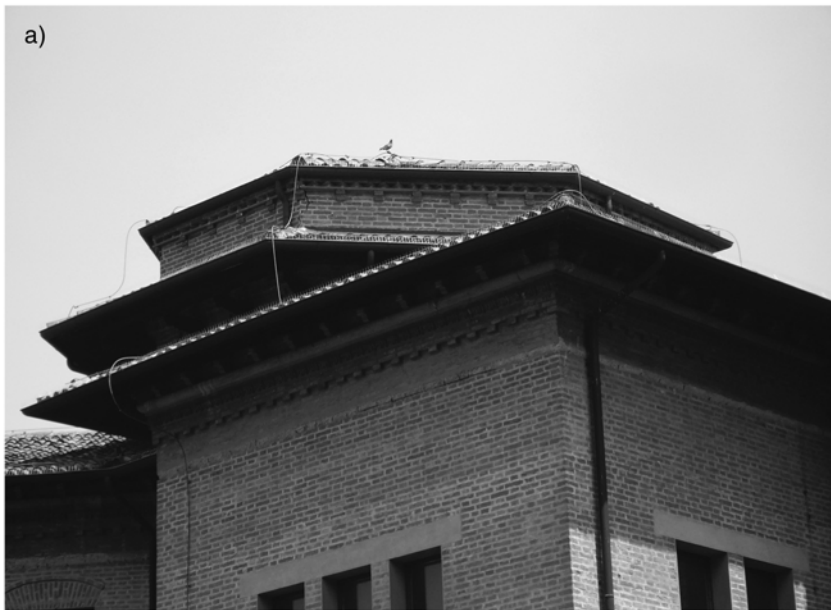
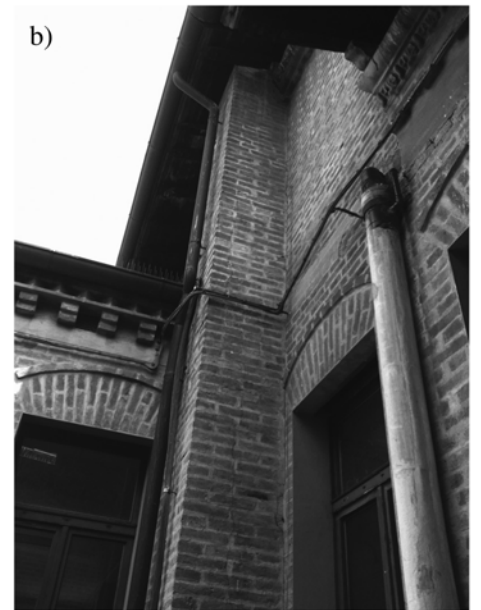
About non-structural components, a medium-heavy crack in the intersection zone between the facade and a masonry chimney has been noticed (Fig. 21b). Also, significant damages into ceiling have been observed, they producing the collapse of some covering panels.

Fig. 21. A very large crack between two masonry walls (a) and a vertical crack between the chimney and the façade (b) of the primary school “Battisti”.
Scuola elementare «Battisti»: una fessura molto larga tra due pareti in muratura (a) ed una fessura verticale tra canna fumaria e facciata (b).

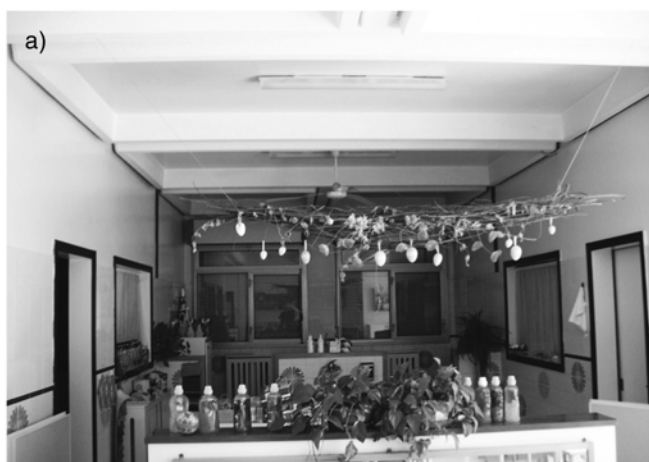
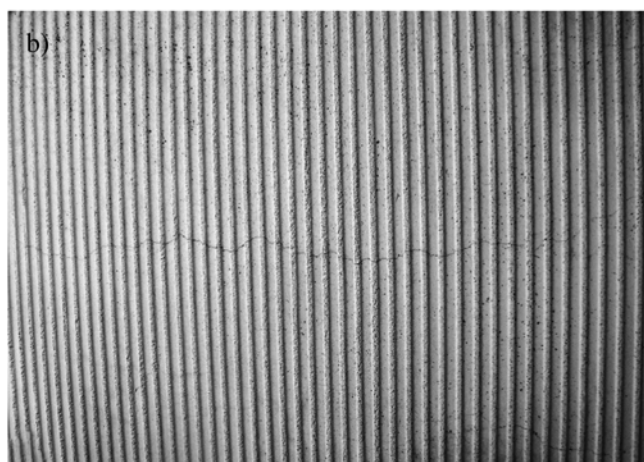
of precast r.c. panels which has shown light and diffused damages after earthquake. In particular, horizontal cracks in masonry walls (Fig. 24b) and vertical cracks at the interaction zones among walls and between walls and floors (Fig. 25) have been recorded.

Fig. 24. Internal view of the nursery (a) and horizontal cracks into a precast r.c. panel (b).
Vista interna dell'asilo (a) e fessura orizzontale in un pannello in c.a. prefabbricato.

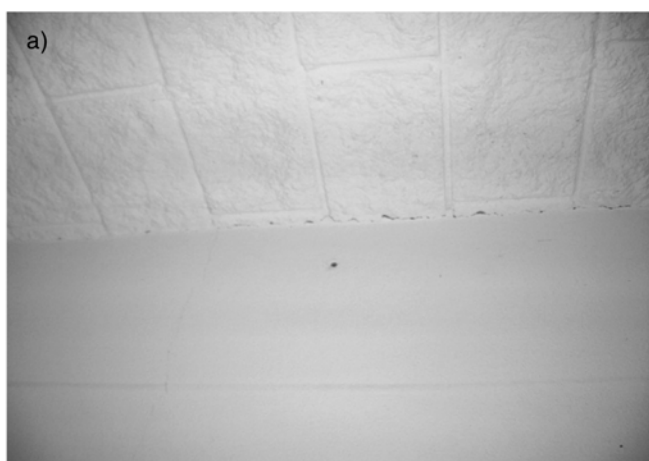
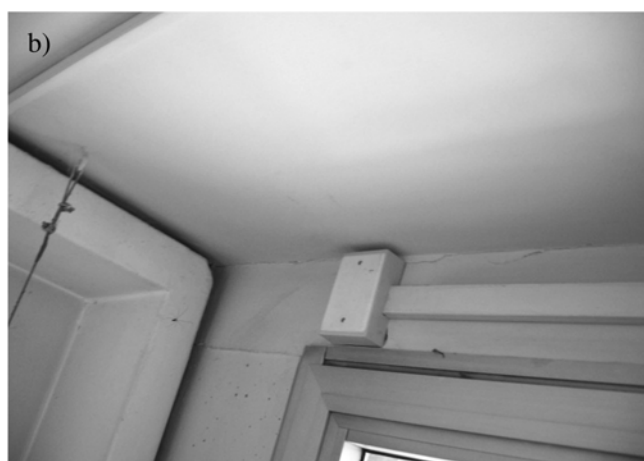
Fig. 25. Wall-floor cracks (a) and small vertical damage between orthogonal walls (b).
Fessure parete-soffitto (a) e leggero danneggiamento tra pareti ortogonali.

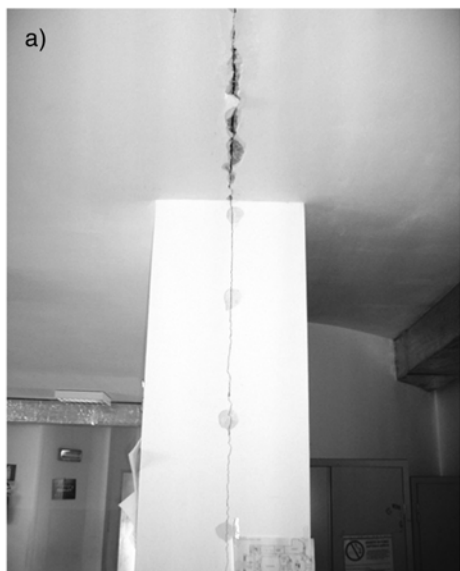
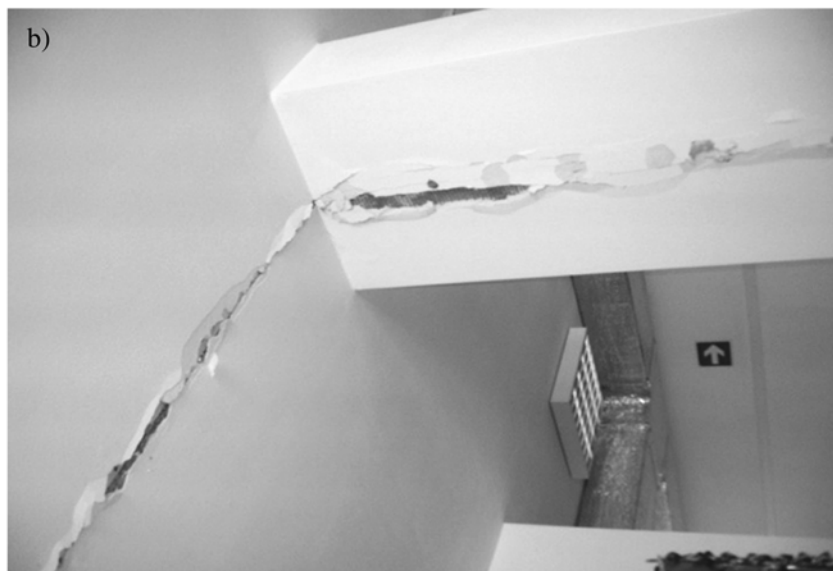
distance between two adjacent buildings, the main damages have been detected there. In fact, important plaster cracks have been observed both among adjacent col-

umns (Fig. 29) and on the floor (Fig. 30a), as well as horizontal cracks have been recorded on the classroom pavement (Fig. 30b) close to the structural joint.

Fig. 29. Vertical crack along the structural joint.
Fessure verticali lungo i giunti strutturali.

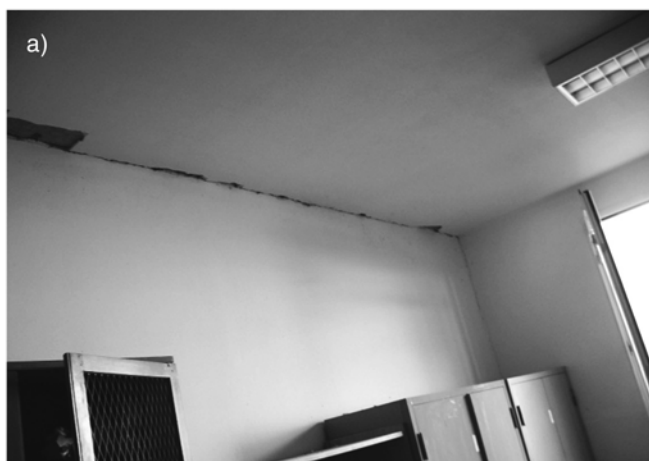
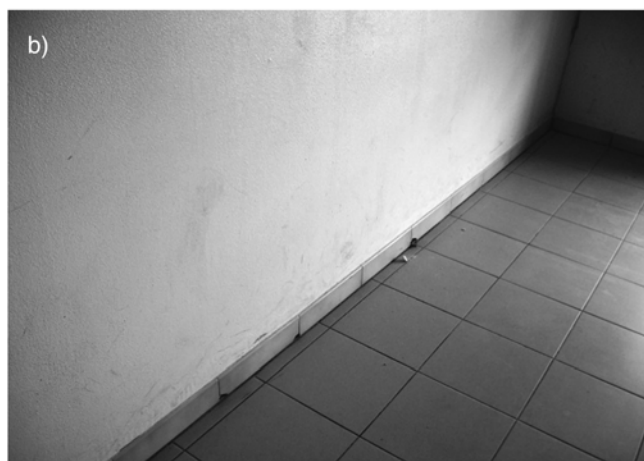
Fig. 30. Cracks on the floor intrados (a) and extrados (b).
Fessure all'intradosso (a) ed estradosso (b) delle solette.

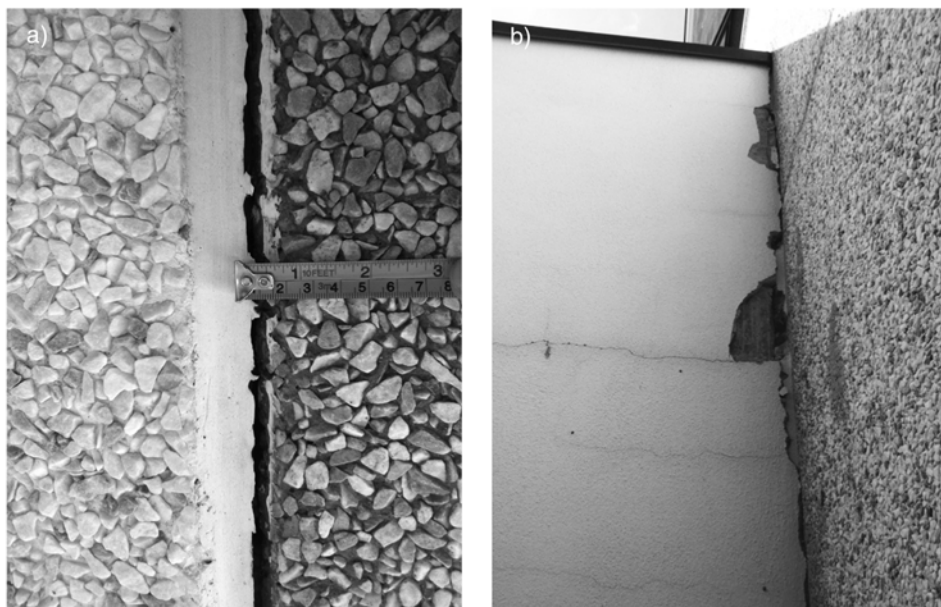
Fig. 32. Column-panel detachment (a) and vertical crack due to hammering effect among adjacent buildings (b). Distacco colonna-pannello (a) e fessurazione verticale dovuta a martellamento tra edifici adiacenti (b).

of them, badly connected to columns, have suffered an overturning out-of-plane mechanism which has produced detachment of panels from columns (Fig. 32a). In particular, a vertical crack developed along the entire building height at the panel-column interaction zone has been noticed. Also the hammering effect between gym and the connection structural body with the school building has been recorded (Fig. 32b).

As a whole, the observed damages, due to the absence of beam-column connections and the inefficiency of panel-column ones, make building susceptible to undergo severe damage under future earthquake, so to require appropriate seismic retrofitting interventions able to improve their global behaviour.
