# Simplified and refined methods for seismic vulnerability assessment and retrofitting of an Italian cultural heritage masonry building

A. Formisano <sup>a,\*</sup>, A. Marzo <sup>b</sup>

In the paper the usability check and the seismic vulnerability appraisal and repairing of a masonry building with cultural and artistic value located in the Municipality of Cento (Ferrara, Italy) after the last Italian seismic events (Emilia-Romagna, 2012 May 20th and 29th), are reported and discussed.

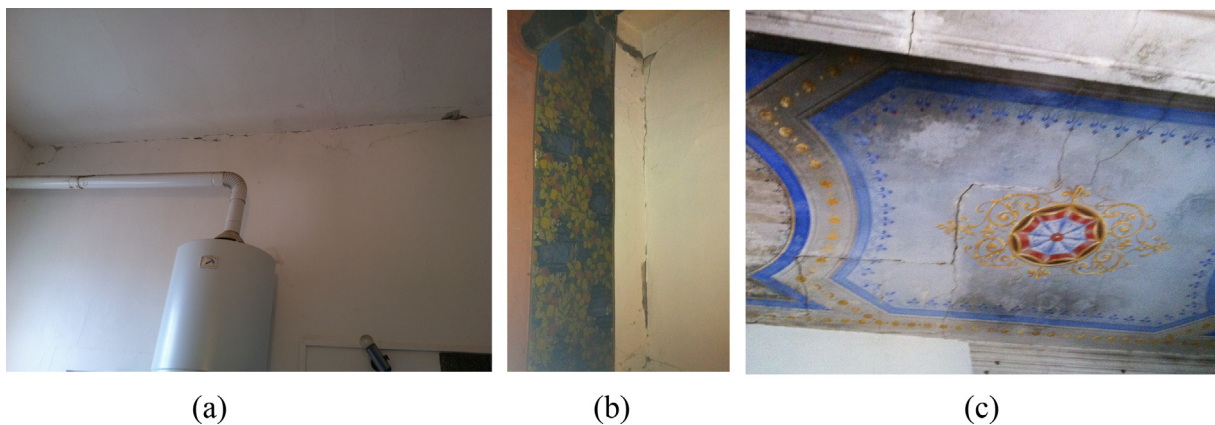
- (1) Detachment of plaster between walls and floors due to the poor connection degree between timber beams and masonry walls (Fig. 4a);
- (2) Detachment of plaster among orthogonal walls, caused by the reduced degree of junction between the walls themselves (Fig. 4b);
- (3) Cracks in the floor ceilings (Fig. 4c);
- (4) Cracks in vaults and arches (Fig. 5a);
- (5) Lesions in the church walls caused by their overturning mechanism (Fig. 5a);
- (6) Diagonal cracks into masonry walls (Fig. 5b);
- (7) Lesions in masonry piers above openings due to lack of effective lintels (Fig. 6a);
- (8) Vertical cracks on walls due to the load transferred by timber beams to the same walls (Fig. 6b);
- (9) Collapse of ceilings caused by excessive deformation of timber beams which, consequently, lost their support (Fig. 6c).

Fig. 4. Cracks between floor and wall (a), between orthogonal walls (b) and in the ceiling (c).

(propping of floors) and some local intervention measures (tying among walls, repairing of cracks, new wall-floor connections) aiming at eliminating the construction seismic deficiencies.

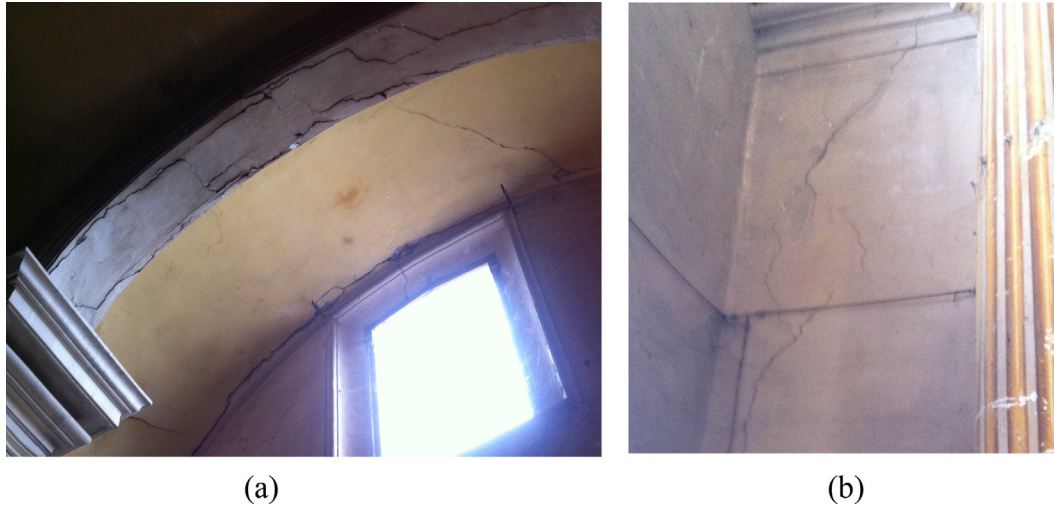
detachment of orthogonal walls, representative of a first mode collapse mechanism, and large cracks within arches and vaults, makes it completely unusable.

Fig. 5. Cracks into arch and vault (a) and pier diagonal cracks (b) in the oratory.

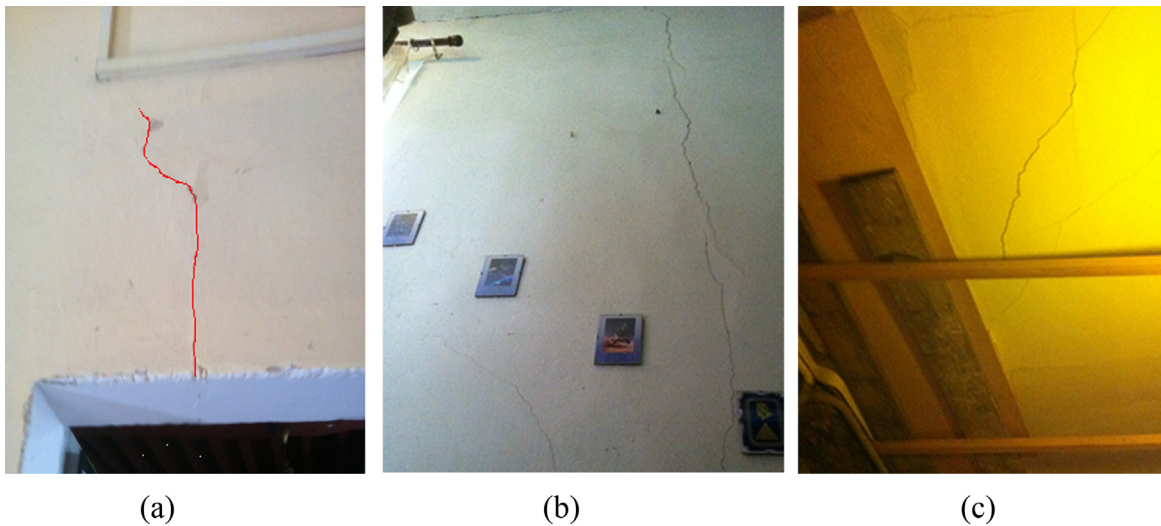
Fig. 6. Crack above door (a), vertical cracks into a wall (b) and propping of a damaged ceiling (c).

After the plaster is removed, the cracks found in the masonry walls are eliminated by replacing the damaged stones with new ones, which are connected by means of lime mortar to the existing masonry apparatus.

The cracks found above the openings into masonry spandrels are abolished by replacing cracked stones with new elements. In addition local reinforcement of the openings below the damaged spandrels is made by means of steel profiles. In particular,

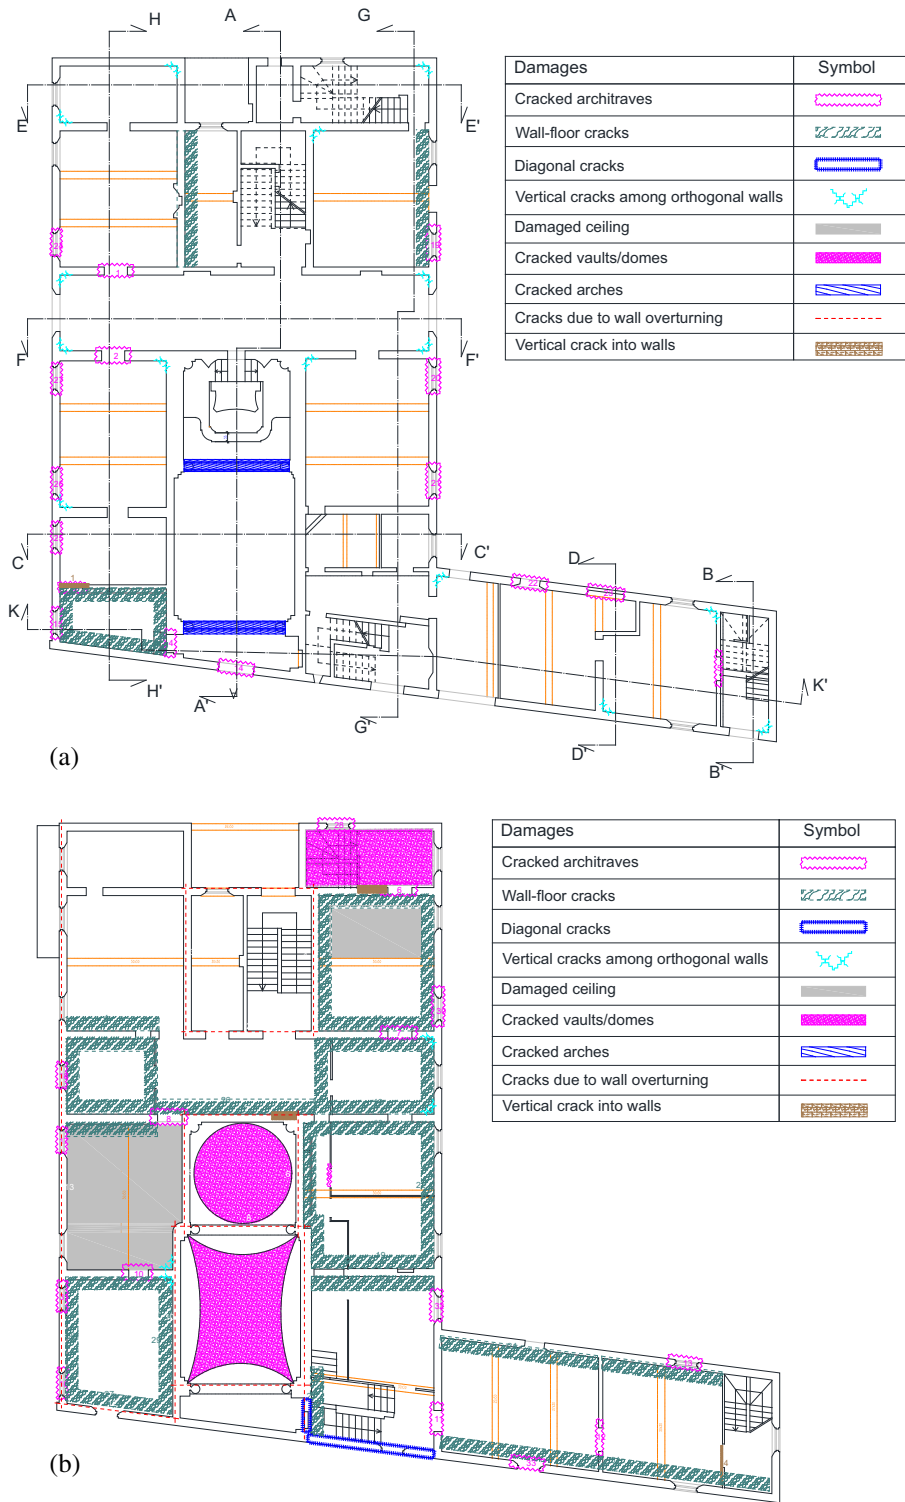
A detailed indication of the crack pattern detected in the building is depicted in Fig. 7.

Fig. 7. Damage patterns at the ground (a) and the first (b) floors.

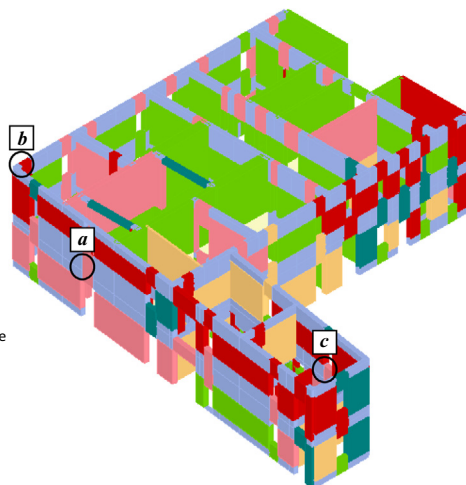
The results of LV3 analysis confirm that  $y$  is the weak direction, also when the nonlinear behaviour and the displacement capacity are taken into account. In fact, the safety factor is less than one, as well as the coefficient  $q^*$  is greater than the allowable limit (3). Also in the direction  $x$  the seismic check is not satisfied, with a safety factor slightly greater than the direction  $y$  one. As in the LV1 analysis level, also with the refined LV3 assessment level, the soft-story mechanism at the first level, where flexural failure is prevailing for the masonry piers, occurred (Fig. 10).

About the comparison of failure modes in the direction  $y$ , LV3 provides a story mechanism at the first level (Fig. 10), which is the same collapse mechanism attained with the LV1 analysis level. With both analysis levels, the prevailing failure mode for the masonry piers in the direction  $y$  is of flexural type. This confirms the reliability of the simplified analysis level adopted from the Italian Guidelines on Cultural Heritage in predicting the seismic behaviour of historical and remarkable masonry constructions.

Fig. 10. Flexural failure mode at the first floor according to the LV3 analysis level.

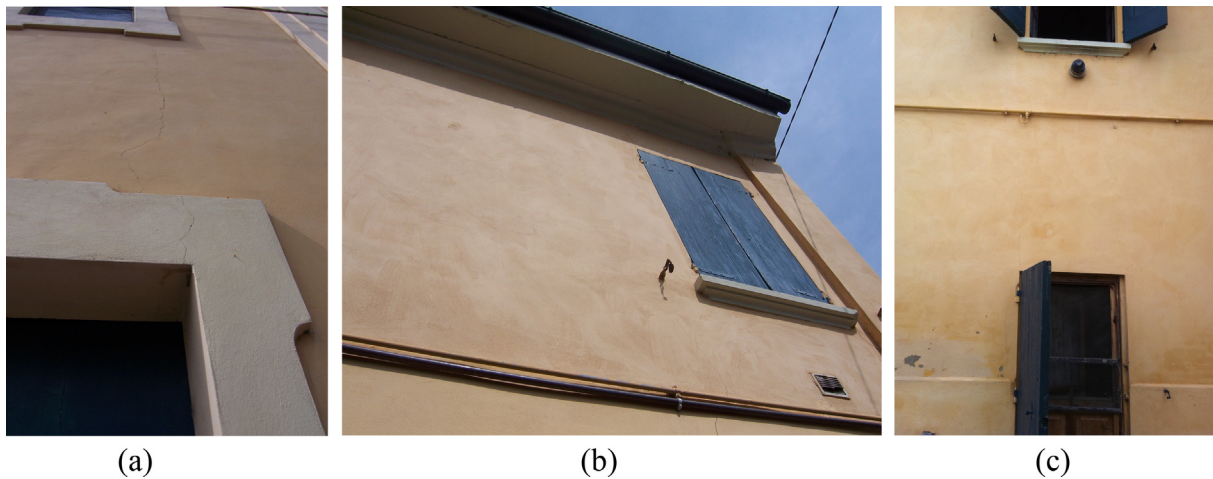
Under the qualitative point of view, the walls damaged by the earthquake in the numerical model show substantially the same crack types detected after the seismic event (Fig. 11). For the sake of example, if the comparison between Figs. 10 and 11 is done, it is noticed that some damaged spandrels, identified with letters  $a$ ,  $b$  and  $c$  in Fig. 10, have flexural failure modes as those identified on the building facades.

Fig. 11. Some spandrels damaged after earthquake: agreement between real collapse mechanisms and numerical ones (see Fig. 10).

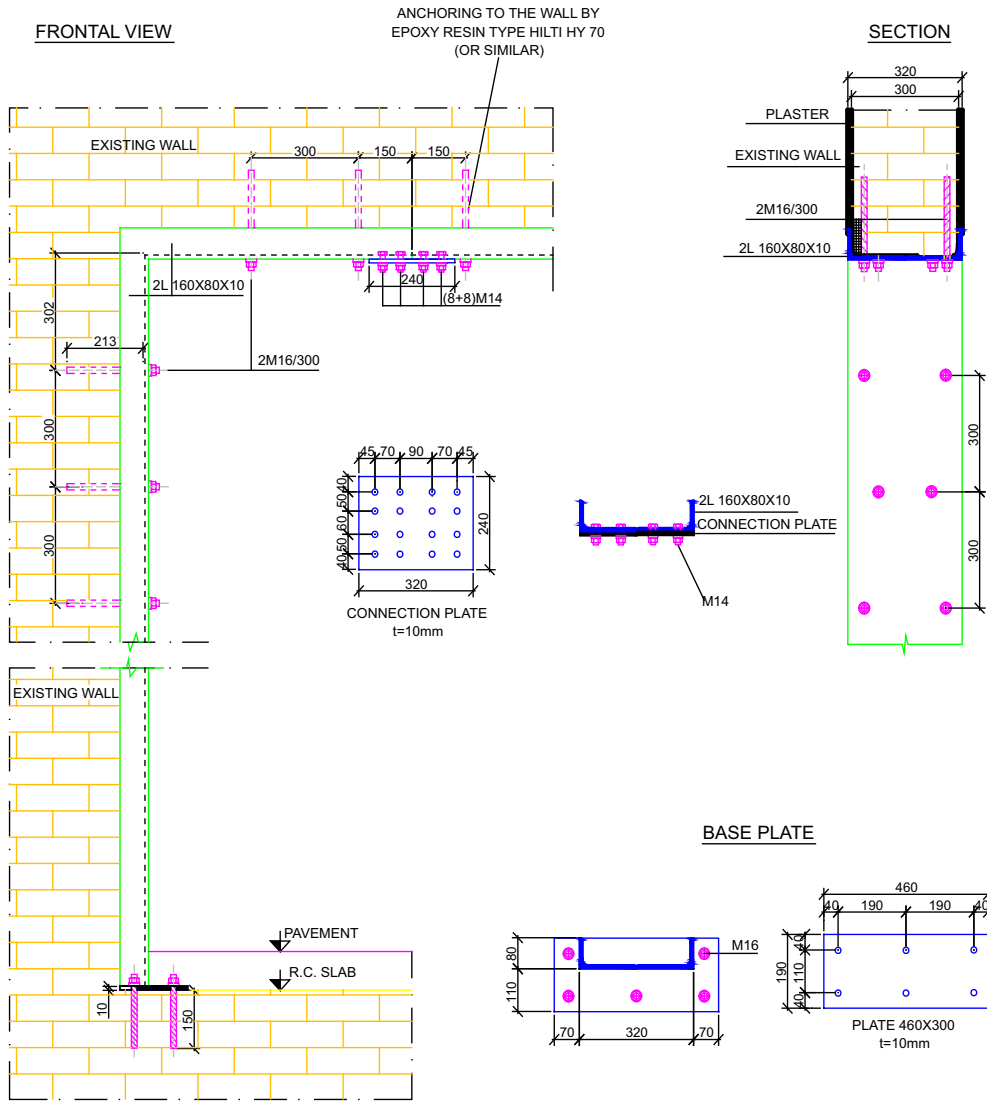
Fig. 12. Details of the opening confinement.

UPN160 profiles and coupled angles 160 × 80 × 10 mm (Fig. 12) are used for 160 mm and 320 mm thick walls, respectively.

These profiles, supplied and put in place under form of columns and beam composing a frame, are connected to the lintels and

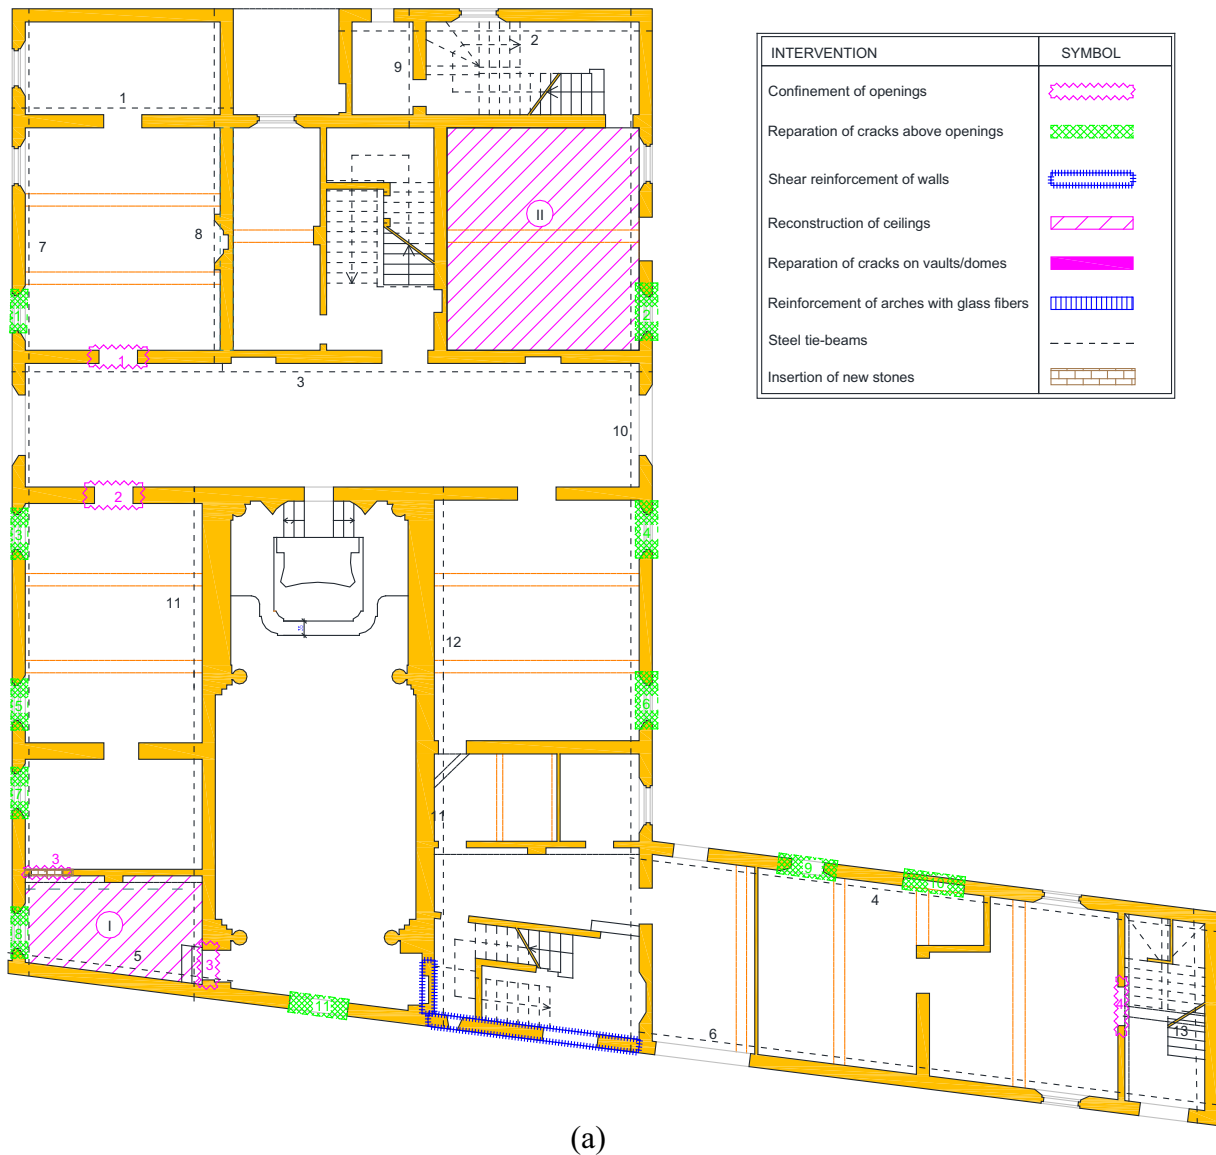
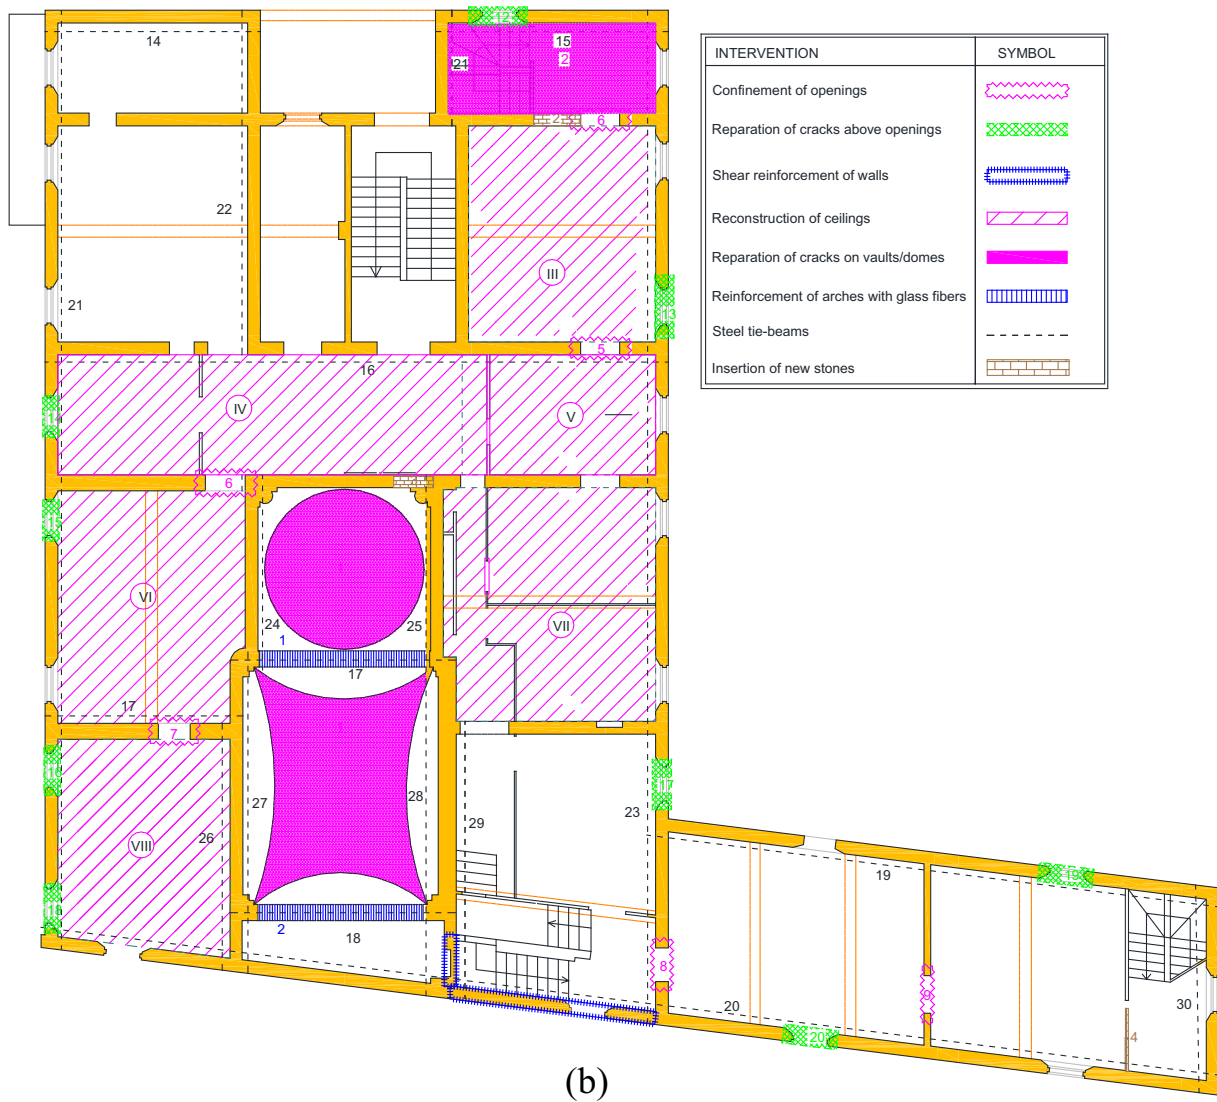
Fig. 16. Placement of local repairing interventions at the ground (a) and first (b) floors.

The interventions listed before have been applied for seismic repairing of the study building, as illustrated in Fig. 16, where their placement into plan layouts of the examined construction is depicted.
