Consolidation Methods of Romanian Historical Building with Composite Materials

The present article will analyse two historical buildings located in Timisoara, will identify the damages and will present several intervention solutions by using fibre reinforced composite materials, for increasing the bearing capacity of structures, while keeping the original stiffness and being reversible and easy to be applied. All these solutions are based on the Chart of Venice principles. The case study buildings are Sf. Gheorghe 2 and Sf. Gheorghe 3, from Sf. Gheorghe square, in the historical centre of Timisoara.

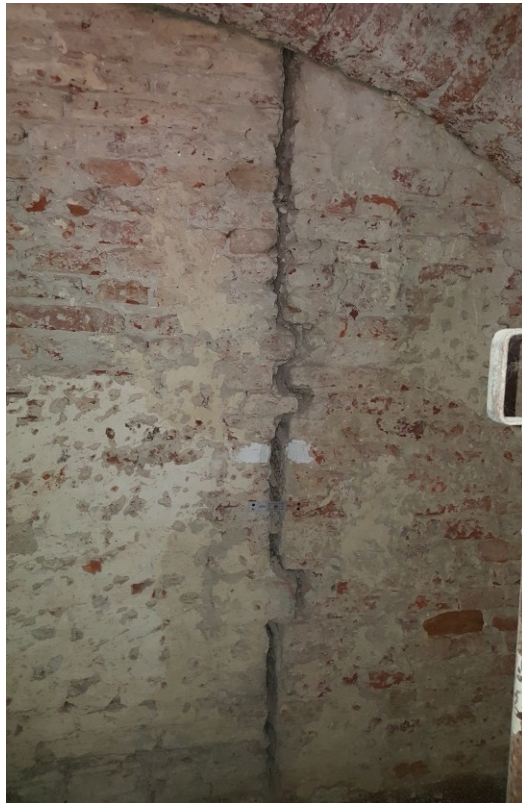
As we can see in Fig.3, on one transversal wall, the cracks are very pronounced at the 1st and 2nd floor, because of the factors revealed earlier, such as different settlements and past earthquakes, very pronounced at the windows sill area [3].

Fig.3 Cracks at the first floor

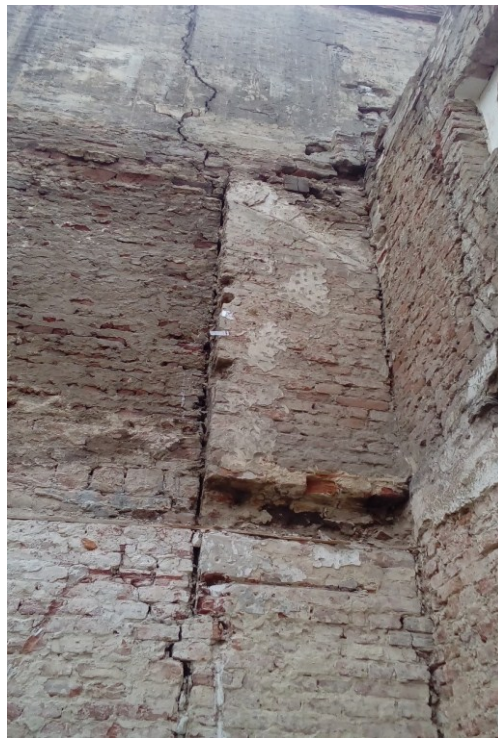
The most dangerous crack was identified on the longitudinal central wall. It starts from the superior area of the wall and continues till the basement, as we can see in Fig.4.

Fig.4 Cracks on the longitudinal central wall

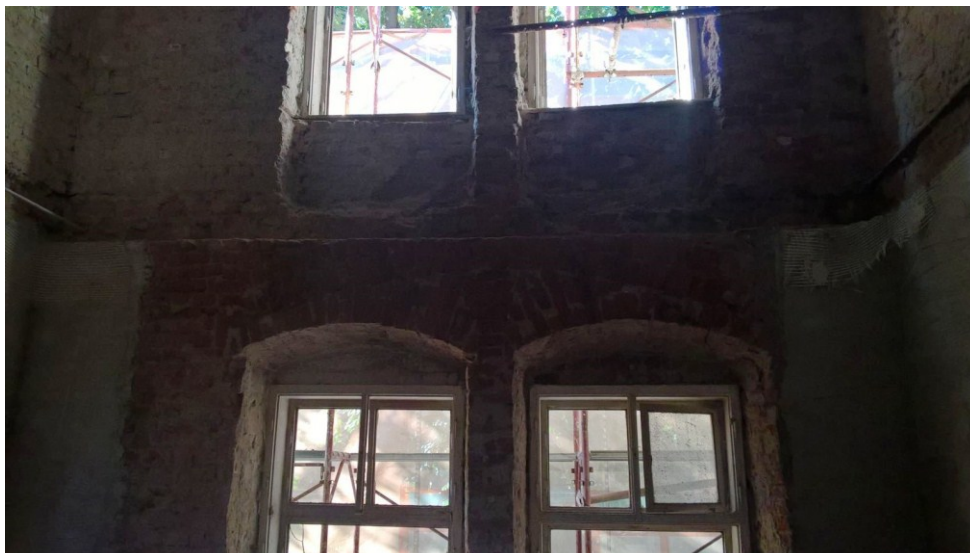
Fig.5 Consolidation of the ground floor corners

The walls were consolidated by setting some stainless steel helical joists for sewing the fissures (AISI 304). Then, a vertical and horizontal glass fibre wired mesh (Rinforzo ARV100) was mounted on top of Geocalce mortar (without cement addition). At last, some vertical metallic profiles will be set, for the stiffening of the wall [8], as we can see in Figures 5-7.

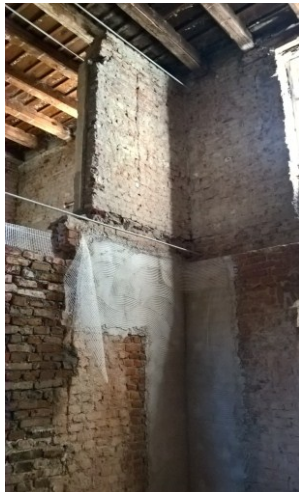
Fig.6 Consolidation of the corners

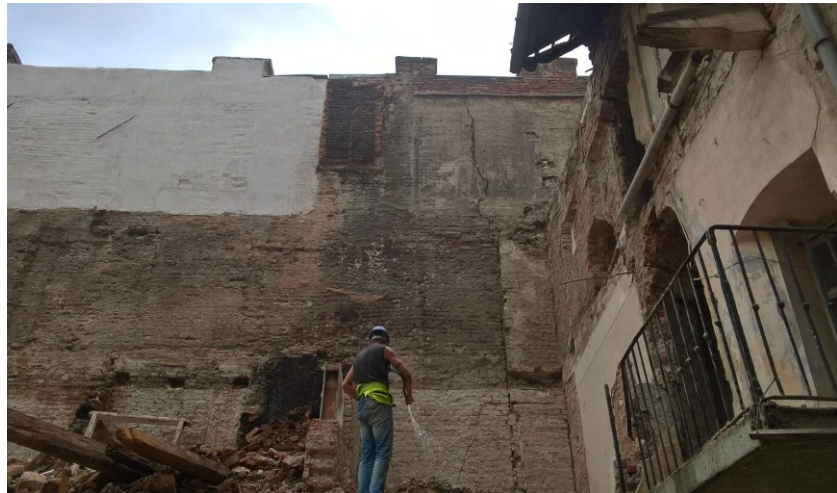
Fig.7 Consolidation of the exterior walls

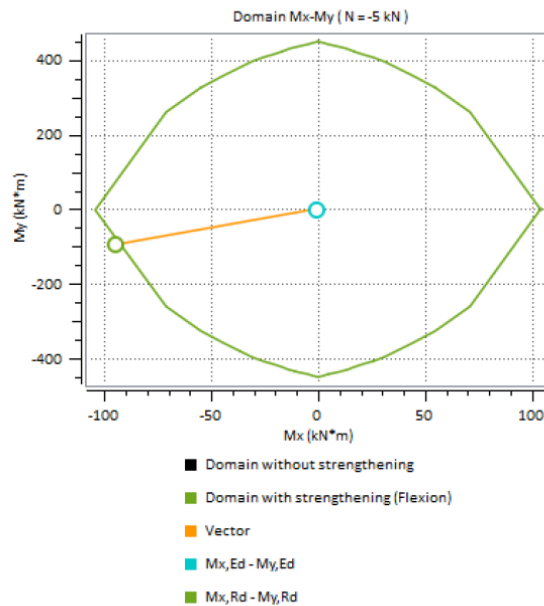
As we can see in Fig.8, the ratio between the acting moment and the resistant moment is not verified for the unconsolidated masonry wall, but it is verified for the consolidated one.

$ M_{Ed} / M_{Rd} $:	0.00529244	Ratio between the acting moment and the moment resistance:
Check Result:	VERIFIED	$[M_{Ed} / M_{Rd} \leq 1.0]$

Fig.8 Ratio between the acting moment and the resistant one

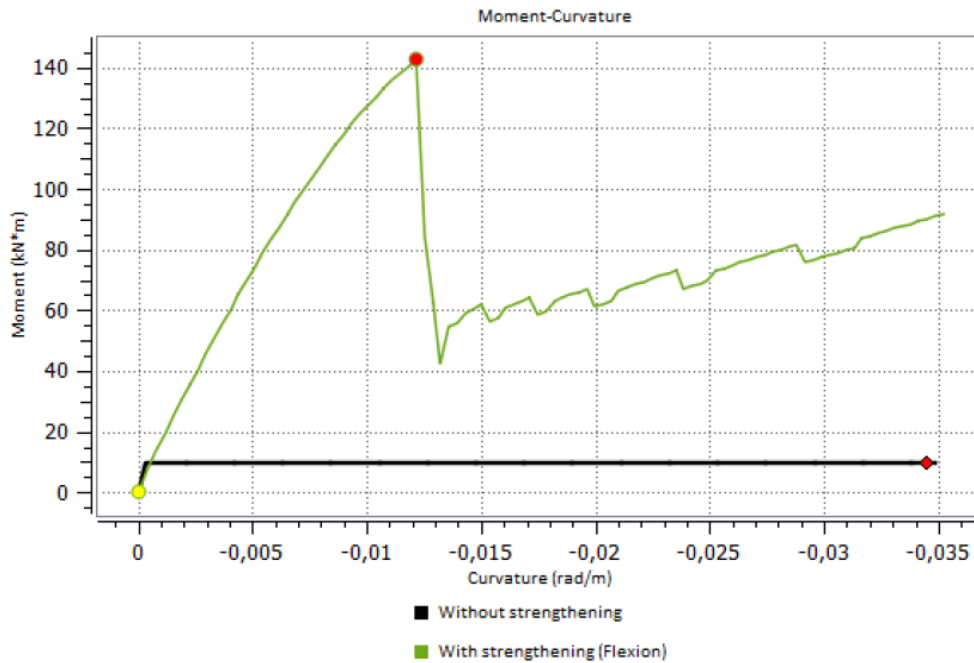
For the moment-curvature analyses, we can see a big difference between the original wall and that with strengthening interventions, as we can see in Fig.9. The ratio between shear action and shear resistance is also verified, as we can see in Fig.10.

Fig.9 Moment-curvature behaviours of original wall and consolidated one

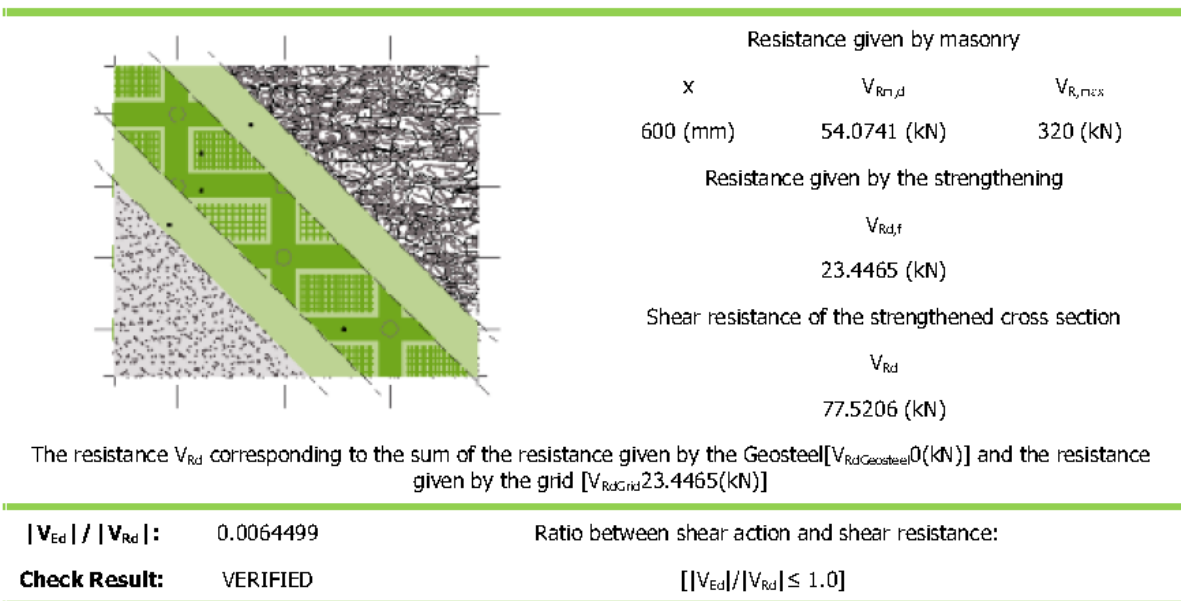
Fig.10 Ratio between shear action and shear resistance for the strengthened wall

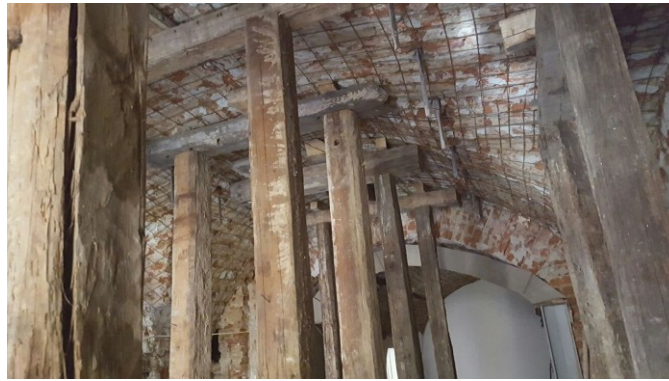
Fig.11 Reinforcement of the vault intrados

The consolidation system, composed of the Geocalce mortar, basaltic and stainless steel wired mesh, has been used for the consolidation of vaults. In particular, a special protective treatment with water-based resin and basalt fibre reinforced mortar (a mix between basalt fibre wired mesh and mineral mortar, based on pure hydraulic natural lime) was set, laying the mesh uniformly over the entire surface of the vault [3, 10], as we can see in Figs. 11 and 12.

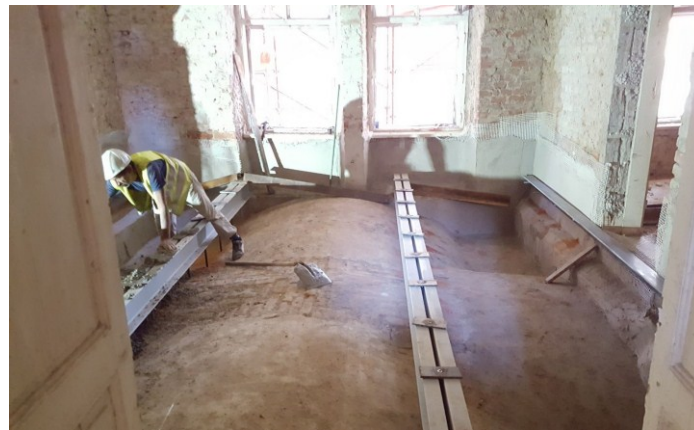
Fig.12 Reinforcement of the vault extrados
