Predictive maintenance for monitoring performance decay of plaster coverings according to the criteria of ISO 15686-7 code

Building in Naples (Italy) - Via Riviera di Chiaia, 270

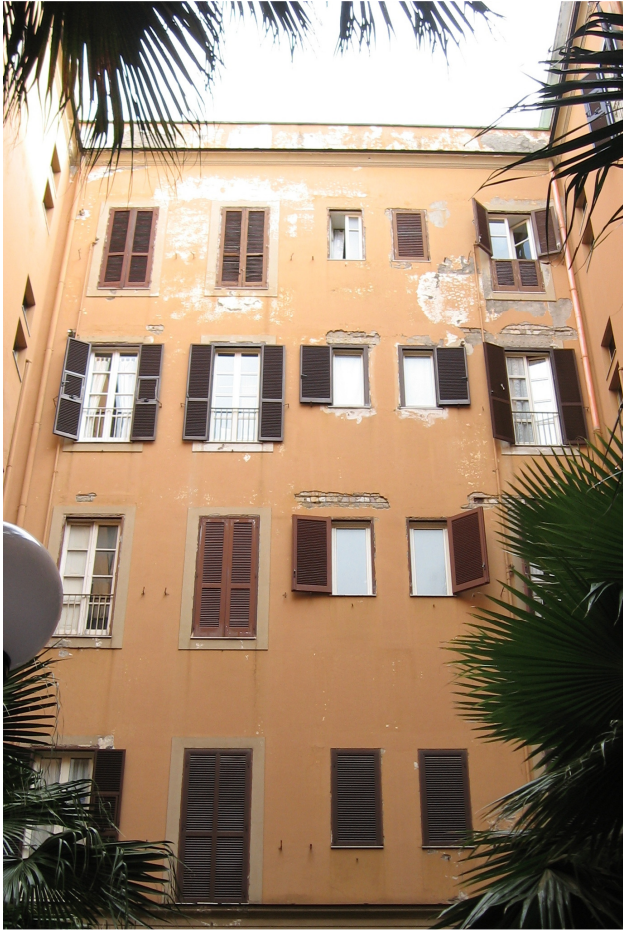
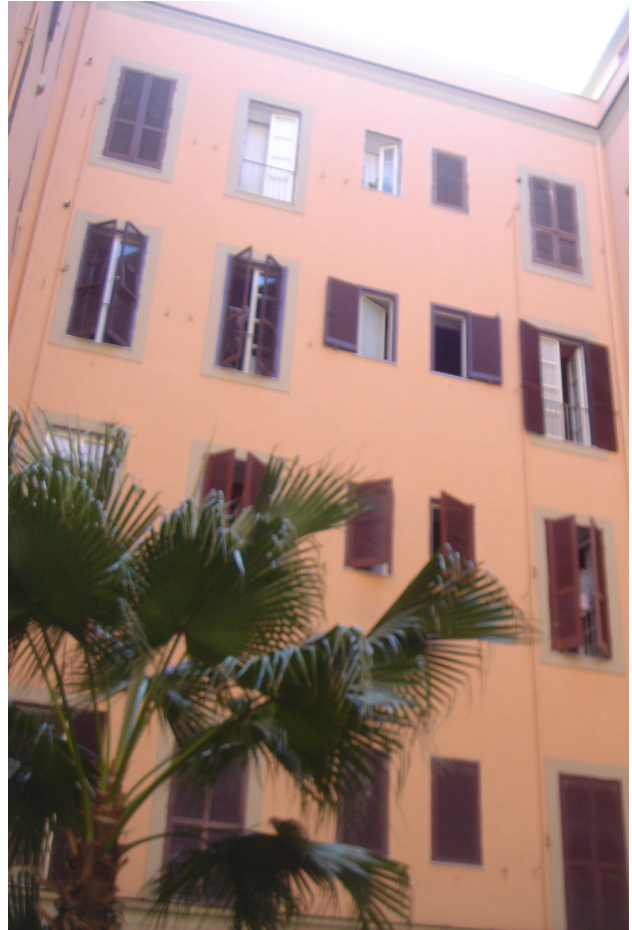
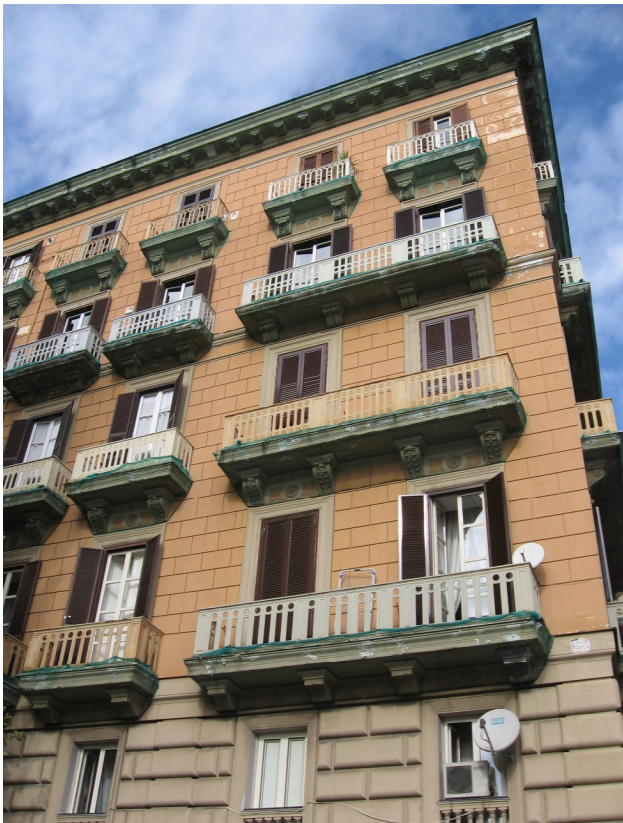
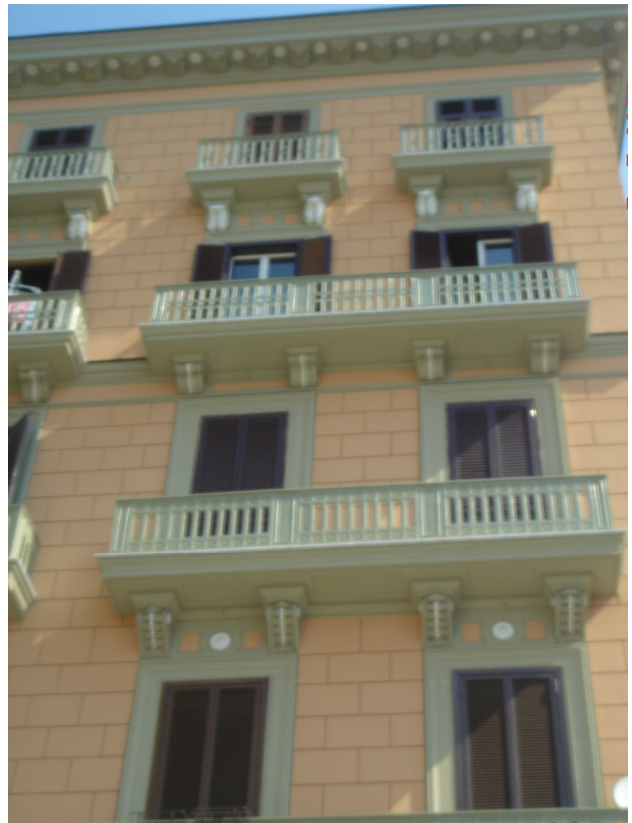
Fig. 1-2 and Fig. 3-4, for example, show an overview of the situation occurring before the interventions, with a building subjected to the following typologies of decay:

- a. chromatic alteration, as a consequence of physical aging;
- b. exfoliation of the finishing layer, as a consequence of rainwater infiltration;
- c. diffuse cracks, due to the vibrations caused by the excavation works for the realization of the subway in the adjacent underground;
- d. detachment of plaster from the surfaces of the facade, both because of phenomena of obsolescence and because of pathologies of static character, and – again - because of infiltrations;
- e. detachment of plaster and concrete from the structures of balconies, making protection systems necessary (see Fig. 3).

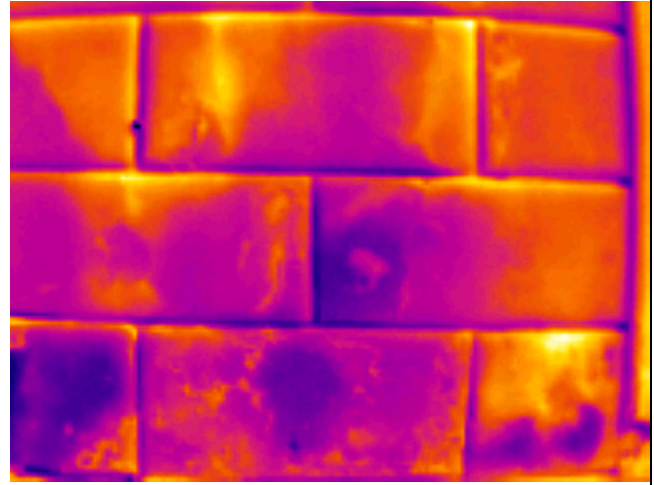
A.1

The building, dating back to '800, has been object of maintenance interventions on the external facade in the end of '90s: some years later phenomena of exfoliation of the finishing in the smooth plaster have started, while the bossed part began to show a more and more evident detachment.

Currently, the phenomena involving the smooth plaster have significantly worsened, while the detachment of the bosses from the wall seems constant, but instable.

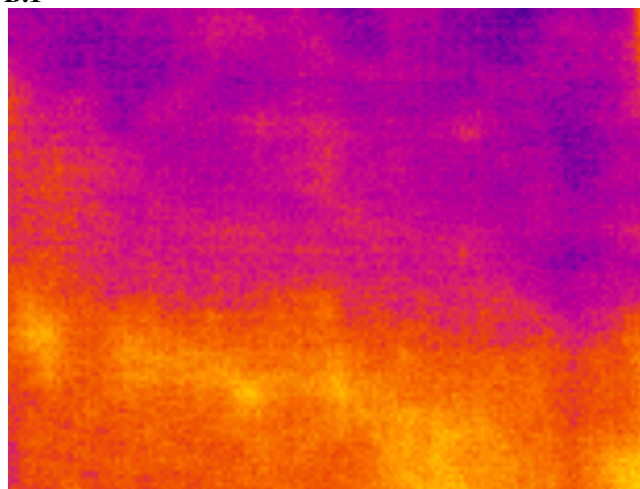
**B.1**

Maintenance interventions have recently been executed, leading to a cancellation of some of the situations that can be rilevated in the thermographic frames reported in the right, which show a little but constant worsening of the lack of adhesion of the plaster from the background.

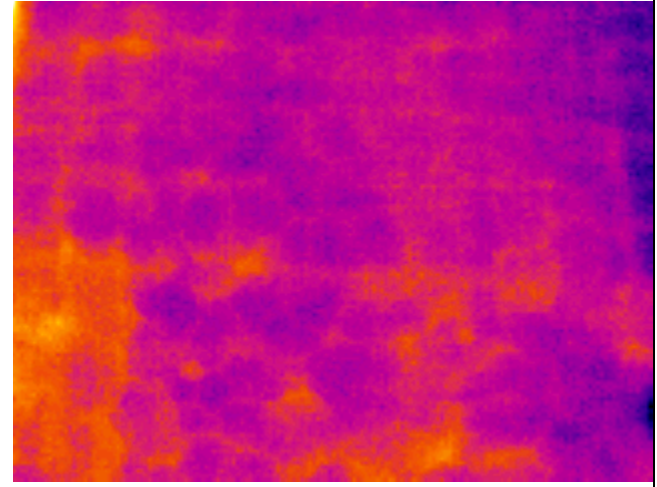
C.1

The building was subjected to maintenance interventions in 2010. Before these works, a slow and progressive worsening of the conditions of adhesion of the external plasters on the side of via Riviera di Chiaia, characterized by an aggressive climate (city environment with intense traffic and sea atmosphere) was noted. The thermographic frames refer, in particular, to the bottom of the prospect, which suffers the most from the vibrations caused by the passage of the vehicles.

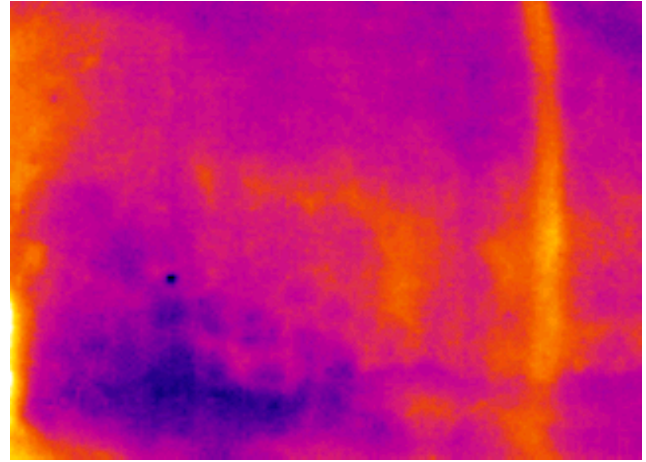
**D.1**

The building dates back to early '900. In 2003 significant interventions of maintenance were executed, including the total reconstruction of external plasters. The thermographics envisage a substantial absence of repetition of the phenomena of performance decay, which had previously occurred with the detachment of wide areas from the background. It must be noted that during the last 10 years the streets surrounding the building have been closed to traffic, removing the stress from vehicles.
