Kinematic analysis of façade collapse mechanisms in historic churches: The case of Sorrento (Naples, Italy)

Luigi Amitrano¹, Giovanna Longobardi², Antonio Formisano^{*,3}

Department of Structures for Engineering and Architecture, University of Naples "Federico II", Piazzale Tecchio 80, Naples 80125, Italy

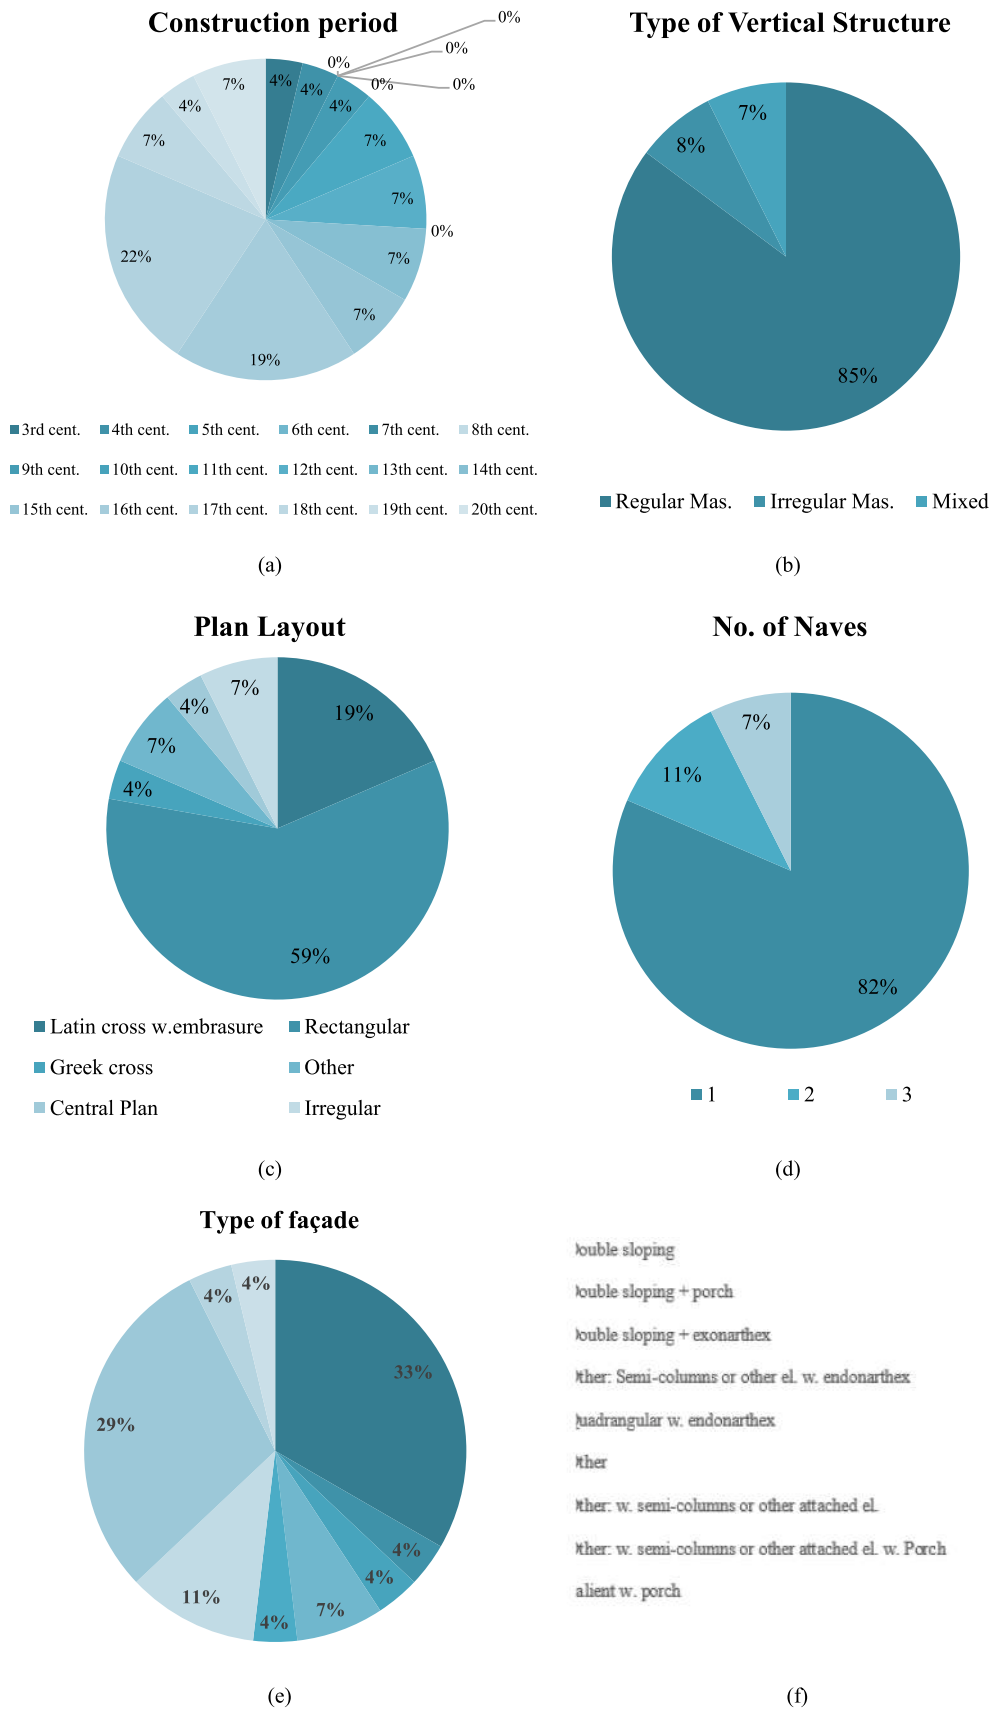
Fig. 7. Data acquired from second-level CarTiS form: a) Construction period, b) Type of vertical structure; c) Plan Layout; d) Number of naves; e) Type of façade; f) Legend.

From an architectural standpoint, the most prevalent plan layout is rectangular, observed in 59 % of the buildings (Fig. 5c), followed by the Latin cross plan. Additionally, a single nave is the dominant spatial configuration, found in 82 % of the sample (Fig. 5d), while only 7 % of the churches have more than two internal naves.

As for the main façade, the most frequently observed typology is the double-pitched façade, present in 33 % of the sample (Fig. 5e). The second most common type, accounting for 29 %, includes facades featuring semi-columns or other architectural elements attached to the external surface. Other façade configurations appear in smaller proportions.

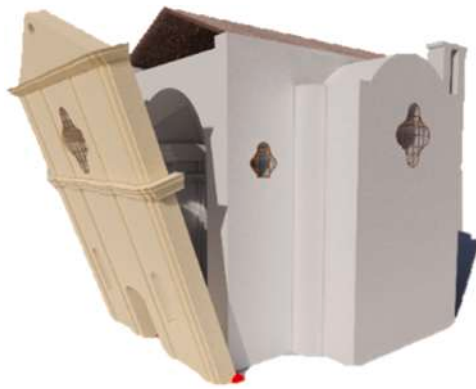
Fig. 8. Example of façade overturning characterized by the formation of a cylindrical hinge at the base of the masonry wall. The case shown refers to the Church of the Addolorata, one of the buildings included in the dataset.

Within this framework, each overturning mechanism is modelled as a kinematic chain, wherein collapse is triggered by a loss of equilibrium associated with the formation of a cylindrical hinge at the base of the masonry panel.

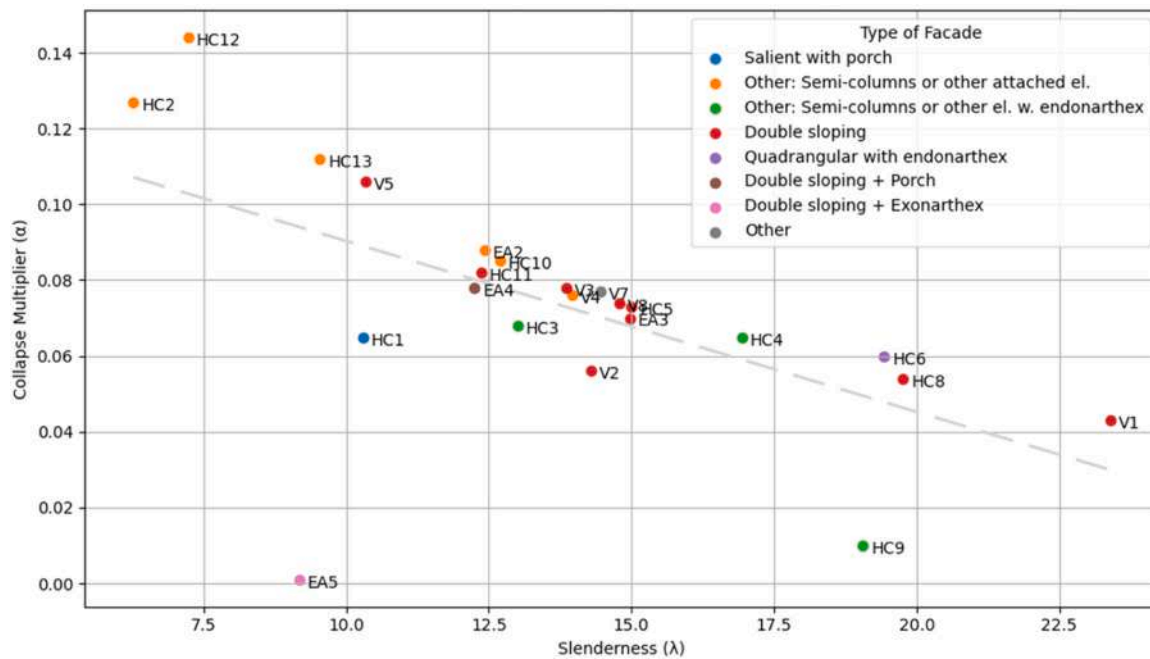
Fig. 13. Comparison between slenderness and collapse multiplier for all the typologies of facades.

Fig. 12 illustrates the relationship between the two parameters, with the slenderness ratio λ plotted along the horizontal axis and the collapse multiplier α along the vertical axis. The facades are represented by coloured points, with different colours corresponding to diverse façade typologies.

The analysis reveals a clear inverse correlation between slenderness and structural capacity: as slenderness increases, the out-of-plane resistance of the façade tends to decrease. This behaviour aligns with mechanical expectations, as slender facades typically exhibit lower stability and are therefore more susceptible to out-of-plane failure mechanisms, even under relatively moderate seismic loads.

However, some data points deviate from the general tendency. For example, typologies V5 and HC13 show relatively low slenderness values but correspondingly high collapse multipliers, while Church HC9 also exhibits a significant deviation from the main trend. These divergences may result from factors such as substantial horizontal thrusts from internal vaulted or domed structures, advanced material degradation or damage, unfavorable local geometric irregularities, and insufficient connections between the façade and adjacent transverse structural elements.

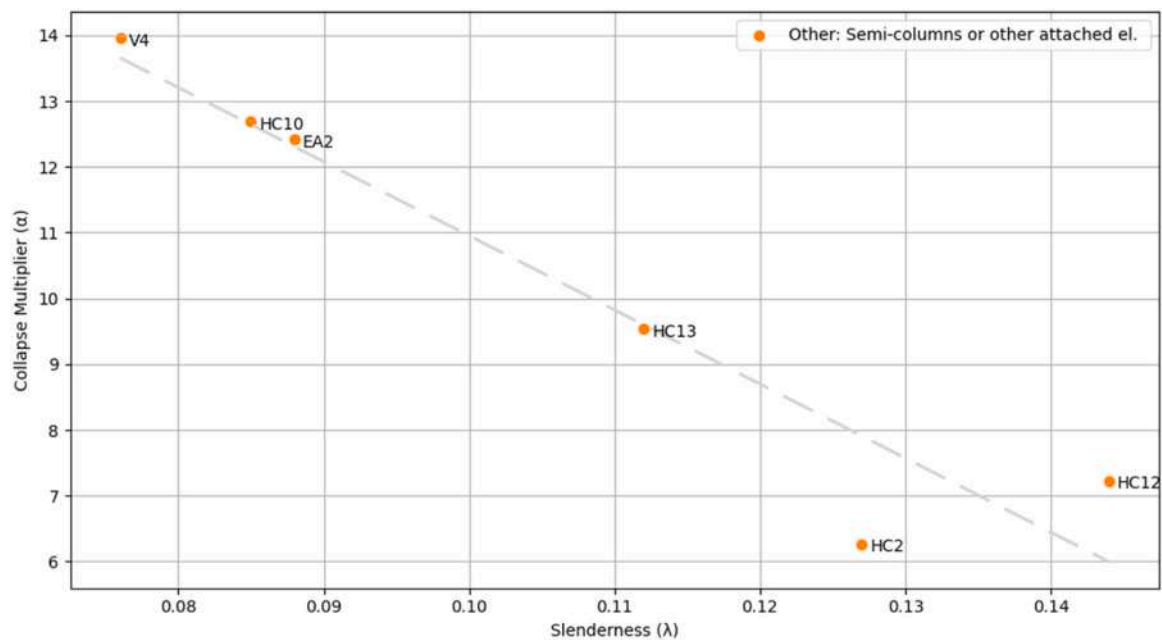
Fig. 15. Comparison between slenderness and collapse multiplier for the second most frequent typology of façade (Other typologies with semi-columns and other attached elements).

The second prevalent façade typology demonstrates inconsistent performance under loading. Architectural features such as semi-columns and decorative elements, though visually prominent, offer no structural contribution unless effectively bonded to the façade. More often, they act as independent bodies, rendering them highly susceptible to transverse actions.
