# Non-destructive evaluation and Structural Health Monitoring of impact induced damage in composite structures using ultrasonic approaches and shearography

**Abstract.** Composite structures are massively used thanks to the high strength-to-weight ratio, making them ideal for lightweight and durable structures in aviation. However, impact may arise at any time during lifetime on composite aerostructures and ensuring their structural integrity via fast inspection is essential to meet airworthiness criteria. Multimodal NDT (Non-Destructive Testing) inspection and characterization of composite structures is a critical process to verify the quality of the composite material and identify any defects. In this context, the paper shows a comparison of different techniques as nondestructive methods: shearography, and phased array ultrasonics. In particular, using shearography as non-contact approach can increase the inspection speed and reliability compared to the state of the art phased array ultrasonics, which is the standard approach used in the aerospace field. For this reason, a sample of interest to the aerospace industry is subject to a debonding, simulated as the result of low velo

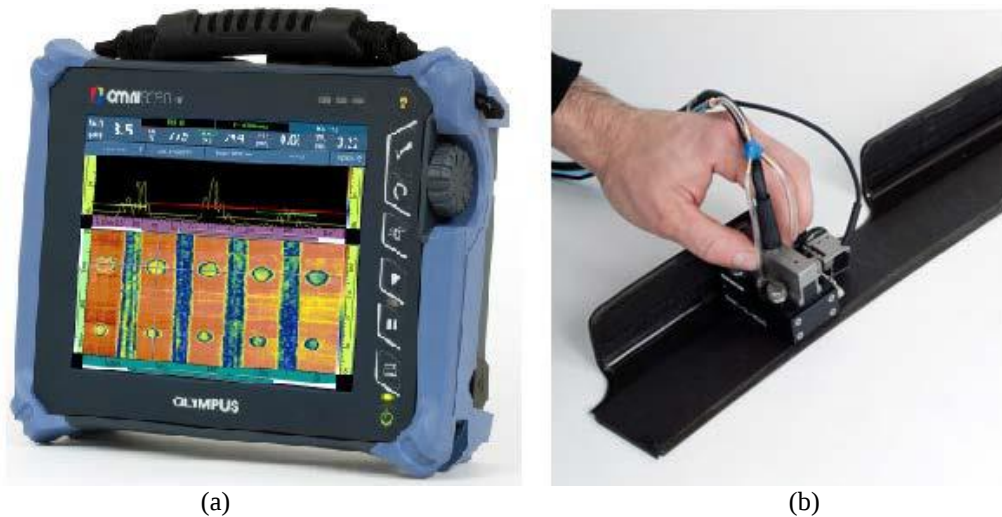
**Fig. 2.** Olympus OmniScan SX flaw detector (a) equipped with a 16:64PR phased array unit (b) able to perform pulse-echo, pitch-catch or TOFD inspection on composite structures.

A first non destructive inspection is carried out by a Phased Array Ultrasonic Testing (PAUT) by Olympus OmniScan SX flaw detector (Figure 2) equipped with a 16:64PR phased array unit able to perform pulse-echo, pitch-catch or TOFD inspection. An encoded 5 MHz, 64 elements linear array probe with a straight wedge is used, coupling the probe and the inspected panel surface with a specific water based gel (Figure 2 b). No calibration blocks are used and the specimen thickness on the unstiffened skin is considered as reference. Tests are carried out with the phased array positioned over the smooth (outer) surface of the specimen, the probe is moved physically along the longitudinal axis while the ultrasonic beam electronically scans along the transverse direction. A mini wheel encoder is used to maintain a precise geometric correspondence of the B-, S-, and C-Scan images with the scanned part. In principle, when detecting debondings, the echo in the A-scan from the interface between skin and stringer is slightly visible when bonding is ensured while its amplitude gets higher when disconnection occurs.
