# Observations on hydrological state of volcanic soil covers: the Celario slope case

**Abstract.** On November 26, 2022, a persistent rainfall triggered several landslides in volcanic soil covers and tuff rock slopes in the northern part of Ischia Island (Italy). The most destructive event was triggered by the impact of a weathered rock mass falling from an above-standing vertical front, then a mudflow was channelized along an open slope with convex morphology, known as “cava Celario”. The main preparatory factor for this landslide was the rainfall-induced drop in suction throughout the pyroclastic cover. Further insights into the amount of suction evolution at the landslide trigger time were thought to be helpful to define proper mitigation strategies. An on-site monitoring activity was undertaken, aiming at characterizing the evolution of the hydrological state of the deposits, through the monitoring of suction within the still-intact deposit located laterally to the landslide initiation zone of Celario, approximately 50 m below the uppermost triggering zone. The suction measurements were correlated with meteorological variables, hence recognizing that the accuracy of the foreca

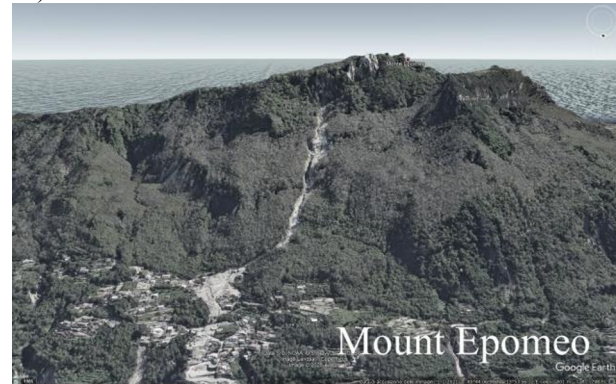
**Fig. 2.** a) View of northern slope of Mount Epomeo from Google Earth (year 2024); b) picture of video footage taken with a drone of the landslide area

Among the many phenomena that occurred on the above mentioned slope, primarily triangular or ribbon-shaped, the one tragically known as the Celario landslide (Figure 2a) originated from the topmost pyroclastic deposits, about 50 cm thick. Video footage taken with a drone showed that the landslide crown area has a triangular geometry, with an apex located at the foot of the ridge of a higher sub-vertical slope (Figure 2b). This triangular shape results from progressive phenomena, which, due to the unstable stress-strain response of the material involved, expand in the direction of propagation, starting from a triggering point at the apex.

The drone footage confirmed that the trigger occurred at the apex, which was impacted by several cubic meters of pyroclastic debris and rock blocks that failed from about 50 m above. After displaying a

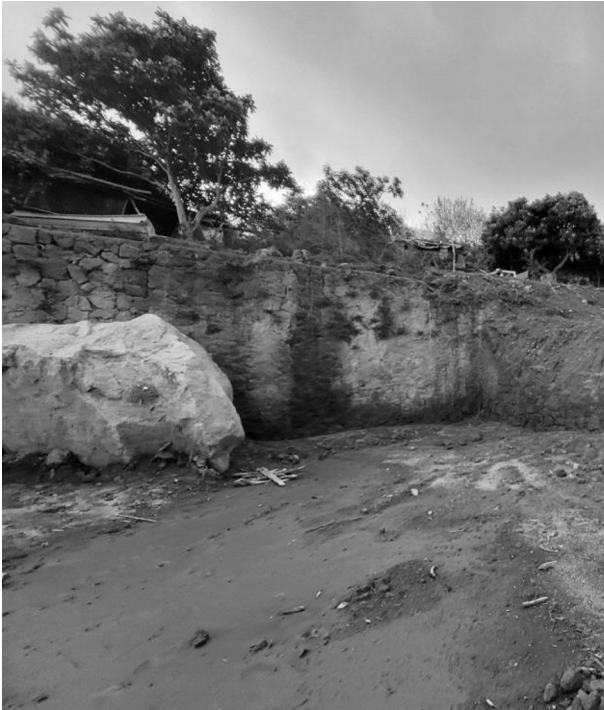
**Fig. 3.** Picture of blocks of tuff rock involved in the runout of the landslide.

triangular shape, the landslide channelled downstream into a groove in the tuff slope containing pyroclastic residuals of different sizes, from silty sand to blocks of several cubic meters, generated by past erosion or landslide phenomena (Figure 3). Inside the channel, the debris increased in volume and speed, uncovering the green tuff formation and turning into a flowslide of considerable magnitude. The landslide determined the loss of twelve lives, including a newborn and two children.

The channelized propagation stage resembles several phenomena occurred at Sarno (1998), with the singularity that this flowslide involved not only medium-fine grained pyroclastic soils (about 40,000 m<sup>3</sup>) but also significant volumes of rock blocks from the previous disintegration of the green tuff formation (about 1,000 m<sup>3</sup>).
