A complex slope deformation case—history

Abstract Slope movements represent a class of phenomena, which can display a great variety of styles, sizes and displacement rates. Some are extremely rapid, short-lived and highly destructive; others are extremely slow and apparently endless. This paper describes an extremely slow soil slope deformation process that is probably active since thousands of years and will certainly go on for many years to come. The results of in-depth investigations carried out after the 1980 Irpinia-Basilicata earthquake integrated by satellite images covering the time interval 1992–2013 have provided a global and consistent framework that allows to draw a reliable scenario about the effects of the geological processes that are active in the area on slope deformation mechanisms.

The Bisaccia hill and its geomorphological setting

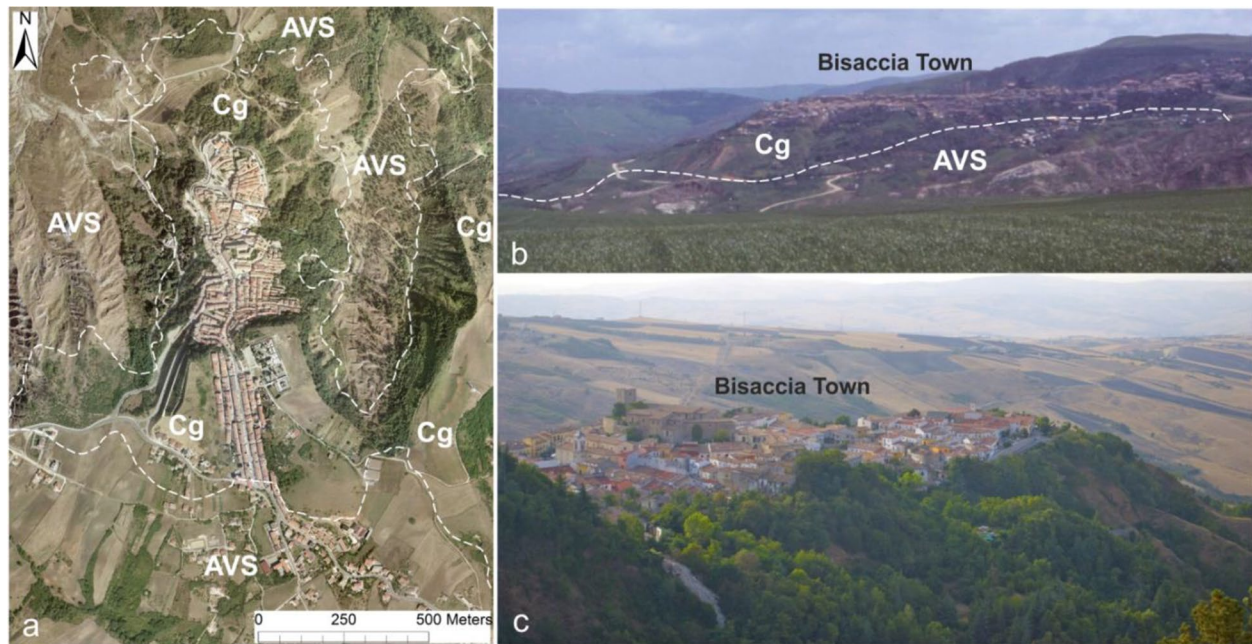
Fig. 1 The Bisaccia hill: **a** orthophoto, **b** the Western and **c** the North-Eastern hillslope. Cg Poligenic conglomerates within a sandy matrix (Pliocene); AVS “Argille Varicolori” formation (Miocene-Oligocene)

Bisaccia hill (Fig. 1) is located in the Southern Apennines chain, 135 km North-East to Naples, Italy. It is a thick elongated platform extending in the South-North direction, which consists of slightly cemented polygenic Pliocene conglomerates overlying the Tertiary tectonized “Argille Varicolori” formation, a deep deposit essentially constituted by high plastic clay shales (Ogniben 1969; D’Argenio et al. 1973; Bonardi et al. 1988).

The conglomerate deposit fills a synclinal that is subjected to intense erosion phenomena, which led to formation of two narrow parallel valleys that bound the eastern and western sides of the hill (Fig. 1a), the eastern “Vallone dei Corvi” and the western “Vallone Ferrelli”. As a matter of fact, erosion has completely dismantled the conglomerates and is rapidly deepening into the fine-grained bedrock. The hill is cyclically hit by earthquakes. The last strong events occurred on July, 23, 1930 ($M = 6.7$), on August, 21, 1962 ($M = 6.4$), and on November, 23, 1980 ($M = 6.9$). The 1980 earthquake, which killed about 3000 people in a vast area of Southern Apennines, is known as the Irpinia-Basilicata earthquake.

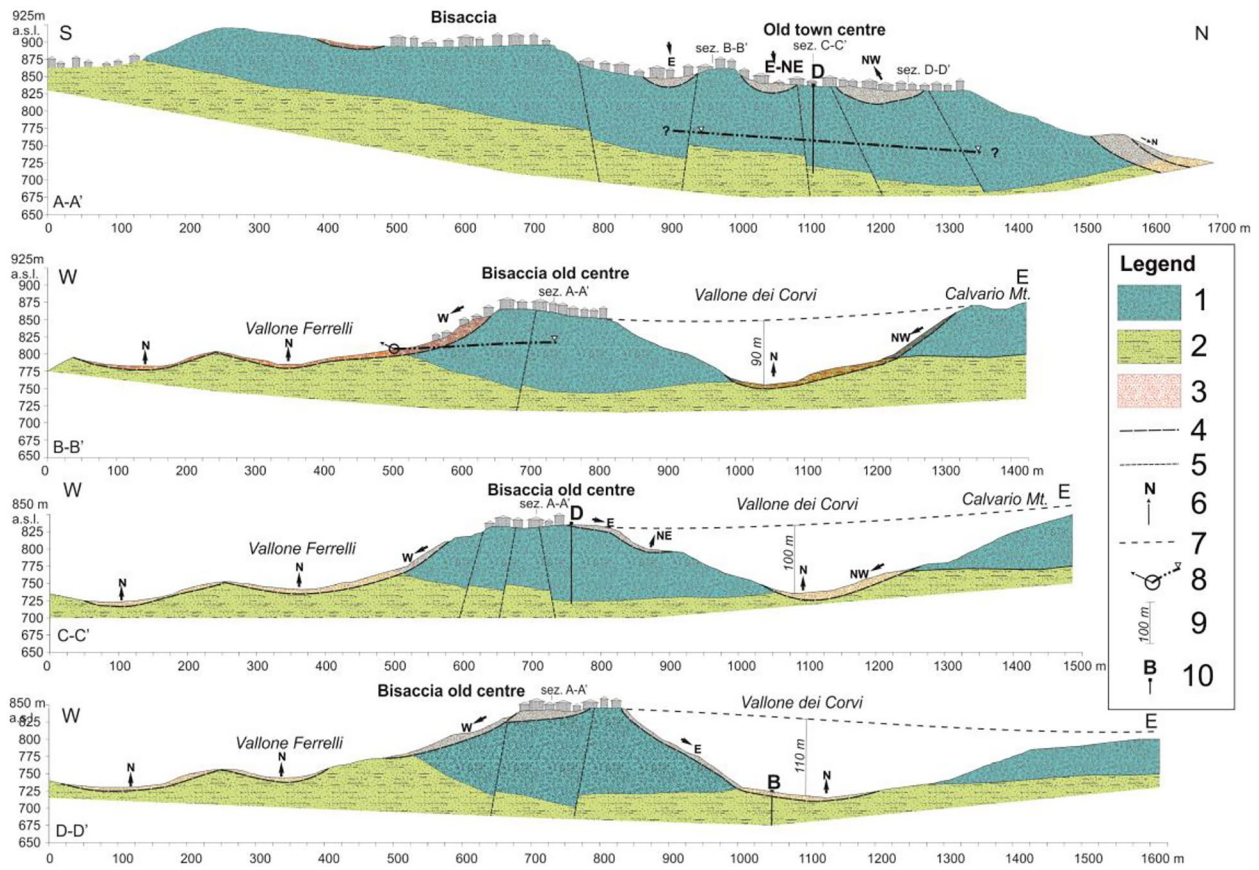
Fig. 3 Geological cross sections of the hill (see Fig. 2): 1 poligenic conglomerates with a sandy matrix; 2 Argille Varicolori formation; 3 accumulation zone; 4 failure surface; 5 major fracture; 6 direction of

landslide movement; 7 presumed original profile of the conglomerate top; 8 spring and water table surface based on data from borehole D; 9 presumed original conglomerate thickness; 10 borehole

The geological sections in Fig. 3 show some subvertical fractures crossing the platform, which displays a stepped morphology characterised by some escarpments and by three terraces located at elevations ranging between 825 and 900 m a.s.l. (Fig. 3a). A major escarpment, about 40 m high, subdivides the town into two parts: the historic downtown (located in the northern sector) and the more recent urban centre located on the highest terrace (southern sector). According to Crescenti et al. (1984), the major escarpment might bound a South-North ancient landslide.

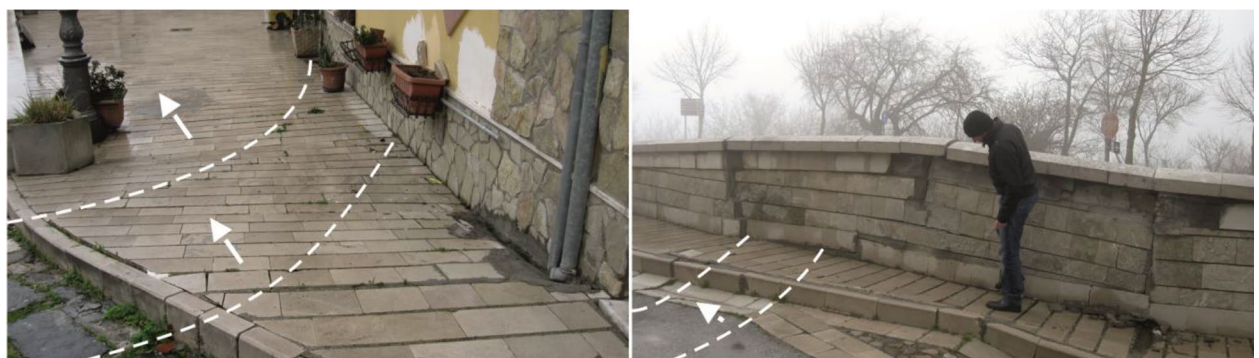
Fig. 4 Effects of ongoing slope movements

As a result of erosion, the boundaries of the platform are subjected to shallow landslides, which generally have their toe into the basal fine-grained deposit. The consequence of these phenomena is a progressive irregular thinning of the hill top, especially in the northern sector (Figs. 2 and 7). The main landslides are shown in Figs. 2 and 3. Figure 4 shows the effects of landslides involving the platform.

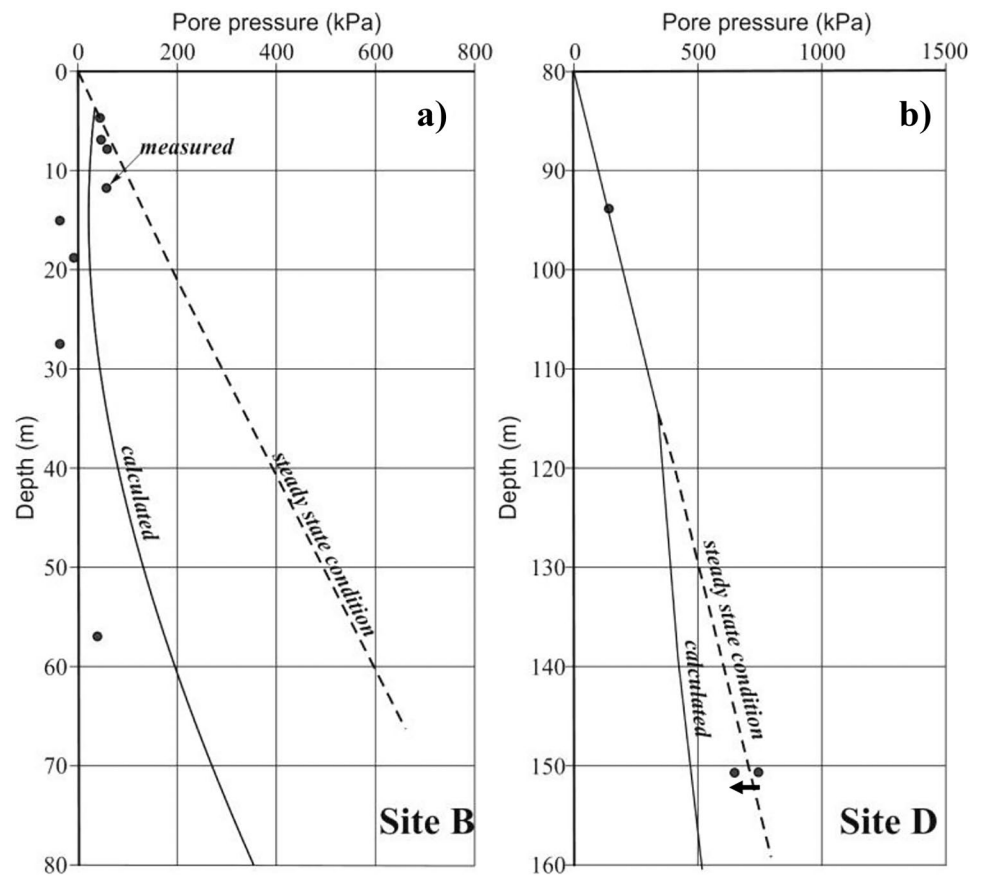
Fig. 6 Pore water pressures measured below the Vallone dei Corvi bed (a) and below the conglomerate platform (b), compared to results of numerical simulations (after Di Nocera et al. 1995)

borehole. The results of all readings over a time interval of 2 years are shown in Fig. 6a. All instruments display quite low values. In particular, the pore pressures measured at Casagrande piezometers were positive and less than the presumed steady-state value obtained from the numerical analyses discussed below, while as

mentioned above, negative values were measured by three deeper vibrating wire cells. Notice that the negative readings reported in the figure are the stable value (around -10 kPa) measured through the last cell at a depth of 27.5 m and those measured before cavitation at the other two cells. In the borehole D located in the town, a Casagrande piezometer was installed at a depth of 95 m within the conglomerate formation, while a vibrating wire

cell was placed in the clay shale deposit at depth of 149.5 m, i.e. 54.5 m below the basal surface of conglomerates. The first piezometer allowed measuring the water level, in the conglomerate slab, 35 m above the top of clay shales (Fig. 6b). Surprisingly, the cell installed in clay shales recorded a continuously decreasing level. In fact, as indicated by the small black arrow in the figure, the pore pressure measured in 1991 (i.e. 11 years after the 1980 earthquake), which is quite higher than the presumed value calculated for steady-state conditions (dotted line), in the following years progressively decreased below the steady-state value.

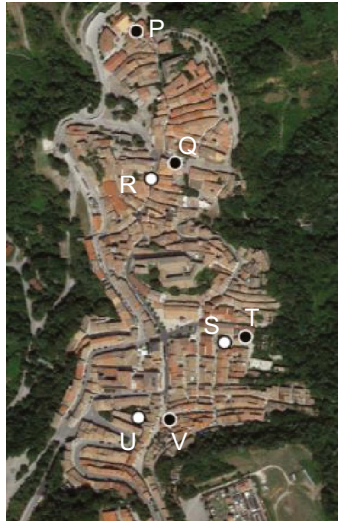
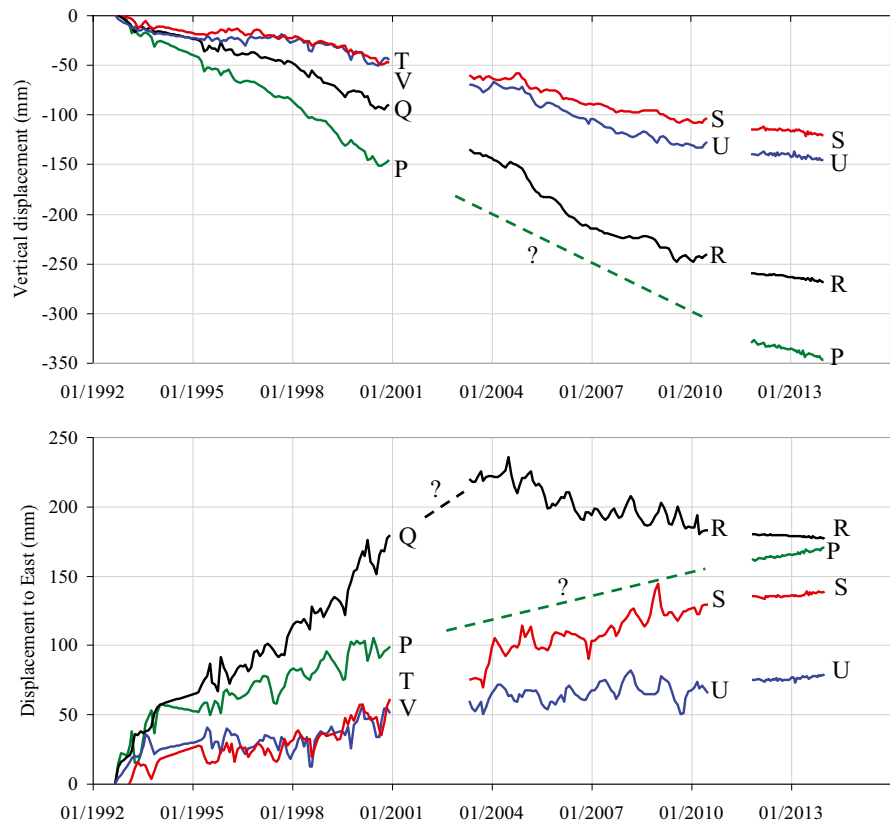
Fig. 11 Time series, for a number of buildings, of vertical displacement (negative if directed downwards) and displacement to East, obtained from satellite ERS, Envisat and CSK data

To further deepen the subject, Fig. 11 shows vertical and West–East displacements of a number of representative buildings for which data are available for both ascending and descending satellite passes in different time intervals. Such an information can be considered more accurate than that provided by Fig. 10, being the data related to specific buildings rather than averaged on wider areas although, of course, more discontinuous in space. For CSK satellite data (2011–2013), since only descending orbit data are available, vertical and W–E displacements were obtained under the hypothesis that their ratio is equal to that obtained in the Envisat monitoring period 2003–2010. The displacement field appears consistent over the entire 20 years observation period (1992–2013), with some evident rate changes in time. For instance, in the zone of buildings Q and R, which are quite close to each other, higher vertical displacement rates have been recorded in the period 2003–2007 than in the interval 1992–2003. On the other hand, if the whole monitoring period is considered,

displacement rates globally seem to decrease with time in the entire built area. The trend of horizontal displacements in the W–E direction appears more complex, with more evident variations in the average yearly rate in some zones than in others, and an apparent change of sign in the zone of buildings Q and R.

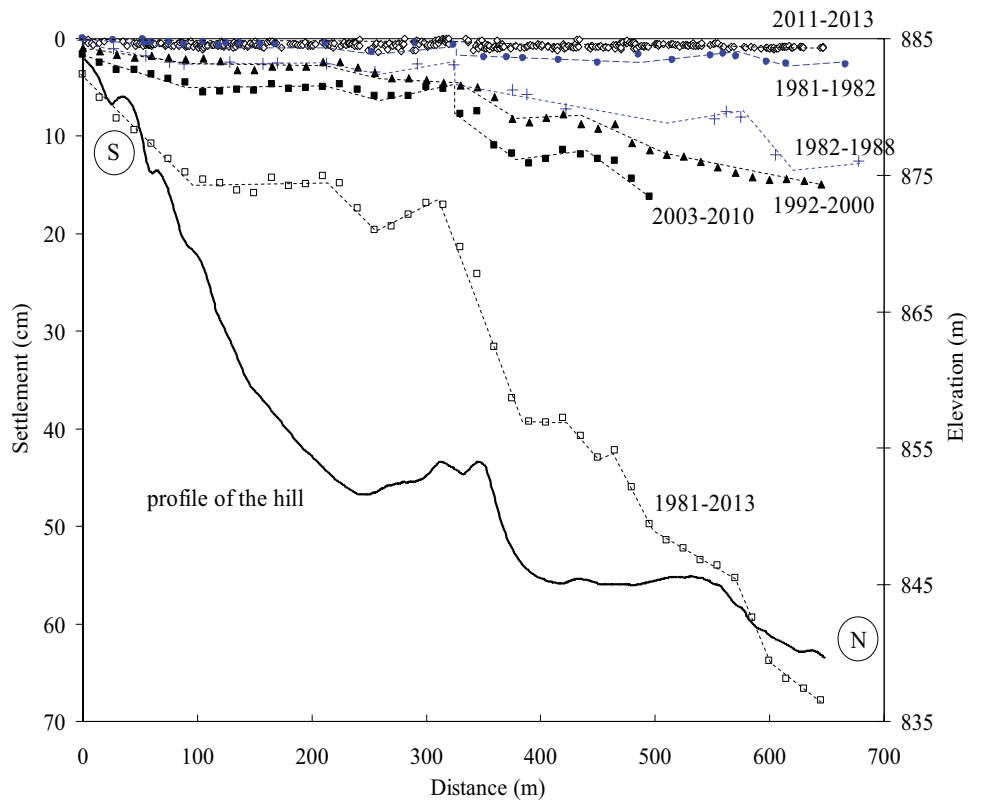
Fig. 12 Summary of data available about vertical displacements along the main axis of the downtown: topographic readings (1981–1982; 1982–1988); satellite images (1992–2000; 2003–2010; 2011–2013); total (1981–2013)

An updated profile of vertical displacements in the South–North hill axis is plotted in Fig. 12 where it is again compared to the platform profile. As a first useful consideration, the trend of recent readings is fully consistent with the previous one. The figure also shows the cumulative 1981–2013 displacements obtained by summing the data from satellite images to those obtained from topographic readings (Fig. 8), integrated with extrapolated values that cover the “black holes” in the time intervals 1988–1992, 2001–2003 and 2010–2011. The obtained plot again suggests a long-lasting deformation process, presumably started well before the 1980 earthquake and characterized by apparently independent movements of single blocks, which led to the present platform profile. The peak

settlement value from 1981 to 2013, just at the northern boundary of the platform, is approximately 70 cm, which corresponds to a rate a little higher than 2 cm/year.

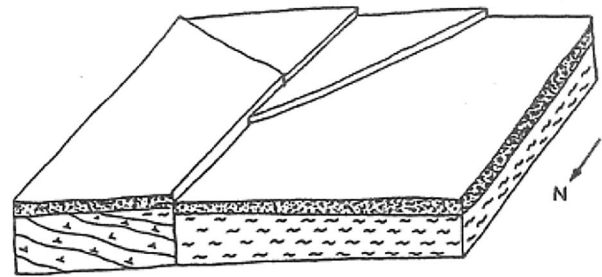
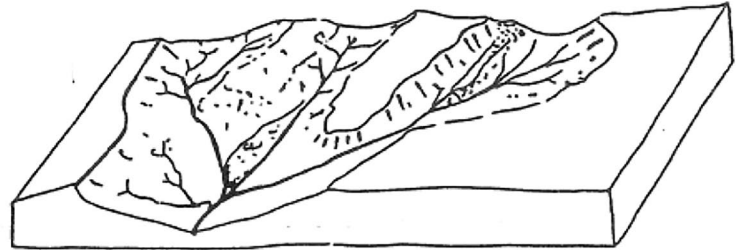
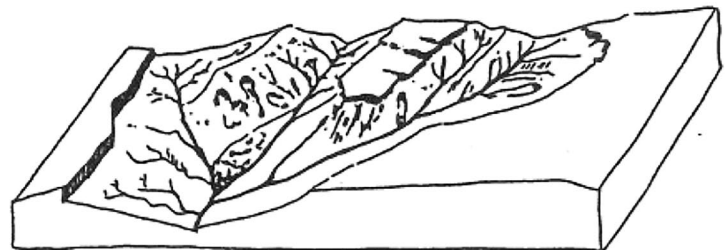
Fig. 13 Evolution of the Bisaccia area (after Di Nocera et al. 1995)

Based on geological data, erosion is supposed to have started about 300,000 years ago along two parallel faults more or less corresponding to the axes of the lateral valleys. Figure 13 schematically reports the geological evolution of the area. Such a process was simulated through a 2D FEM numerical analysis (Picarelli and Urciuoli, 1993). The initial top of conglomerates was assumed to be horizontal, and then these were gradually removed in order to reproduce the present morphology of the area. The rate of conglomerate erosion was considered to be either constant or variable assuming a threefold increase after complete dismantling of the slab in order to account for the different erodibility of conglomerates and of clay shales. The groundwater table was initially located at the top of clay shales, then, after removal of the uppermost conglomerate layer, it

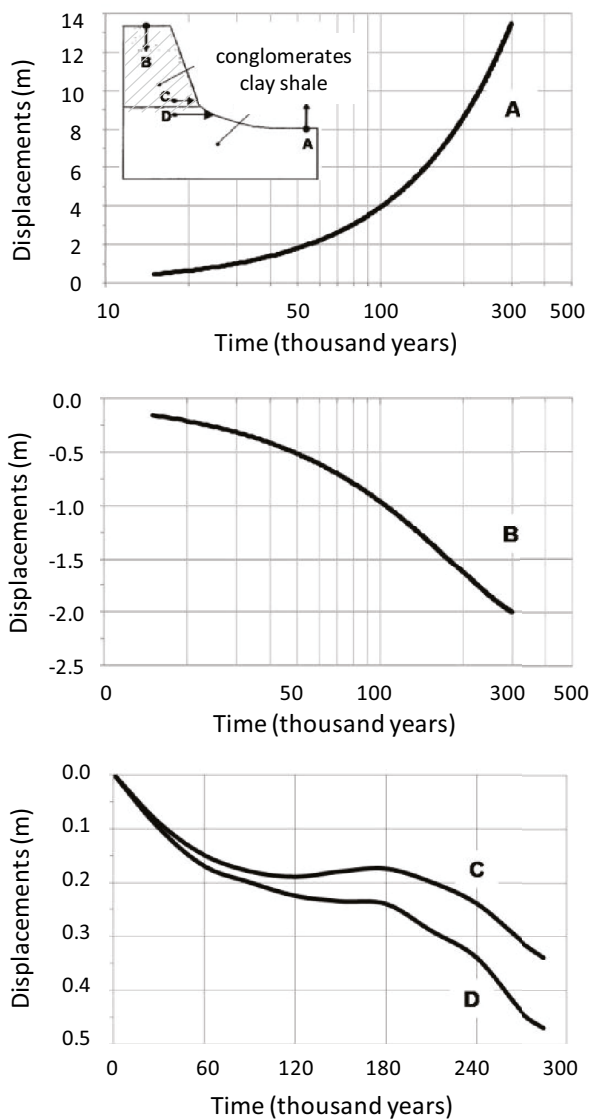
Fig. 14 Calculated time-dependent swelling of the centre of the valley's bed (A), settlement of the hill (B) and horizontal displacements of conglomerate bed (C) and clay shale top (D) (Urciuoli 1992)

The main result of the analysis was a strong and delayed swelling of the valley floors (a in Fig. 14) and some sinking of the hill within the basal formation (b in Fig. 14) due to the combined effect of unloading caused by erosion and both high deformability and low permeability of clay shales (Urciuoli 1992; Picarelli et al. 2002). Another important output was some lateral spreading of the hill due to decrease of the lateral confinement; in particular, the analysis suggests the formation of a shear zone at the top of the basal formation (c and d in Fig. 14). Some clues about that might be provided by the water content profiles of clay shales (Fig. 15) obtained from measurements on samples taken from the boreholes B and D, compared to the values calculated through the numerical analysis

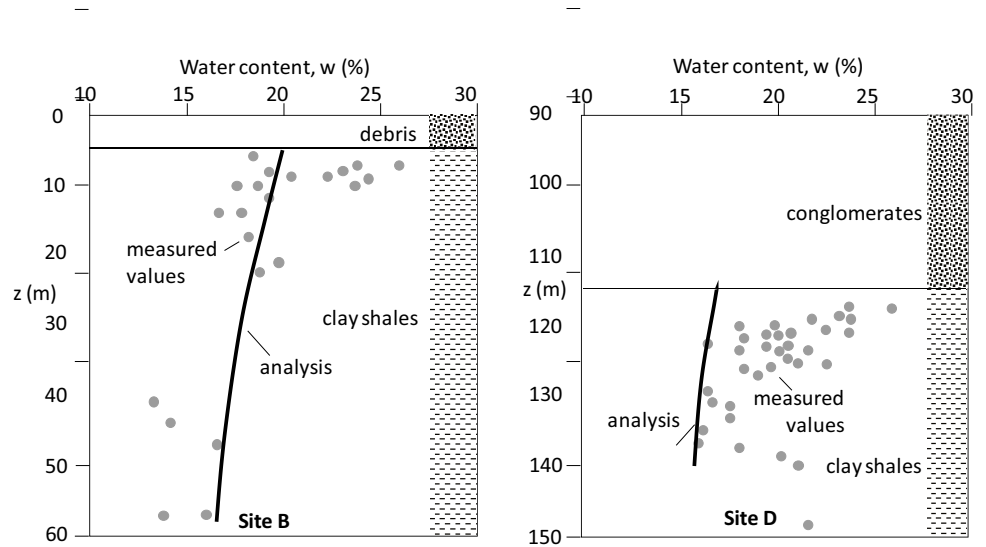
Fig. 15 Measured and calculated water content profiles in the subsoil of eastern valley (**site B**) and under the conglomerate bed (**site D**) (redrawn after Picarelli and Urciuoli 1993)

(Picarelli and Urciuoli 1993). In particular, while these last can capture the trend of the water content profile along the vertical B, they underestimate the water contents measured within a depth of about 15 m under the platform. This might just indicate the presence of a thick shear zone generated by the process of lateral spreading discussed above.

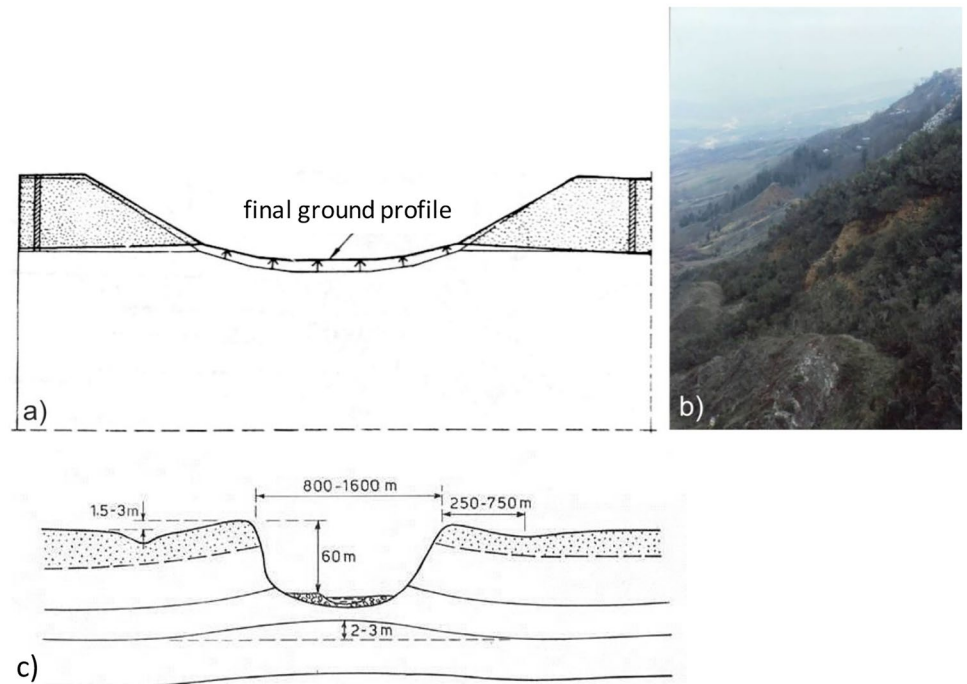
Fig. 16 a) Simplified cross section of the Bisaccia hill and displacement vectors obtained from numerical analysis (Picarelli and Urciuoli 1993); **b)** the Eastern Bisaccia hillslope that is sinking in the clay shale deposit; **c)** effects of erosion in the Saskatchewan river valley (Matheson and Thomson 1973).

Figure 16a shows the calculated deformation of a cross section of the platform. In particular, it shows that the lateral blocks are subjected to some rotation, which implies a distortion of the slab and formation of a concave interface at the conglomerate-clay shale contact. The figure also suggests the development of tensile stresses at the base of the platform, which might lead to formation of further vertical cracks. Interestingly, a similar deformation field as in Fig. 16a has been observed in some Canadian river valleys indented in highly plastic clay shales (Fig. 16c).

All these results are consistent with the general framework provided by field surveys and by monitoring, depicting in a convincing way the deformation process of the platform. Figure 16a, in particular, clearly shows the mechanism of sinking of conglomerate blocks in the bedrock (see also Fig. 16b). Also, a careful consideration of

Fig. 16a could explain the observed horizontal movements in the East–West direction as a result of the combined effect of lateral spreading and of tilting of blocks that is confirmed by the tilting of some buildings (Di Marino 2011); in particular, a clockwise or anti-clockwise rotation can justify westward or eastward movements. It also justifies the presence a deep aquifer above the deformed concave top of the bedrock under conglomerates as shown by piezometer readings in borehole D (Fig. 6b). Finally, the analysis allows explaining the deficient pore pressure field measured in the subsoil of the eastern valley (borehole B, Fig. 6a). In fact, due to the low permeability and high depth of the fine-grained bedrock, the erosion rate is quick enough to generate a constant deficient pore pressure regime within a deep zone under the valleys bed (Koppula and Morgenstern 1984; Fenelli and Picarelli 1990). Such a pore pressure regime seems to play a significant role on the stability of the hillslopes. In fact, accounting for the low shear strength of clay shales, a steady-state pore pressure profile (as in Fig. 6) would imply the triggering of deep landslides favoured by the presence of vertical fractures in the conglomerate slab. Under this condition, the platform should have been completely dismantled by landsliding since long time. Instead, due to

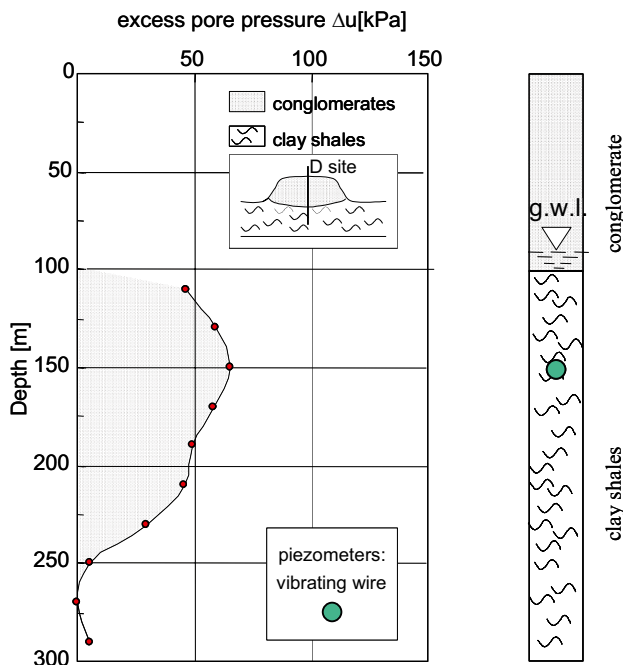
Fig. 17 Calculated excess pore pressures induced by the Irpinia-Basilicata earthquake (Olivares and Silvestri 2001)

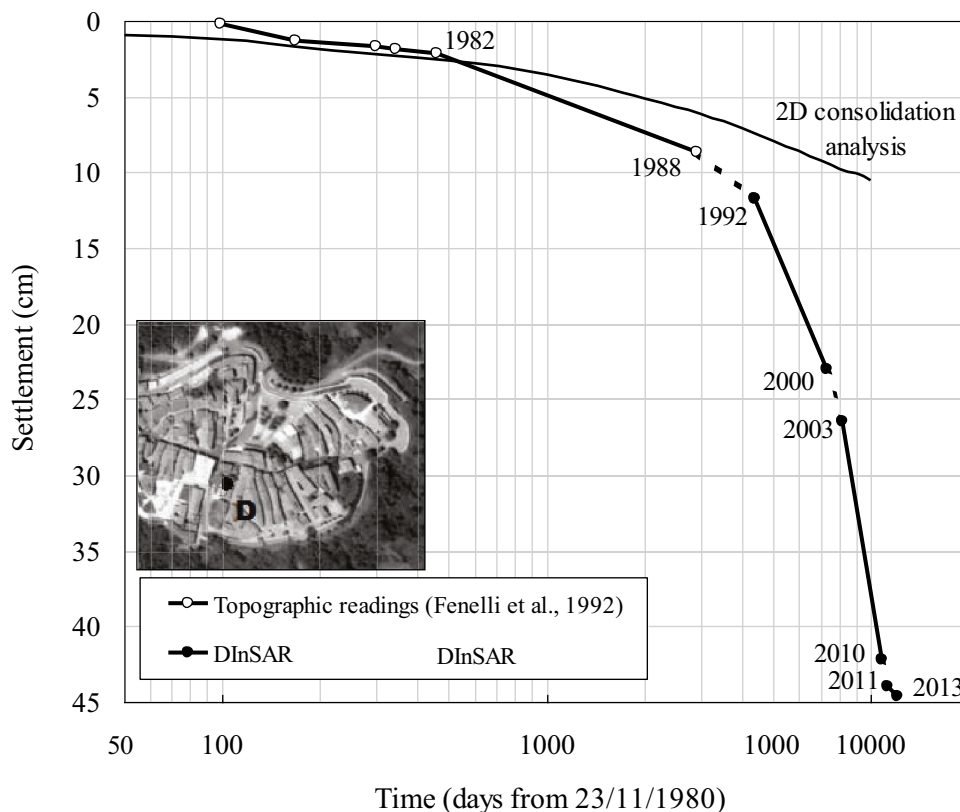
Fig. 18 Temporal evolution of the vertical displacement at point D based on both topographic readings and satellite images compared to calculated post-seismic consolidation (modified after Lampitiello et al. 2001)

The temporal evolution of vertical displacements of the platform since February, 1981, until 2013 (thus ignoring the deformation cumulated in the time interval between November, 1980, and February, 1981) can be obtained coupling the readings obtained by topographic measurements and satellite data. A plot of settlements at site D in the northern sector of the town is shown in Fig. 18. In the same figure are reported the results of numerical analyses based on the results of laboratory tests on natural samples (Lampitiello et al. 2001), in the assumption of 2D dissipation of the calculated excess pore pressures triggered by the 1980 earthquake. The evolution of the settlement rate is characterized by a typical decreasing trend, even though the monitored displacement is higher than the predicted one well before the availability of satellite images. Such a difference might be explained by the presence of a thick compressible shear zone. These considerations suggest that any strong earthquake occurring in the area at hand can lead to similar effects contributing to the ongoing deformation process.
