Comparison between in situ experimental data and Italian code standard values

G. Marghella, A. Marzo, B. Carpani & M. Indirli

ENEA, Laboratory of Seismic Engineering and Natural Disaster Reduction, Bologna, Italy

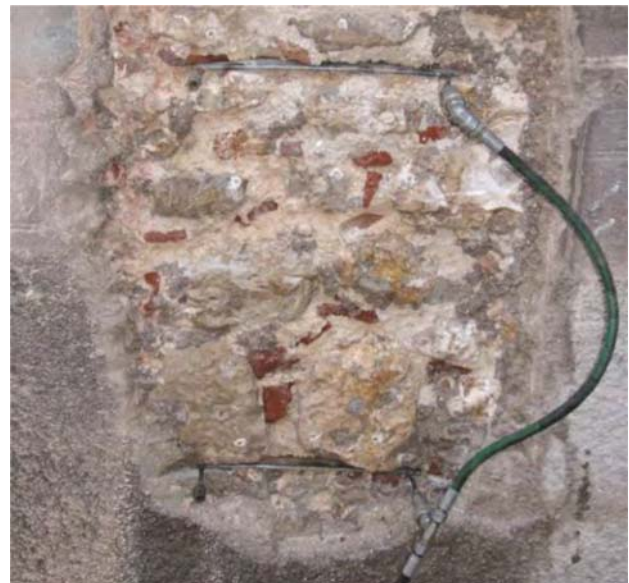
Figure 2. Santa Maria del Suffragio church (*T1* masonry).

Aiming at the comparison between the experimental output and the reference values, the investigated data have been classified, according to NTC 2008, into two main classes (Figure 1) among several typologies (Figures 2–5): *T1*, irregular stone masonry (pebbles, erratic, irregular stones), Figure 2; *T2*, roughly-hewn stone masonry with facing walls of limited thickness and infill core, Figure 3. These two typologies, very common in the historic buildings of the central area of Italy, can be found in the city of L'Aquila with the following constructive main features. *T1* is characterised by irregular courses and very poor care for the horizontal set up of the stonework layers; the calcareous stone

elements are undressed, of irregular or slightly rounded shape and of different sizes (8÷30 cm). *T2* shows more regular courses (with a certain attention in order to arrange horizontal layers) and roughly-hewn stone elements. In both types, the spaces between the larger stones are filled with smaller elements and fragments of brick, in order to reduce mortar layers and improve the normal strain of panels. The binding material is usually quicklime mortar but, according to historical sources, sometimes *pozzolana* was added, especially in the outer part of the wall, to provide the mortar with hydraulic property (Zordan 1992).

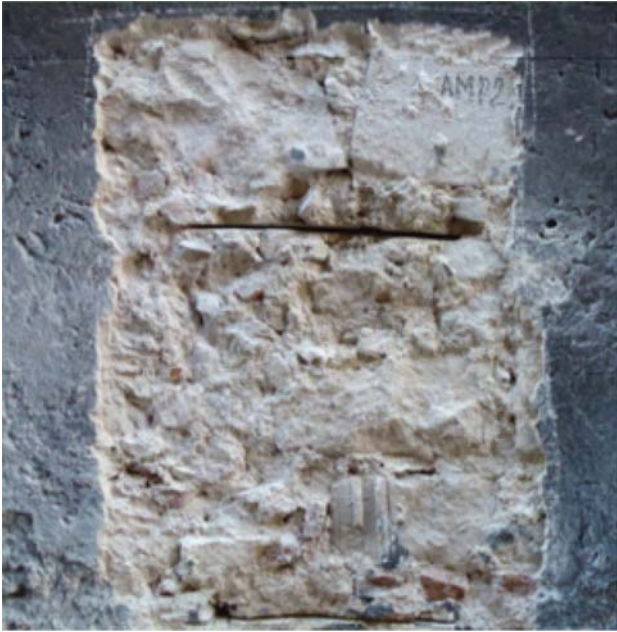
Figure 3. Archbishop-Cathedral compound (T2 masonry).

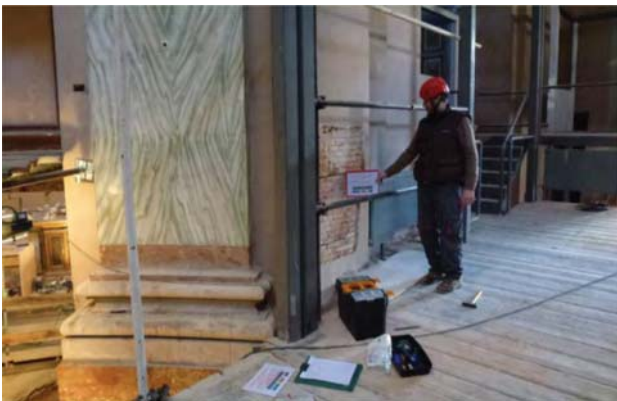
Figure 4. Sant'Agostino church (B masonry).

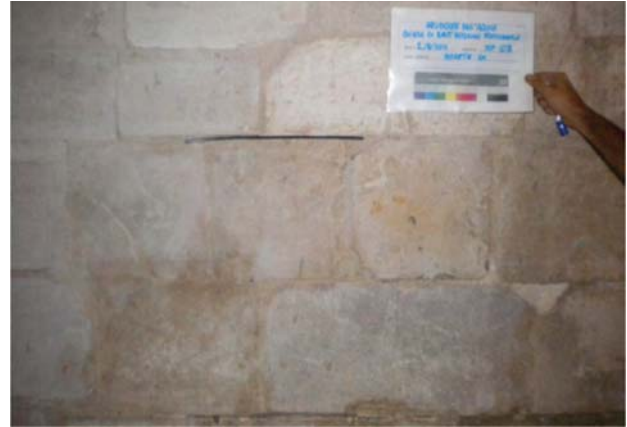
Figure 5. Sant'Eusanio church (*DS* masonry).

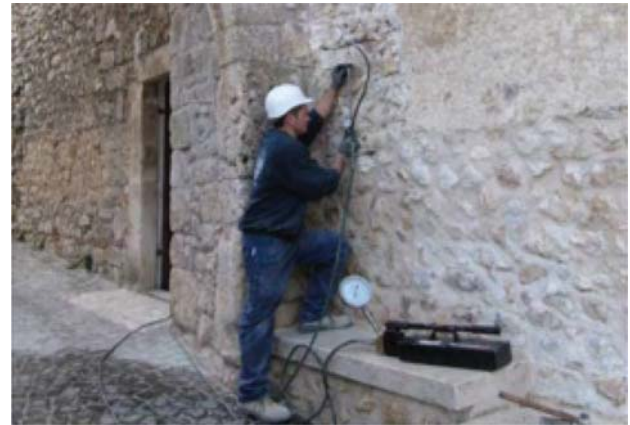
Figure 6. Example of double flat jack test.

The most widespread semi-destructive test is realised with the use of the simple/double flat jacks (ASTM C1196/91, ASTM C1197/91 & ASTM D4729, Figure 6); the main advantage is the assessment of the masonry *in situ* stress level (single) and deformability properties in compression (double); this technique allows an approximate estimate of the compressive strength of the portion of masonry under investigation; on the other hand, it is quite expensive, and not applicable when the historic building walls have mural paintings or decorations, because the removal of plaster is needed.

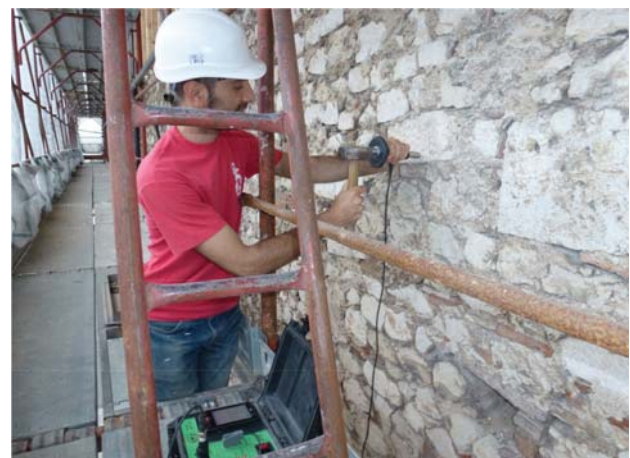
Figure 7. Example of sonic/ultrasonic test.

Quick and cheaper non-destructive sonic/ultrasonic testing provides a qualitative evaluation of the masonry homogeneity, through the investigation of the wall section morphology, detection of discontinuities, voids and crack/damage patterns (EN 583, EN 12668, ASTM C1383 & ASTM E494, Figure 7).

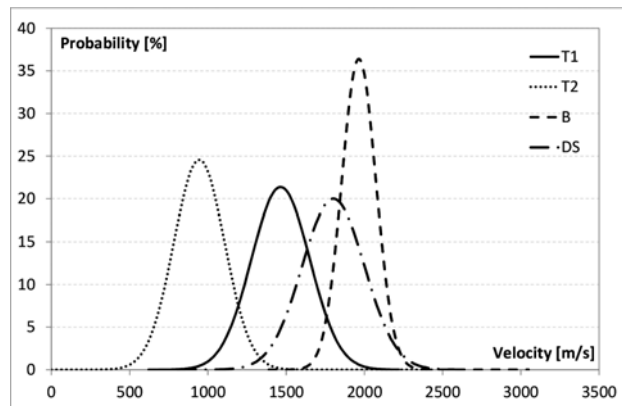
Figure 8. Gaussian distribution of the ultrasonic velocity for the investigated masonry types.

The probability distribution of sonic/ultrasonic velocities on the inspected masonry patterns is depicted in Figure 8; it appears that minimum/

maximum standard deviations are accomplished respectively with B and DS masonry types. Finally, the diagrams Young modulus E vs. sonic/ultrasonic velocity v and compression stress σ_c vs. sonic/ultrasonic velocity v for all the investigated masonry patterns are respectively plotted in Figures 9 and 10.

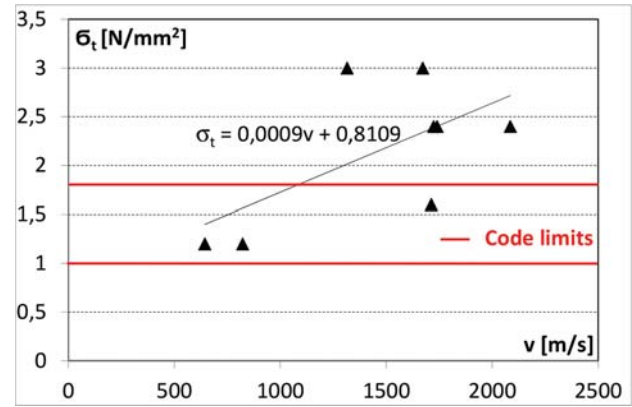
Figure 12. σ_t vs. v relationship for *T1* masonry and comparison with standard values.

masonry (8 sites). Therefore, sufficiently reliable Young modulus E vs. sonic/ultrasonic velocity v (Figure 11) and compression stress σ_t vs. sonic/ultrasonic velocity v (Figure 12) correlation laws have been derived for that typology.

The achieved results have been used to implement simple linear relationships (E - v ; σ_t - v) aiming at understanding, in the case of execution of sonic/ultrasonic tests without the support of more expensive flat jack tests, if the experimental mechanical properties of *T1* masonry fall within the codes requirements.

From the analysis of a wide - but not exhaustive - set of investigated data, it is clear that NTC 2008 standards cover the scattered range of experimental values only for the lower limit, both for E and σ_t (E - v : $E_{\min} = 690$ N/mm²; σ_t - v : $\sigma_{t\min} = 1.0$ N/mm²); on the contrary, the upper limit is too conservative (E - v : $E_{\max} = 1050$ N/mm²; σ_t - v : $\sigma_{t\max} = 1.8$ N/mm²).

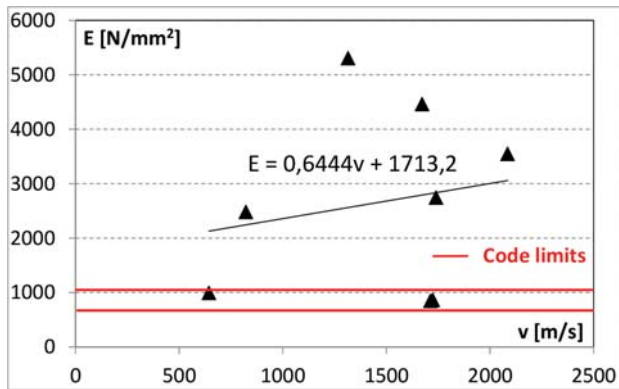
Figure 11. E vs. v relationship for *T1* masonry and comparison with standard values.
