# Large scale seismic vulnerability and risk evaluation of a masonry churches sample in the historical centre of Naples

**Abstract.** This paper investigates about the seismic vulnerability and risk of fifteen masonry churches located in the historical centre of Naples. The used analysis method is derived from a procedure already implemented by the University of Basilicata on the churches of Matera. In order to evaluate for the study area the seismic vulnerability and hazard indexes of selected churches, the use of appropriate technical survey forms is done. Data obtained from applying the employed procedure allow for both plotting of vulnerability maps and providing seismic risk indicators of all churches. The comparison among the indexes achieved allows for the evaluation of the health state of inspected churches so to program a priority scale in performing future retrofitting interventions.

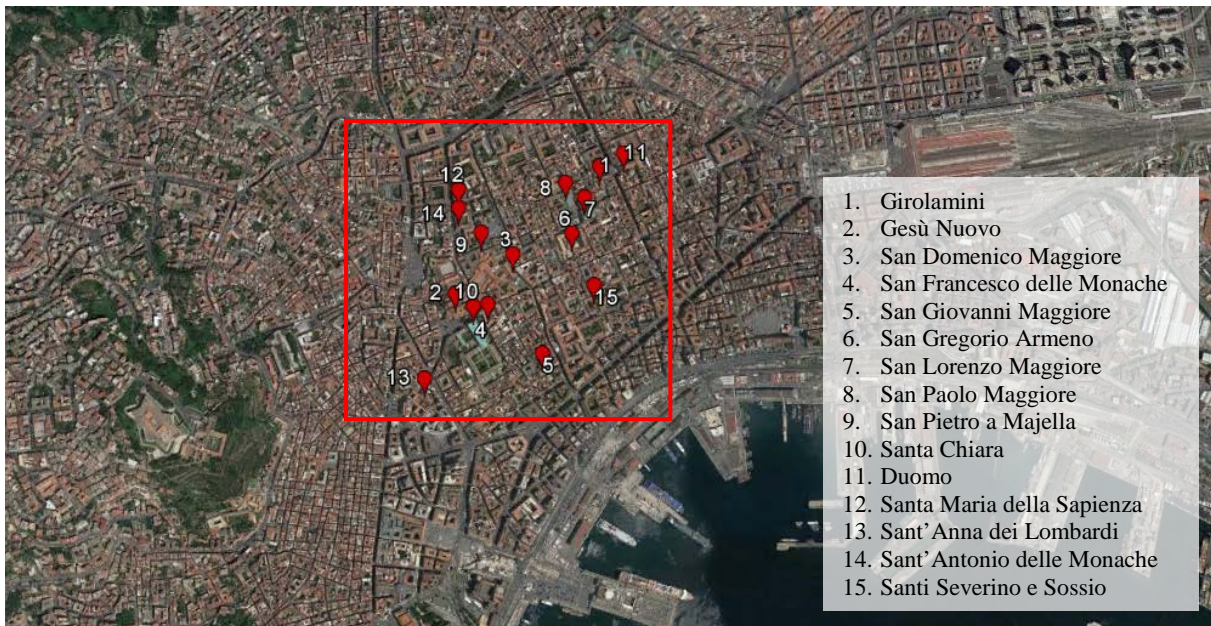
**FIGURE 1.** Churches of the historical centre of Naples under investigation

In 1995 the historical centre of Naples has been declared by UNESCO as World Heritage Site. However, the largest part of buildings in this zone are in precarious structural conditions. Moreover, after the 1980 Irpinia earthquake, a lot of buildings showed evident structural damages. Therefore, on the basis of these premises, a scrupulous attention to monumental buildings, with particular reference to religious ones seriously affected by recent earthquake [1], should be deserved. In the paper the study proposed is addressed to evaluate the large scale seismic vulnerability and risk of fifteen churches, whose location in the historical centre is shown in Figure 1.

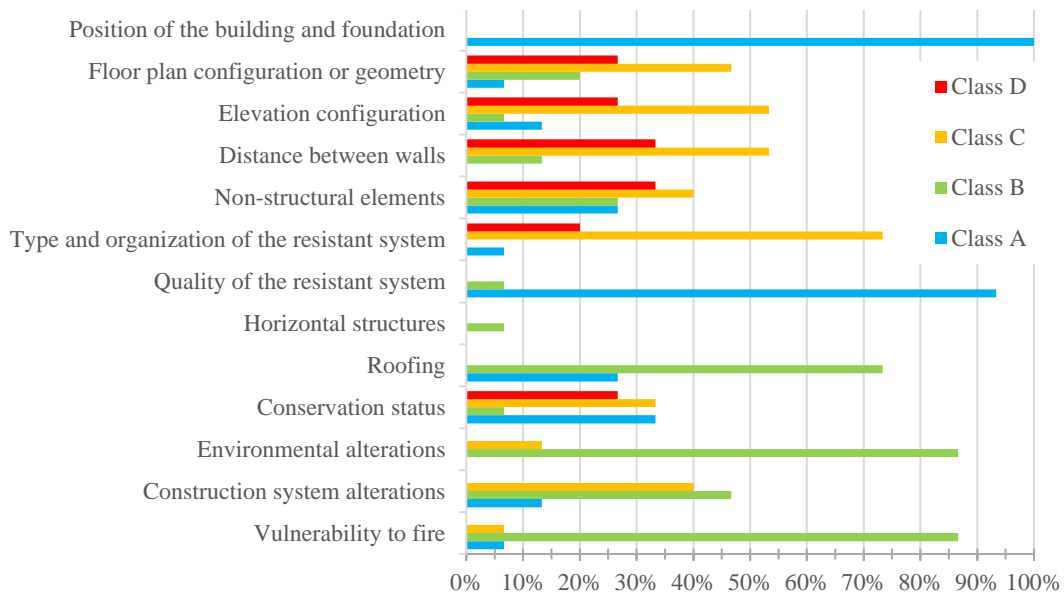
**FIGURE 2.** Percentage distribution of parameters classes

Afterwards, the seismic vulnerability of each church is evaluated by examining the parameters related to the different peculiarities of inspected constructions. The parameters, grouped into a survey form, are thirteen [2] and ten of these have been selected from the second level seismic vulnerability technical datasheet proposed by the Italian Group of Defence against Earthquakes (GNDT) [3]. For the compilation of the form, it is possible to associate a class, from A (the best) to D (the worst), to each parameter. In Figure 2 the percentage distribution of classes assigned to each parameter for all the churches examined is reported.

The results are not very harmonised each other. The only parameter common to all churches is *location of the buildings and foundations*. In fact, on the basis of this parameter, all churches are classified in class A [100%]. This means that all the constructions are placed on the same subsoil, namely a Neapolitan yellow tuff soil with a slope less than 10%. For each case, the vulnerability index is defined by the formula:

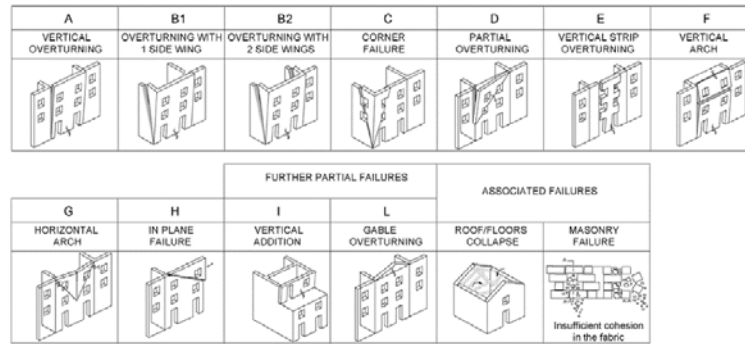
**FIGURE 3.** Potential collapse mechanisms

A further analysis is focused on the knowledge of possible collapse mechanisms. Through the in-situ inspection of every church, the potential collapse mechanisms, selected among those shown in Figure 3, are identified.

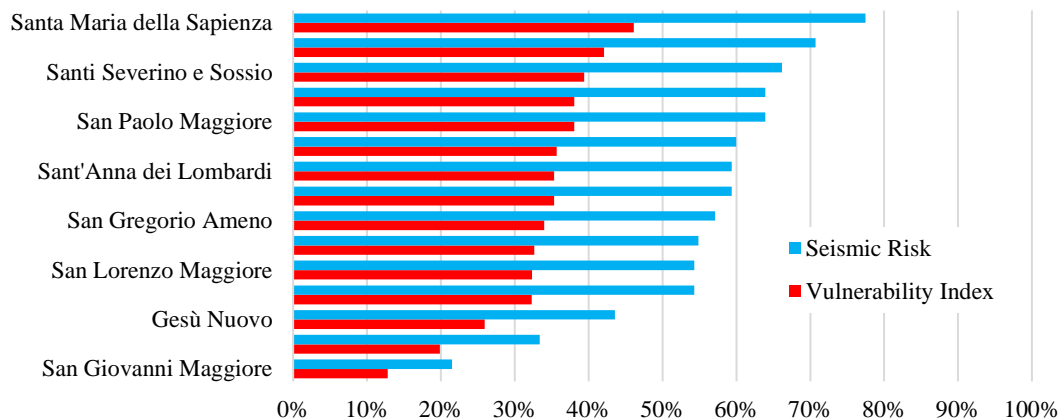
**FIGURE 4.** Vulnerability Indexes and Seismic Risk indicators (in descending order) of the inspected churches sample

All the churches examined within the historical centre of Naples have shown vulnerability indexes and seismic risk ones with scores ranging between 10% and 50% and between 20% and 80%, respectively (Figure 4).

The most vulnerable church is *Santa Maria della Sapienza*, which has a vulnerability index of 46.12. In fact, at the present, this building is unusable. On the other hand, the church in better structural conditions is *San Giovanni Maggiore*, which underwent recent seismic retrofitting works, consisted on steel ties aiming at both stopping the incipient facade overturning mechanism and improving the containment of the masonry vault thrusts.

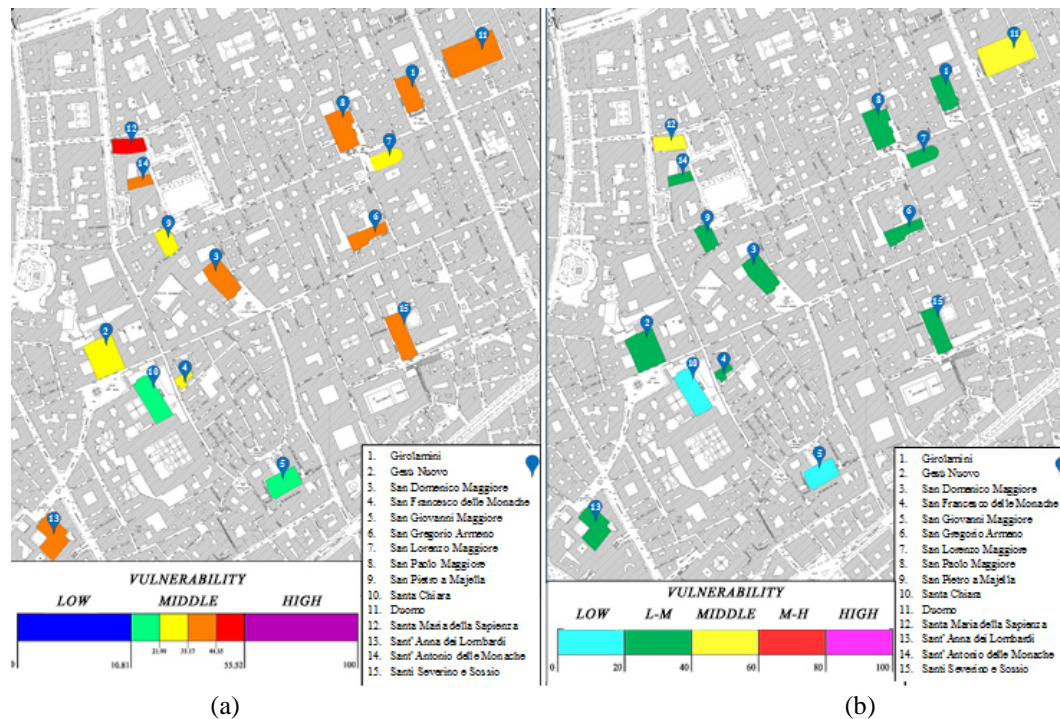
FIGURE 5. Vulnerability indexes of investigated churches according to the University of Basilicata (a) and GNDT (b) methods

In Figure 5 the vulnerability maps of the inspected churches within the historical centre of Naples are plotted. In these maps the vulnerability index ranges are indicated with different colours according to two different classification methods. In the left picture, following the University of Basilicata method [4], the vulnerability index is divided into three classes: low, middle and high; while in the right picture, the GNDT method is used, it classifying the construction vulnerability into five classes: low, middle-low, middle, middle-high and high. From both methods it appear that the churches have a medium vulnerability level.
