# Proceedings of the 4<sup>th</sup> WTA International PhD Symposium

# **MATERIALS TESTED BY TIME. QUALITY AND DURABILITY OF THE RESTORATIONS OF THE TEMPLES OF PAESTUM FROM THE NINETEENTH-CENTURY APPROACHES TO THE CONTEMPORARY ISSUES OF CONSERVATION**

Paestum Heritage, Archaeological Restoration, Durability, Compatibility

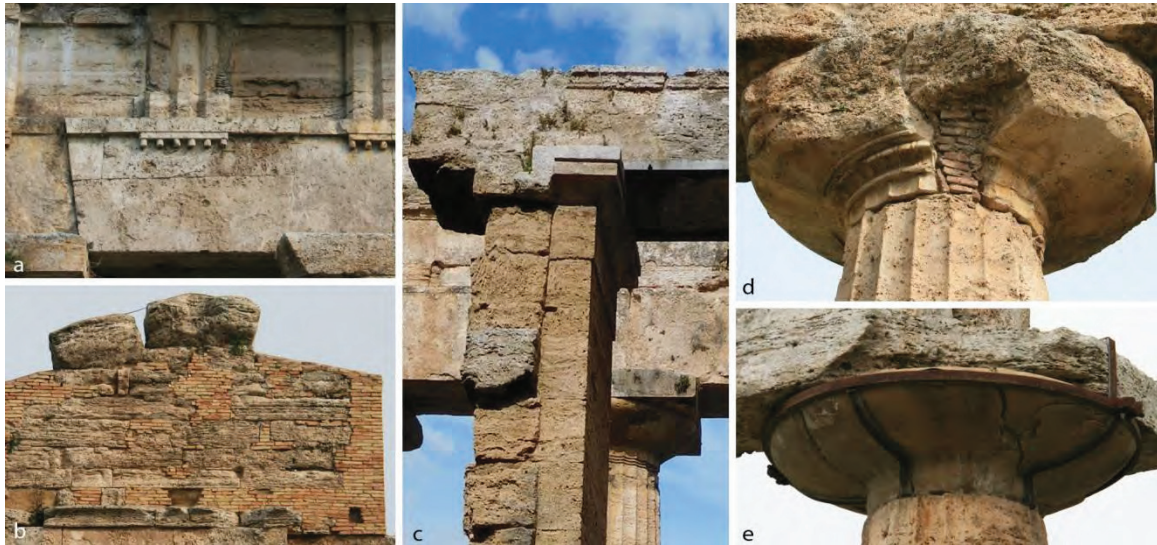
Figure 1: a) temple of Neptune, western architrave. Integrations in travertine blocks (1805); b) temple of Athena, eastern gable. Additions in brick masonry (1829-30); c) temple of Neptune, architrave and pillar of the order of the cell. Additions in travertine blocks and iron chains (1850-53); d) temple of Athena, column of the eastern side. Addition in fragments of bricks (1853-54); e) Basilica, capital of an internal column. Strengthening with iron devices (1855-56).

by the apposition of a layer to protect the metals from the weathering. Although these interventions did not take place, the principles of compatibility and durability behind them guided the work carried out by Antonio Bonucci in 1805 on the same temple [3]. The technician filled the largest gaps of the architrave of the western front and of the underlying columns using travertine blocks fixed with visible iron clamps and the smaller ones with stone splinters tied with lime mortar. These additions, well preserved today, appear materially and chromatically compatible, while remaining always distinguishable from the ancient layers because of their regular geometry or particular finishing. In the case of the temple of Athena, Bonucci opted for iron chains – removed during more recent restoration yards – as a way to connect and bind some collapsing elements in correspondence of the north-eastern corner.

Another remarkable intervention is the partial reconfiguration of the gables of the same temple with brick masonry intentionally chosen by Ciro Cuciniello in order to ensure the distinguishability of the new parts [4]. After a detailed work of analysis of the state of conservation of the structure (1829), the architect decided to use the brick masonry to re-define the geometry of the missing portions «so as not to confuse – he wrote – the modern work of restoration with the venerable ruins of that ancient monument». In this case the additions, well-preserved over time, appear today like prostheses with simplified geometries which adhere to the profile of the ancient portions without compromising their perception. The same constructive expedient was used for smaller gaps where Cuciniello realized local brick insertions.

During his Direction of the site of Paestum (1849-1860), Ulisse Rizzi showed a notable ability in adding, only where indispensable, iron chains, limited portions of brick masonry or travertine blocks with well-smoothed surfaces, all clearly different materials from the ancient ones [5]. In his contribution to the restoration works of the three temples, the technician was able to adjust the entity of the intervention and choose technical expedients and material solutions in relation to the specific structural issues to deal with. In the case of the temple of Neptune, the architect defined the integrations, necessary to avoid the collapse of the western portions of the inner order of the cell, by reusing some of the fallen stone blocks and by adding new parts made of the same travertine and connected by iron chains. This intervention successfully combined the aesthetical and historical instances carrying on a culturally aware dialogue between existent parts and additions. Whilst retaining the same material and geometries of the ancient parts, the new blocks were indeed well-smoothed in the surfaces in order to ensure the differentiation from the ancient rough finishes. Elsewhere, in case of limited integrations, the technician used brick blocks tied with lime mortar as to fill the smaller gaps and to redefine single elements. For the Basilica and the Athena's temple, which did not display equivalent critical situations, Rizzi decided to curb some limited collapse mechanisms of the columns by placing iron chains and circles, adapted to the profile of the different elements – abacus, capitals, shafts – and adjustable as needed. Many of these interventions, well-preserved today, show the good quality of the formal and technical choices. In particular, the travertine integrations appear in good state of conservation and remain always well recognizable from the nearby ancient portions, despite the effects of time and weathering on surfaces.

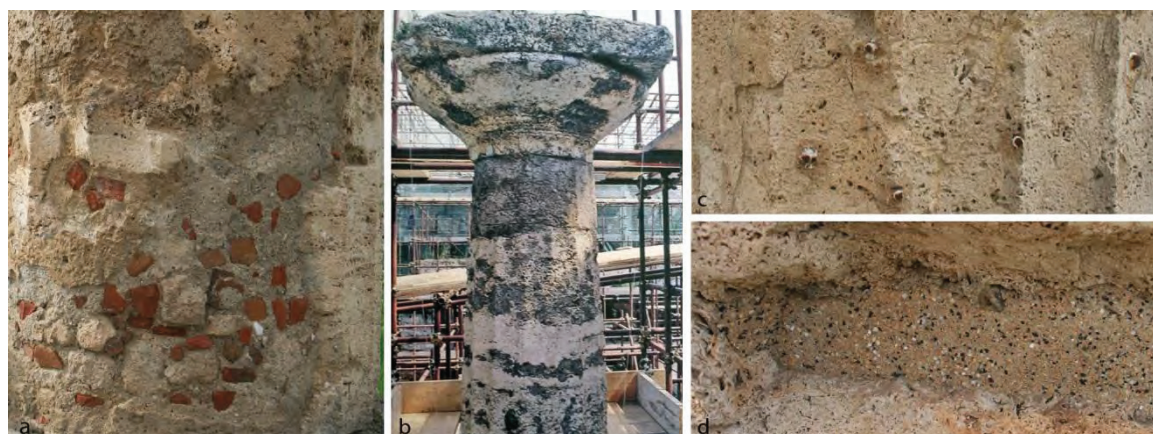
Figure 2: a) temple of Athena, column of the northern side. Addition in fragments of bricks and concrete (1926); b) temple of Neptune, column of the upper order. Integrations in bricks and concrete (Fifties); c) temple of Athena, column of the eastern front. Reinforced perforations (1962); d) temple of Neptune, column of the northern front. Integration made of lime mortars (1997-2002).

Starting from 1907, further restoration works were carried out following the new and more systematic excavation yards led by Vittorio Spinazzola [7]. In a first phase, the interventions determined the reconstruction of some of the columns of the forum mixing tambours found on site with other stone integrations [8]. Later, during the Twenties and the Thirties, Amedeo Maiuri carried out restoration yards characterized by a generalized inclination toward the replacement of the nineteenth-century iron devices with thinner bars placed at the intrados of the architraves, as in the case of the north-eastern corner of the Athena’s temple. Elsewhere, Maiuri replaced some of the nineteenth-century stone additions – considered mechanically and aesthetically unsuited – with new integrations realized by «working from inside» the columns with localized injections of a mixture of cement and volcanic sand filled, in some cases, with a core of brick blocks [9]. Let alone his undocumented reconstructions of a large portions of the northern city-walls, Maiuri also completed the anastylosis of one of the columns of the so-called temple of the Peace within the forum of the city. In this case, he reused three ancient tambours and one capital found on site and integrated these latter with six new stone tambours, tied through brass bars and cement. Starting from the Fifties, new and heavier works were carried out, in a first phase, by Pellegrino Claudio Sestieri: in particular, some structures of the forum, the so-called Votive column and two columns of the upper order of the cell of the Neptune’s temple were integrated by resorting to extensive cement additions [10]. Within the same structure, several gaps of the shafts of the columns of the inner order were filled with cement mortars coloured in shades of orange in order to chromatically level out additions and existent parts [11].

Furthermore, what emerges from the following works, carried out during the Sixties, is the complete indifference shown with respect to the comprehension of the construction history and structural functioning of the temples – elements that should be considered, instead, as cultural guidelines. The project, in fact, determined the realization of a heavy strengthening intervention which was not aimed at all at ensuring the material and mechanical compatibility with the ancient structures. In particular, the eastern front of the Athena’s temple – already object of the nineteenth-century restorations, partially removed during the previous works – was strengthened by the definition of a dense network of steel bars linked to capitals by reinforced concrete anchors and diffused integrations with cement mortar. In addition, hundreds of armed perforations were realized to connect architraves and capitals, as well as to strengthen the shafts of the columns [12].

This intervention showed immediately its technical and cultural limits: in addition to being particularly invasive and totally irreversible, it determined the complete and definitive alteration of the structural behaviour of the temple. Moreover, it showed over the years several problems linked, including an increased vulnerability to damages caused by lightning strikes – attracted by the presence of metallic devices –, and limited durability and resistance in the interaction with the ancient materials. These issues remain critical nowadays for the conservation and protection of those architectures.

ness in the technical choices. The diffused cement additions displayed advanced phenomena of decay as erosion, disintegration, and pulverization, only a few decades after their realisation. Moreover, the cement integrations carried out during the Fifties on the columns of the Neptune's temple in absence of the preventive cleaning operations, have determined diffused detachment, scaling and delamination. The evaluation of the state of conservation of the eastern front of the Athena's temple represented an even more complex issue. In this case, the presence of the armed perforations determined two relevant problems: first, this system – characterized by the definition of strong bonds between architraves and columns – had completely changed the structural identity of the building by introducing a hyperstatic behaviour. Second, the choice to carry out totally irreversible and invisible perforations and cement injections did not allow technicians to evaluate the state of conservation of the internal reinforcing steel. In addition, the study that preceded the more recent restorations highlighted the general incompatibility between this system and the physical and mechanical characteristics of the travertine, whose porosity did not react well to the injected mixtures, and favoured, at the same time, the penetration of meteoric water and moisture, increasing the risk of oxidation.
