Seismic assessment of Romanian Orthodox masonry churches in the Banat area through a multi-level analysis framework

This paper aims to show some results of seismic assessment of Romanian Orthodox existing masonry churches, by extending the multi-level approach proposed by the Italian directive for seismic risk evaluation of cultural heritage. To this scope, a sample of six existing churches is examined, belonging to a church typology characterized by a single vaulted nave and a bell tower incorporated into the main façade. All churches considered in this study are located in the Banat region, which is an area with a medium–high seismic hazard.

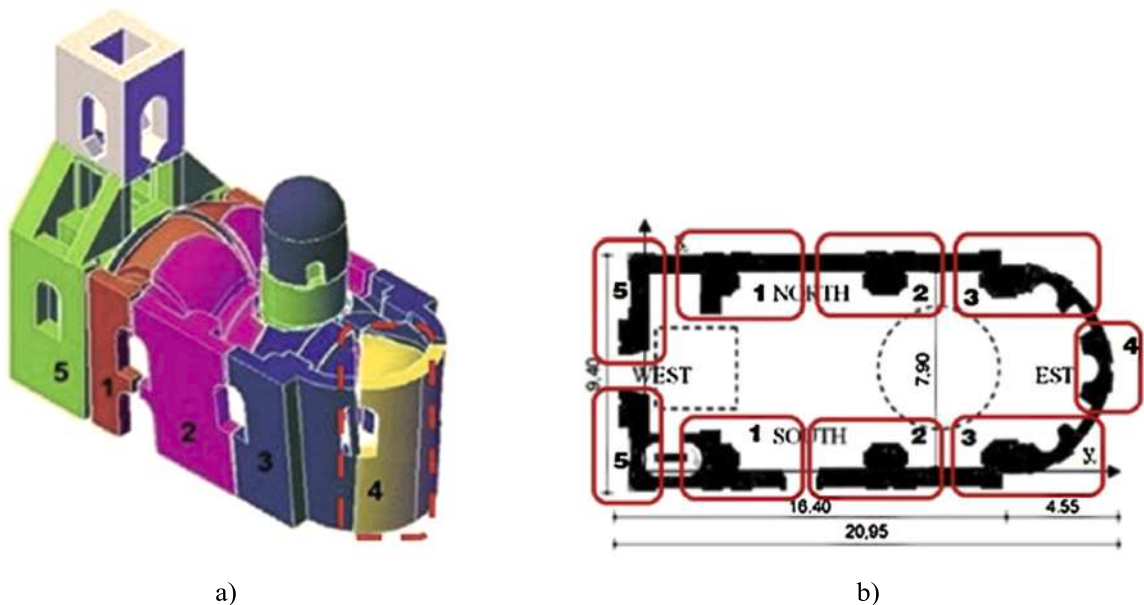
Fig. 1. Failure rigid blocks schematization: a) axonometric view; b) plan view.

division in rigid blocks (macro-elements) for existing Romanian Orthodox masonry churches investigated in [41,43]. Moreover, recent investigations have highlighted that in this area earthquakes with a significant vertical component occurred, resulting in severe damage on masonry structures, such as vertical shear cracks deriving from the differential vertical soil movements, that can furtherly facilitate out-of-plane collapses [7,44].

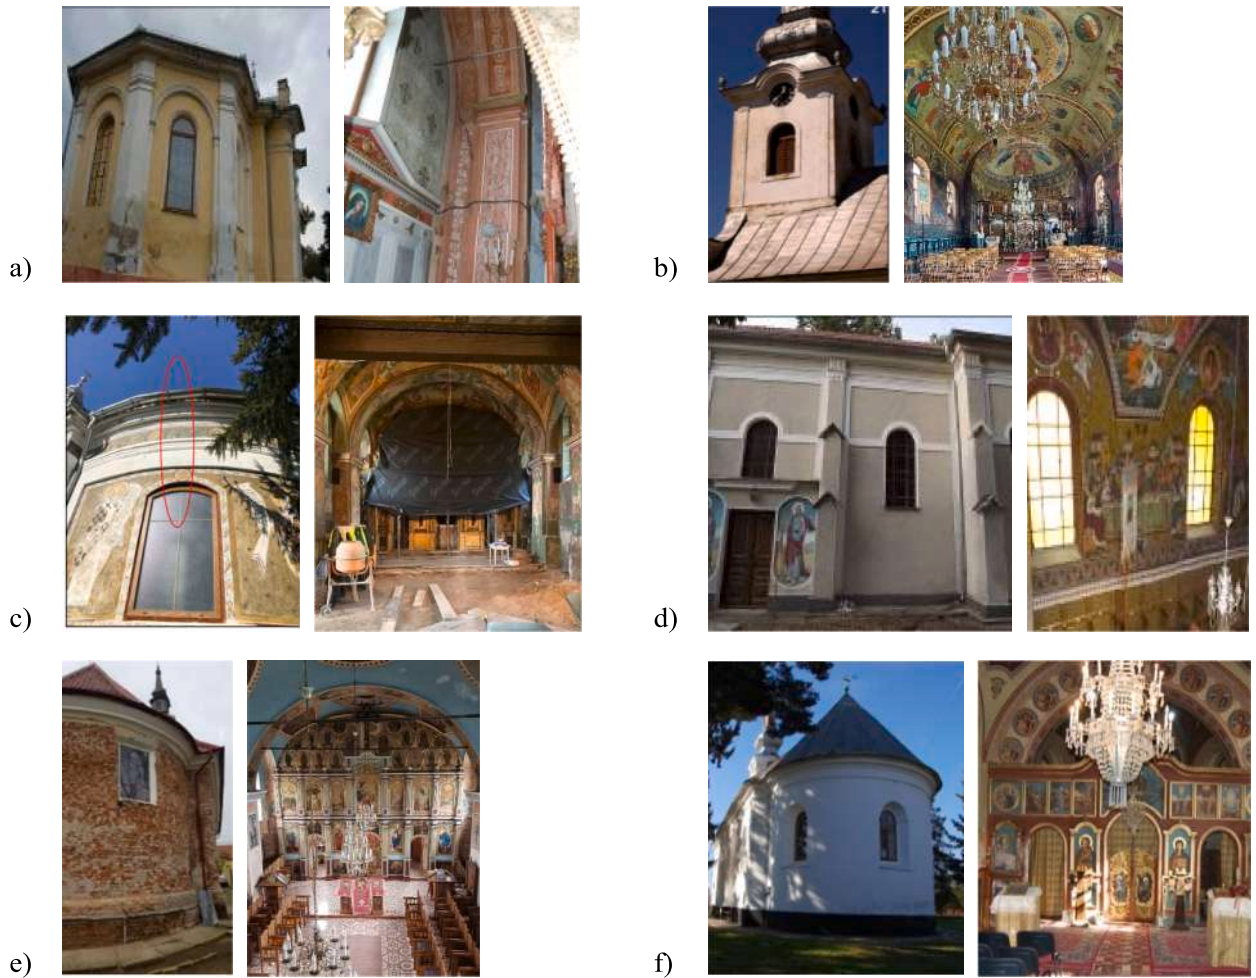
Fig. 4. Exterior and interior pictures which show the conservation state of the investigated churches: a) Holy Spirit Descent Church of Cenad; b) Virgin Mary's Nativity Church of Chizătău; c) Saint Nicholas Church of Bocea; d) Saint Nicholas Church of Bencecu de Jos; e) Saint George Church of Beregsău Mare; f) Jesus Resurrection Church of Belinț.

All the investigated buildings present a plan with a unique central nave, built in brick masonry with perimetral massive walls with thicknesses up to 160 cm. The most common damages observed on the investigated churches are due to lack of preservation in the past years, showing cracks on the structural walls, damaged plaster and paintings (Fig. 4).

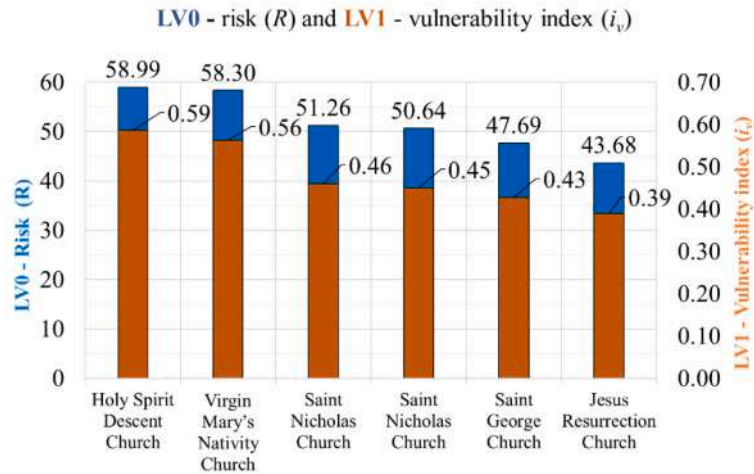
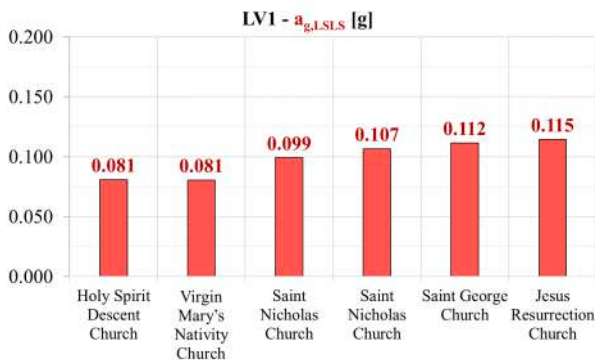
Fig. 8. a) LV0 and LV1 results comparison; b) the calculated LSLs acceleration $a_{g,LSLS}$; c) the calculated LSLs acceleration factor $f_{a,LSLS}$ for each church.

As expected, there is a close correlation between a_g and i_v . A higher vulnerability index corresponds to a lower seismic capacity of the structure, and vice versa. According to the LV1 approach, it results that the church with the best seismic performance is still the Jesus Resurrection Church, as found by applying the LV0 approach. Moreover, the LV0 (Fig. 7) and the LV1 (Fig. 8) results are in agreement in ranking the seismic performance of the churches considered.

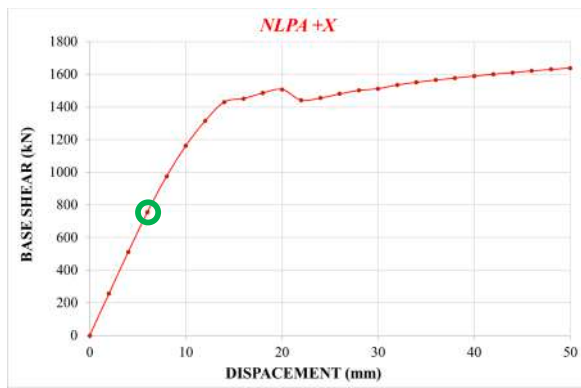
Fig. 14. *NLPA+X*: capacity curve and crack status for several load steps increments.

Fig. 14 through Fig. 18 report the results of the *NLPAs* performed. In particular, each figure shows the capacity curve (in the form of base shear vs displacement, the latter referred to the control node choice in all the analyses corresponding to the upper masonry portion of the belfry, at a height of 17 m, centrally on the side facing the nave), and a crack status for three load steps highlighted on the capacity curve.

In particular, as one may note as for *NLPA+X* (Fig. 14) localized horizontal cracks, due to an overturning, occur at base of the soaring portion of the bell tower and of the belfry. The same conclusion may be drawn in the case of *NLPA-X* (Fig. 15). The *NLPA+X* reaches higher values of base shear than the *NLPA-X* since, as it is possible to note, along this direction the aula vaulted structure is compressed while, in the case of the *NLPA-X*, it is in tension offering, on the contrary, a lower strength when the tower is pushed along the direction *-Y*. Both *NLPA+X* and *NLPA-X* highlights that along the longitudinal direction arises the overturning of the bell tower soaring portion, that is the most church vulnerable portion. Therefore, this conclusion validates the assumption of having this part as macro-element in the *LV2* approach. For completeness, Fig. 16a and Fig. 16b depict a detail of crack status onset where the bell tower damage is localized, referred respectively to the *NLPA+X* third load step and *NLPA-X* fourth load step of the *NLPAs*.

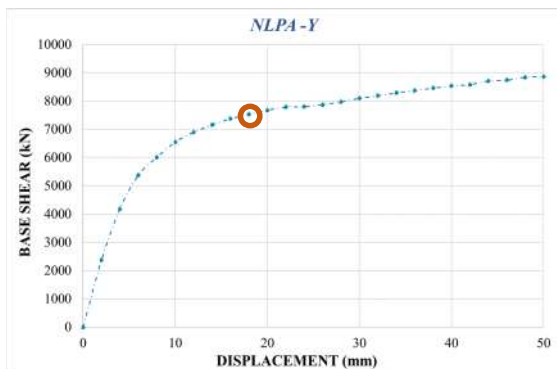
Fig. 18. *NLPA-Y*: capacity curve and crack status for several load steps increments.

As regards the *NLPAs* performed along the transverse direction (*Y* direction), the results obtained are plotted in Fig. 17 and Fig. 18 for *NLPA+Y* and *NLPA-Y*, respectively. In this case, differently for the *NLPAs* along the *X* direction, cracks are not localized in a specific portion of the church, but they are widespread in all the masonry elements, such as walls, aula arches, triumphal arch, barrel vaults, bell tower, and apse. Moreover, cracks distributions are quite similar for both *NLPA+Y* (Fig. 17) and *NLPA-Y* (Fig. 18). Therefore, in this case it is not possible to identify a unique local mechanism (such as the bell tower in the case of *NLPA+X/NLPA-X*), but all the architectural portions (i.e. macro-elements) interact among them in the global response. Fig. 19 reports a particular of the crack status referred to the second step of the push-over analyses. Of course, this result is deeply conditioned by constructions details knowledge (such connection degree among the elements, presence of interventions, and of current crack patterns) that, as known, heavily influence the numerical modelling. They are essential in defining numerical models and in identifying the potential local response mechanisms that may occur. In the case analysed all the elements are assumed to be perfectly collaborating each other by ignoring, therefore, any local situation that may modify the assumption made. Therefore, the assumption made with the *LV2* method with respect to the lateral response tends to overestimate the church current capacity since, due to the interaction among the elements, a premature failure may occur in lateral walls before the aula arches collapse.
