# Defect Augmented Heritage-BIM For Masonry Structures Leveraging Deep Learning-Based Segmentation

Xinyu Tong, Cheng Zhang, Jingyu Zhou & Luigi Di Sarno

Built heritage; convolutional neural network (CNN); defect mapping; defect segmentation; Heritage Building Information Modelling (HBIM); masonry structure

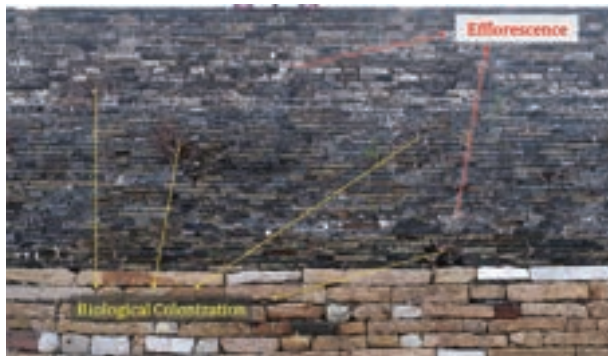
**Figure 1.** Masonry structures covered by a large area of efflorescence, plant vines and erosion.

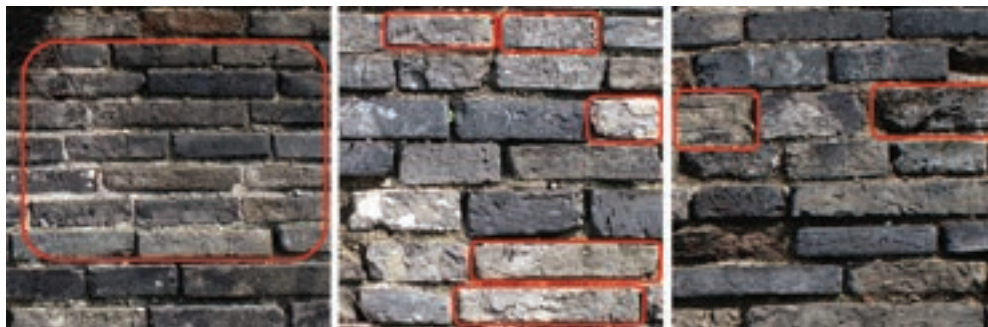
**Figure 2.** Erosion defect with different damage extent showing different appearance.

representative description with an example image. In practice, however, the same defect category may exhibit various appearances due to different damage extents. For example, emerging erosion, superficial erosion, and deep erosion may display different roughness and colours, as shown in Figure 2. If they are classified under the same label in the training set, it may disrupt the model from extracting key features. Therefore, to accurately identify defects without omissions, the category needs to be further subdivided based on the damage extent.

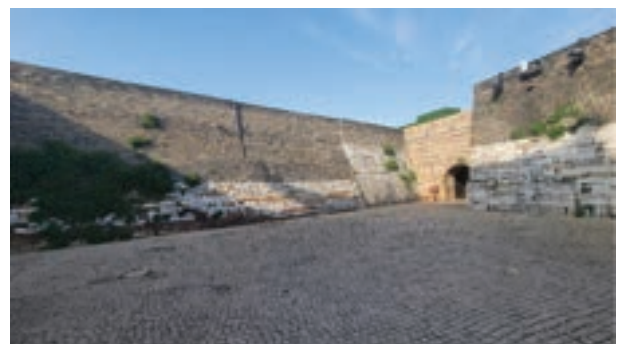
**Figure 9.** Ancient city walls of Pan Gate Historical site.

A case study was carried out at the Pan Gate ancient wall, Suzhou, China, as shown in Figure 9. The current structure was built in 1351 and underwent reinforcement, restoration, and reconstruction between 1976 and 1981. The construction materials consist of bricks, stones, earth, mortar, and a small amount of wood with diversity in type, shape, and size. Multiple categories of defects are present and causing damage, including erosion, efflorescence, biological colonization, and missing part, as shown in Figure 10. Among these, erosion and efflorescence are distributed over large areas with irregular shapes; plant vines extend

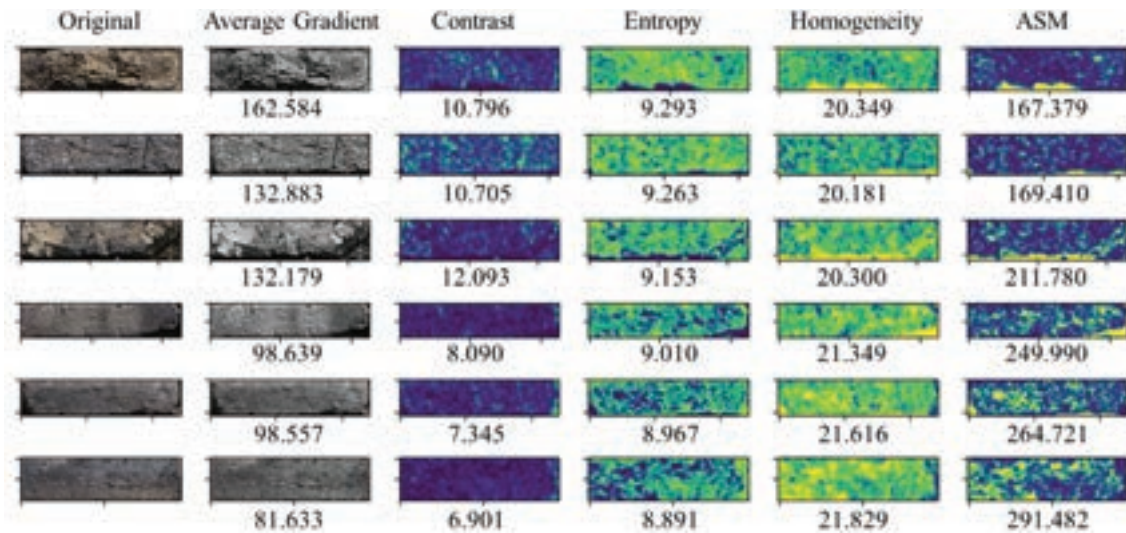
Figure 11. Calculation results of GLCM features and image gradient for individual bricks.

Specially, for bricks which have ambiguous damage extent of erosion, the indicators of GLCM and image gradient were computed for individually cropped images of bricks, and some calculation results are presented in Figure 11. The average of the normalised value of each indicator was taken as the final result. Based on the screening rules in Table 2, a value less than 0.35 is

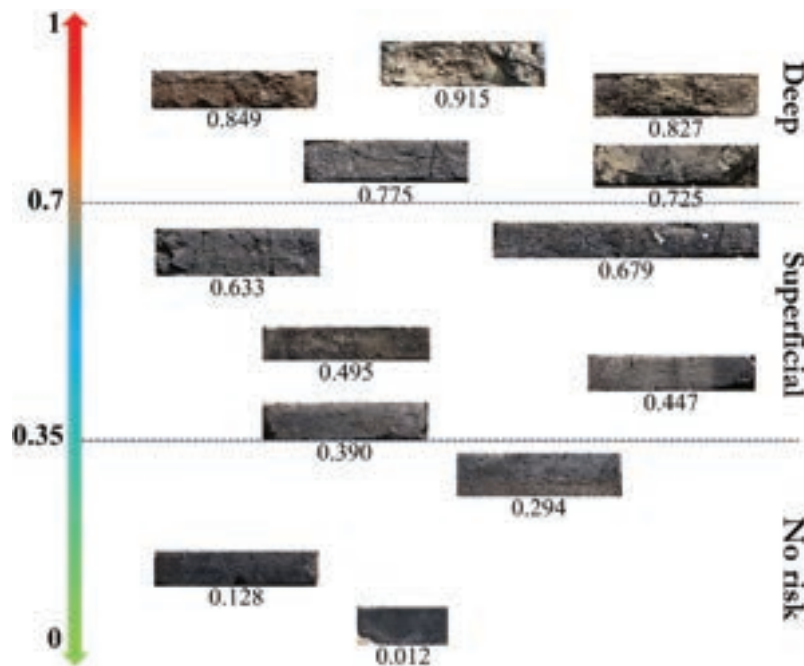
Figure 12. Bricks with different damage extent classified by the normalised value.

classified as “No risk,” a value between 0.35 and 0.7 is classified as “Superficial erosion,” and a value above 0.7 is classified as “Deep erosion”. Some of the classification results are illustrated in Figure 12, showing that the established rules clearly classified bricks with different damage extents.

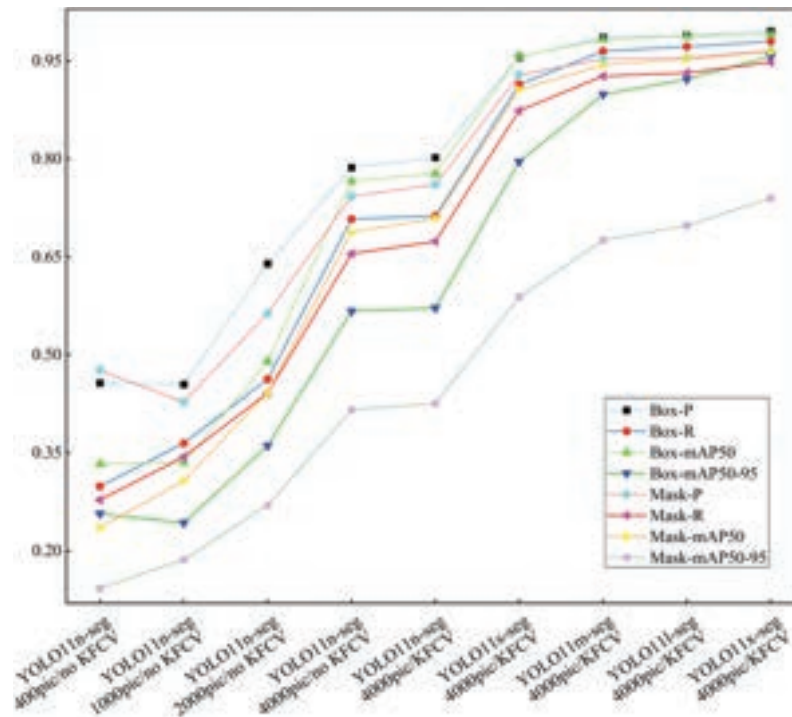
Figure 14. Comparison of the metrics among different training strategies in Detection and segmentation tasks.

nano (n), small(s), medium(m), large(l) and extra-large (x), were investigated under the 4000-image training set to obtain the optimal model. The overall results for all categories in segmentation tasks are shown in Table 3, and the comparison of the metrics among different training strategies in detection and segmentation tasks are shown in Figure 14, which demonstrates that the augmented dataset effectively improves training accuracy, addressing the issue of inadequate samples in the original dataset. Larger-scale pre-trained models also improve accuracy, but come with increased computational costs. Comparing the results from k-fold cross-validation to a single training revealed an average improvement of 1.98%.

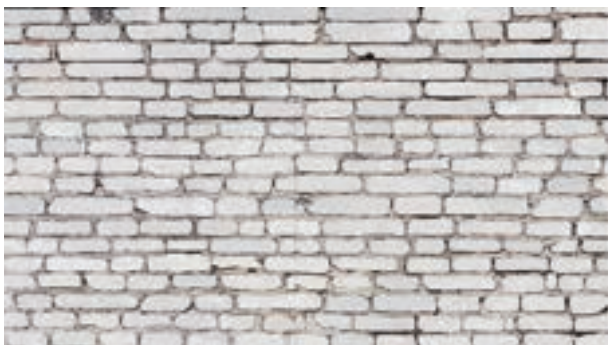
Figure 16. Masks of masonry units.

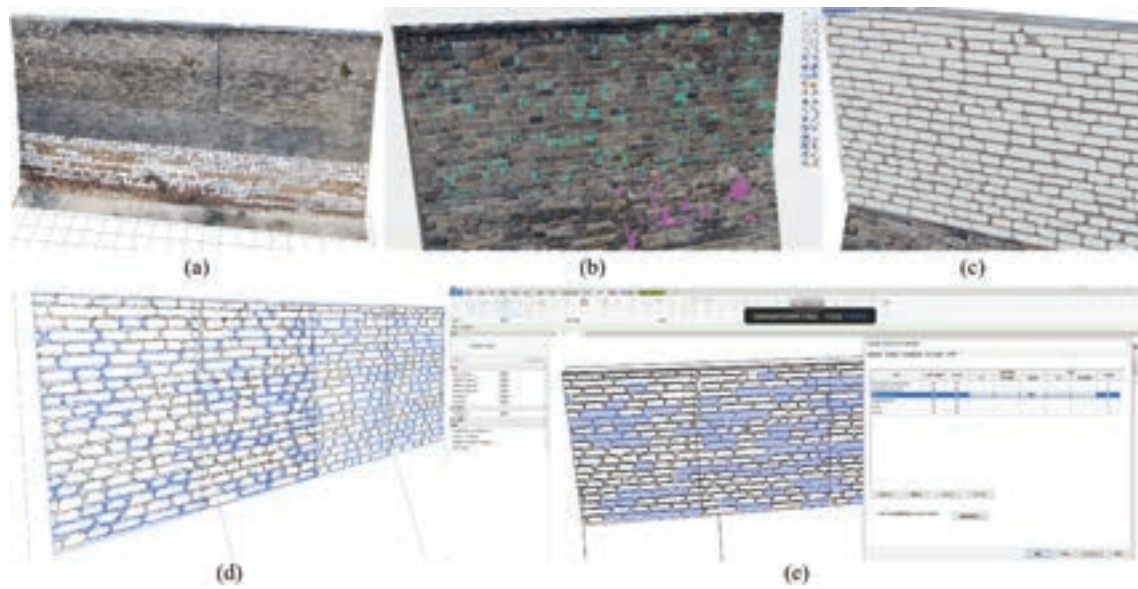
**Figure 17.** (a) Layer-1 mesh model; (b) Layer-2 lightweight model with mapping defects; (c) parametric masonry unit components in Layer-3; (d)&(e) bricks with specific defect are highlighted in H-BIM.

facade model, which were then used for defect and masonry unit identification; the resulting masks were then mapped onto the surface, as shown in Figure 17(b). Above processes were implemented through programming on Python. To generate the Layer-3 model, the masonry unit masks located in the same plane range were extracted, and their contours were parametrically converted into individual components, as shown in Figure 17(c). The generation of masonry unit components was performed in Rhino, with the built-in Grasshopper plugin used for programming. This allowed the identified masonry unit contours to be automatically numbered and converted into individual components. Subsequently, the relative positions between defects and masonry units were determined based on the principle outlined in the Methodology for assessing the defect condition of each masonry unit. The semantic information for each masonry unit

The algorithm could read the form file, filter specific attributes, and display the corresponding masonry unit with a particular colour in Rhino. Figure 17(d) shows bricks with efflorescence being displayed in blue for easy identification of their positions in H-BIM. The model was also attempted to be transferred into Revit, and each masonry unit was set as a separate type. The transferred attributes were checked and organised by personnel to ensure they display correctly in Revit. Components with specific defects could be filtered out using the filter tool, as shown in Figure 17(e).

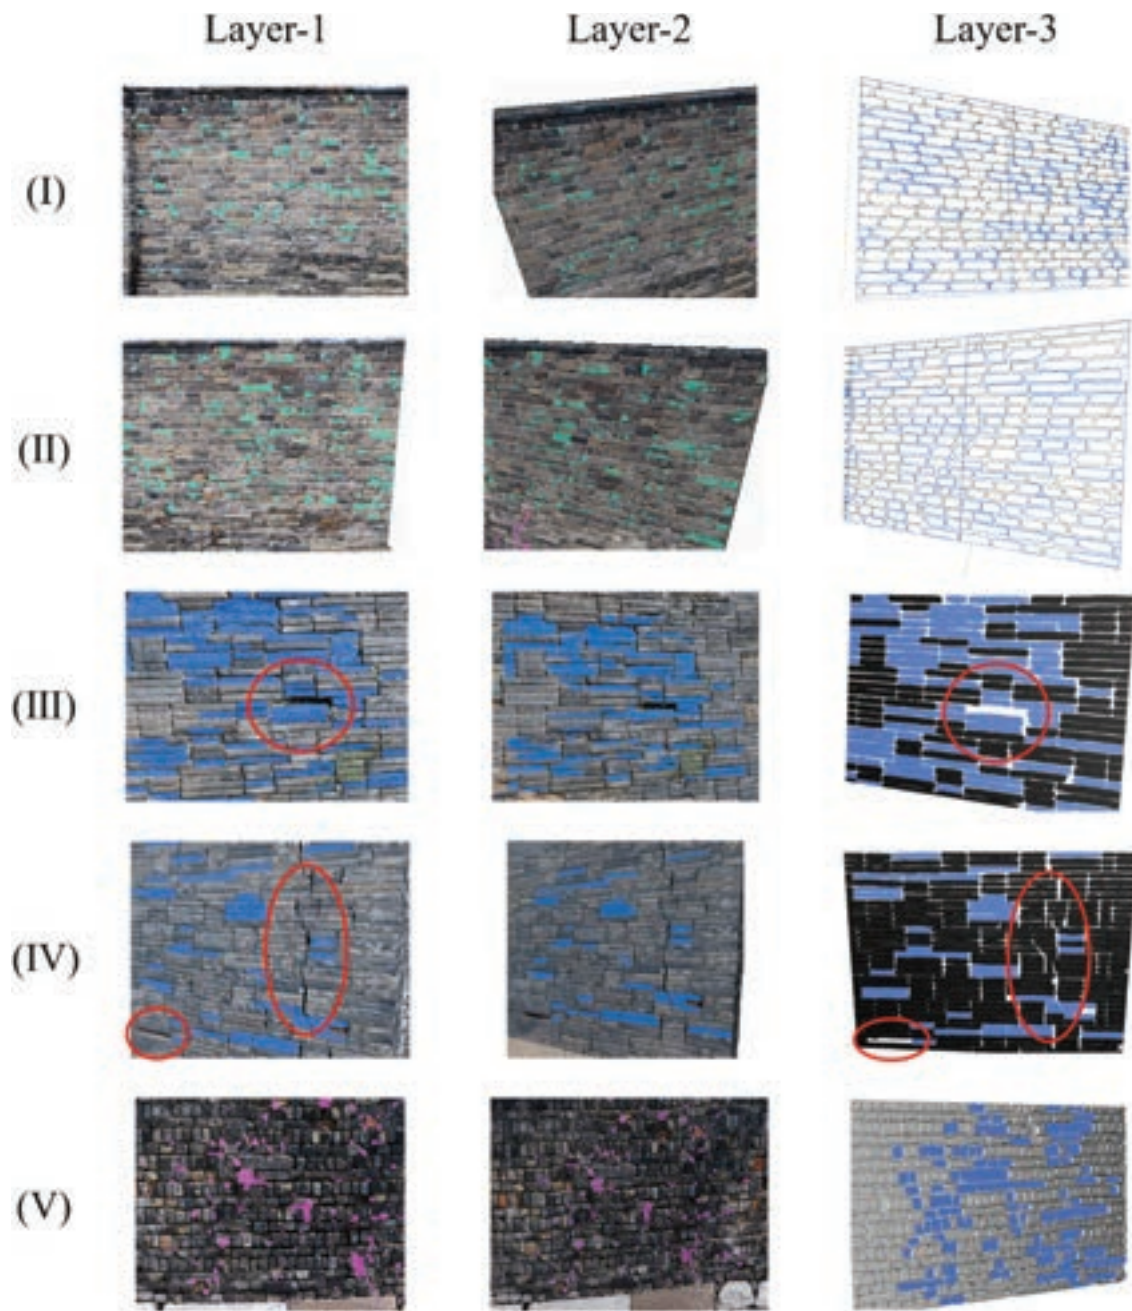
**Figure 18.** Result of the defect augmented three-layer masonry H-BIM.

Figure 18 shows some locations of the Layer-1, Layer-2 models with mapped defect masks, along with the Layer-3 models at corresponding locations. The examples illustrate three different geometries of the bricks, each with varying sizes, contours, and arrangements. In locations (I) and (II), the bricks are arranged in a neat fashion with one long and one short, but with inconsistent sizes. In locations (III) and (IV), the bricks are the most regular, featuring an arrangement of four long and four short in an orderly manner. Location (V) presents bricks that are small, irregular, and arranged in a mixed horizontal and vertical orientation. The contours of these bricks can be accurately identified by the trained model and converted into parametric components. The thickness of the brick components can be adjusted via parameters, with (I) demonstrating a portion of the contours extending outward, (II) illustrating the bricks extending inward, making the bricks embedded within the wall, and (III), (IV), (V) showing the brick contours converted into mesh models and combined with the wall surface. If the thickness of individual bricks and stones are measured during field surveys, a specific thickness can be assigned to each block. The examples indicate that the parametric brick components not only accurately reflect the realistic masonry arrangement, but also can identify and reflect the shapes of missing elements and cracks (as shown at the positions circled in red in (III) and (IV)). A small number of positions with lower accuracy are primarily affected by plants covering the wall, causing difficulty in accurately capturing brick contours, which requires manual adjustments. Furthermore, the examples demonstrate that the defects

match the corresponding bricks. To clearly display defect positions, one type of defect is selected for demonstration, where models (I) and (II) are efflorescence, models (III) and (IV) are deep erosion, and model (V) illustrates biological colonization. The defect masks in Layer-2 are registered with corresponding bricks and assigned as parameters in Layer-3, highlighted in blue.
