## **Experimental ambient vibration tests and numerical investigation on the Sidoni Palace in Castelnuovo of San Pio (L'Aquila, Italy)**

**Abstract:** In the present paper the experimental and numerical activities related to in-situ Ambient Vibration Tests performed on a monumental masonry building placed in Castelnuovo of San Pio (Italy) are presented. The obtained experimental results, able to identify the dynamic characteristics of the investigated palace, have been successively reproduced by means of a building FEM model through the ABAQUS calculation code. Numerical frequency analysis has been also performed on the original building aiming at evaluating its reduction in stiffness due to earthquake. Finally, appropriate retrofitting interventions have been proposed, their effectiveness being proved by numerical analyses on the improved palace FEM model.

**Reference** to this paper should be made as follows: Formisano, A., Krstevska, L., Di Lorenzo, G., Landolfo, R. and Tashkov, L. (2018) ‘Experimental ambient vibration tests and numerical investigation on the Sidoni Palace in Castelnuovo of San Pio (L’Aquila, Italy)’, *Int. J. Masonry Research and Innovation*, Vol. 3, No. 3,

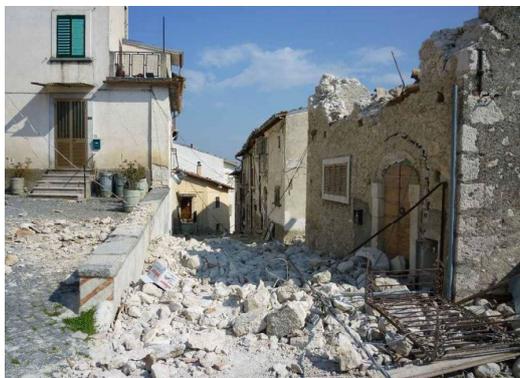
**Figure 3** The historical centre of Castelnuovo of San Pio after the Abruzzo earthquake (see online version for colours)

Before the earthquake, the historical centre mostly consisted of 2–3 stories ordinary buildings characterised by a low quality masonry structure.

The seismic event produced many damages and several collapses. However, it is worth to be noted that a lower damage level was observed in the buildings at the hill toe as respect to the constructions located on the hilltop. This aspect is due to some factors related to the topographic amplification, which have contributed to the strong shaking at the highest elevation of the village.

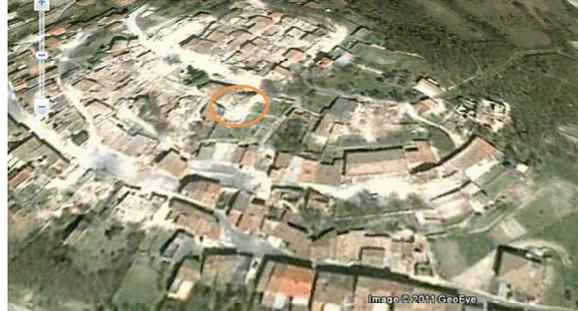
**Figure 4** Bird's-eye view of the Sidoni Palace (circled in red) (see online version for colours)

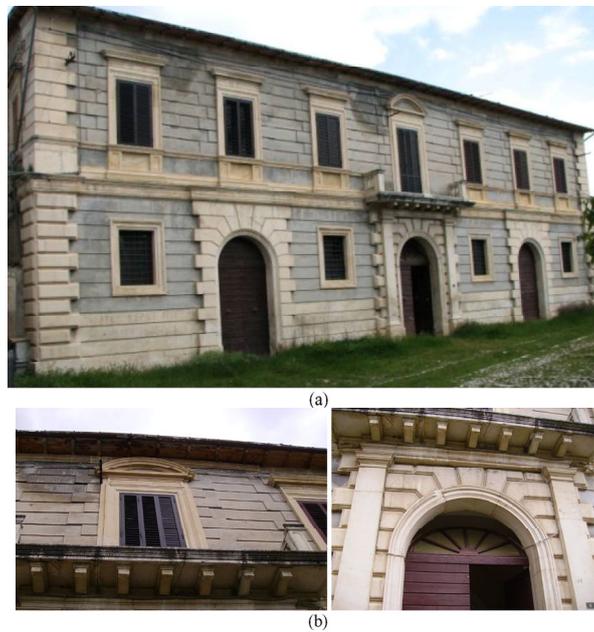
**Figure 5** View (a) and details (b) of the Sidoni Palace main façade (see online version for colours)

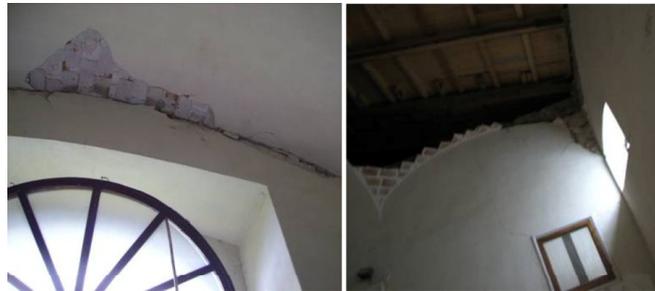
**Figure 8** Damages occurred in the vaulted ceilings (see online version for colours)

After earthquake no damage was recorded in the building facade, whereas significant damages and collapses of some masonry vault parts took place inside (Figure 8). Moreover, some of the steel floors at the building first level were destroyed by the earthquake, as illustrated in the building 3D views plotted in Figure 9.

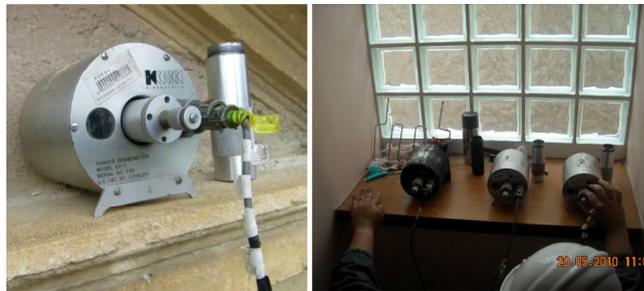
**Figure 11** Equipment for ambient vibration measurements: the Ranger type seismometers (see online version for colours)

During the ambient vibration measurements of Sidoni Palace, three seismometers Ranger type Kinometrics product were used (Figure 11) and the measured signal was amplified by four channel signal conditioner (Figure 12). The amplified and filtered signals from the seismometers were then collected by high-speed data acquisition system (Figure 13(a)), which transformed the analogue signals into digital ones. A personal computer (Figure 13(b)) and a special software for online data processing were used to plot the time histories of recorded velocities by the seismometers together with the response Fourier amplitude spectra (FAS) at any recorded point.

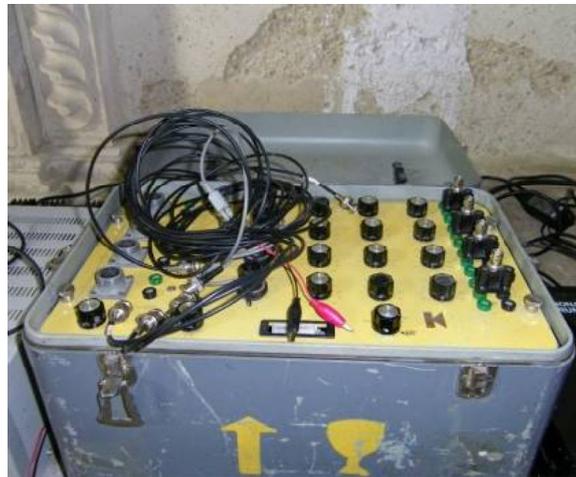
**Figure 12** Equipment for ambient vibration measurements: the four channel signal conditioner (see online version for colours)

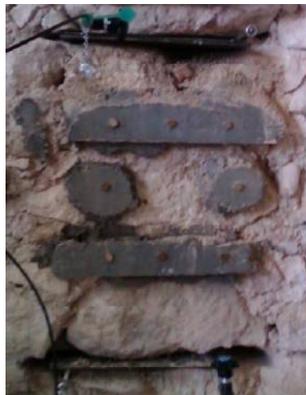
**Figure 20** Flat jack test on masonry: test set-up (see online version for colours)

As far as the material modelling is concerned, since the analysis is aimed at the structural global response identification, a continuum homogeneous material has been assumed. In addition, considering that the frequency analysis is purely a linear perturbation analysis type, only linear elastic properties of the masonry are required. So, the density has been assumed on the basis of the provisions of the Italian Ministerial Circular (Ministerial Circular (M. C., 02/02/2009), 2009), it being equal to  $19 \text{ kN/m}^3$ , while the elastic modulus  $E$  has been opportunely calibrated on the basis of flat jack tests performed on masonry (Figure 20).

$A_C$ , Cutting area	882 cm <sup>2</sup>
$A_J$ , Flat jack area	778 cm <sup>2</sup>
Jacks distance	30 cm
$K_m$ , Jack constant	0.78
$K_a [A_J/A_C]$	0.88
