Seismic damage assessment of school buildings after 2012 Emilia Romagna earthquake

Antonio Formisano*

SUMMARY – In the paper the usability checks performed on precast RC gyms and masonry school buildings, located in the Municipalities of San Pietro in Casale (BO), Bomporto (MO) and Bondeno (FE) after the seismic events occurred on 2012 May 20th and 29th, are reported and discussed. First, the main features of surveyed buildings have been identified. Later on, on the basis of the detected damages, their seismic deficiencies have been recognized. Finally, the indication of some appropriate simple interventions for retrofitting studied buildings has been given.

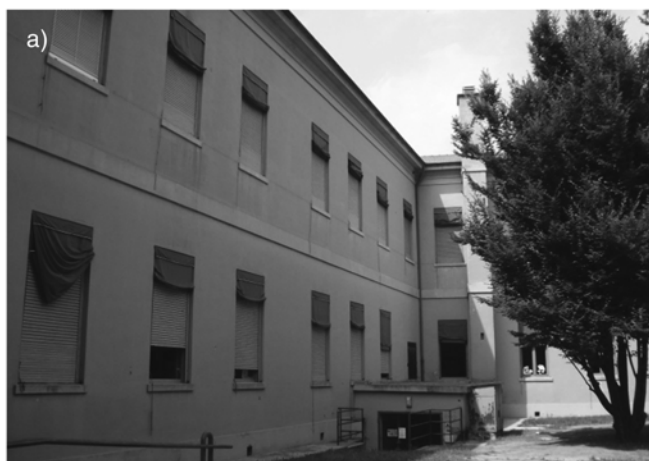
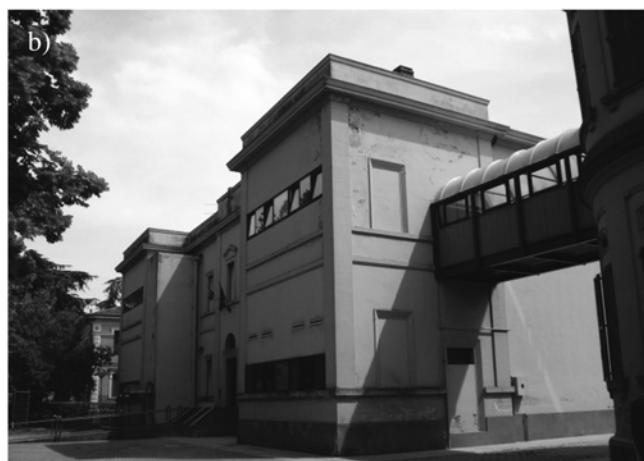
Fig. 8. Back views of the ancient (a) and the new (b) parts of the "De Amicis" school buildings.
Vista della parte antica (a) e della parte nuova (b) della scuola «De Amicis».

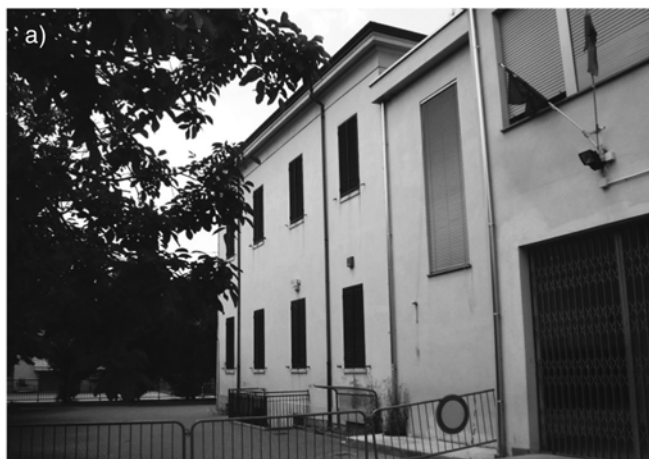
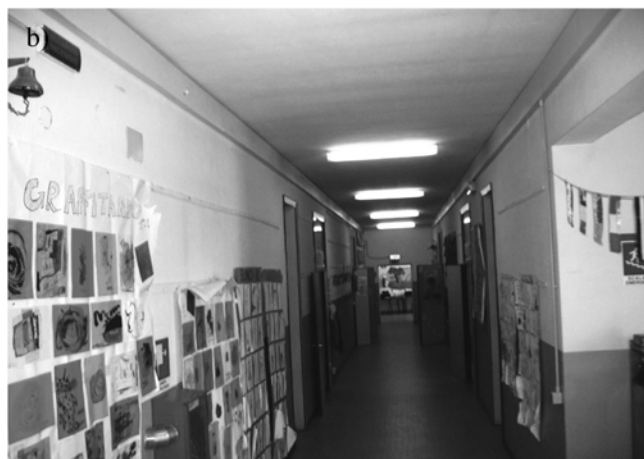
The oldest construction (Fig. 12a), built before 1919, has a load bearing vertical structure analogous to the one of other investigated schools and mixed steel beams – hollow tiles floors (Fig. 12b).

Fig. 12. Masonry structural unit of the school building "Menotti": external view (a) and internal corridor covered by a mixed steel beams-hollow tiles floor (b)

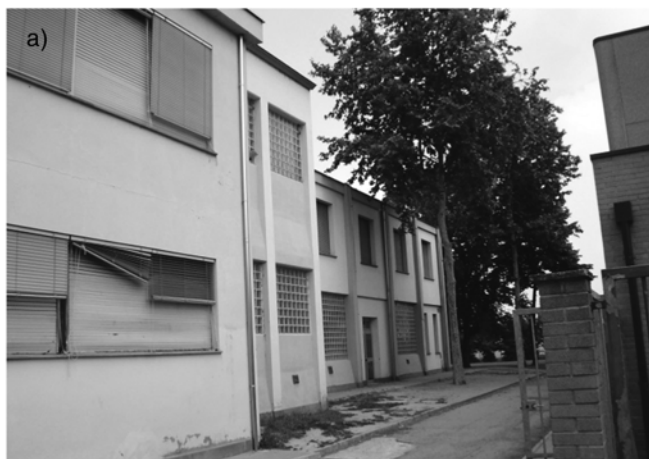
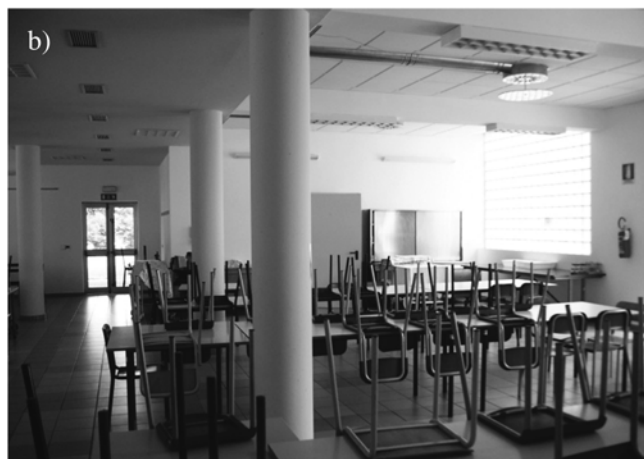
Damages to structural and non-structural components have not been recorded (Fig. 15b). Nevertheless, also in

Fig. 15. The new r.c. structural unit of the “Menotti” school: external view (a) and refectory (b).
La nuova unità in c.a. della scuola «Menotti»: vista esterna (a) e refettorio (b).

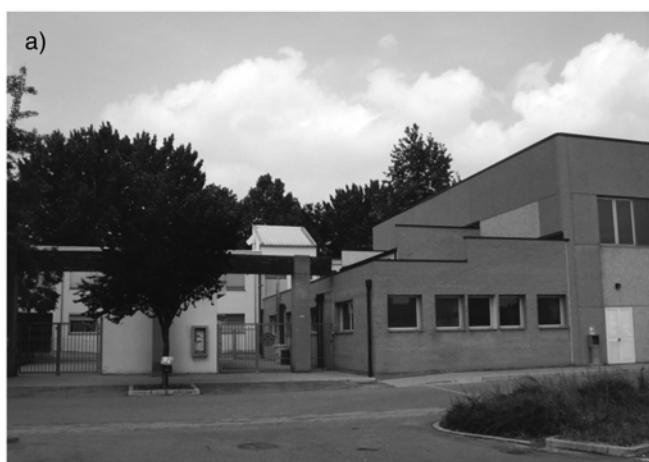
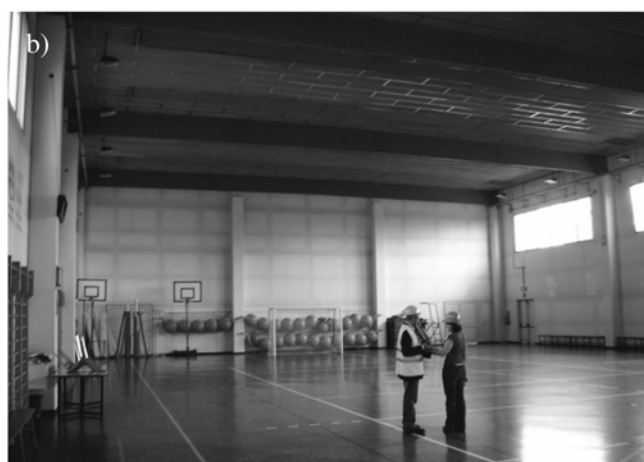
Fig. 16. External (a) and internal (b) view of the “Menotti” gym building.
Vista della palestra della scuola «Menotti». (a) esterno, (b) interno.

The building has not shown damages to load-bearing vertical structures, whereas precast cladding panels have overturned externally to the building, their connection with columns being completely compromised. In addition, some damages to ceiling, consisting of failure of some panels, have been detected.

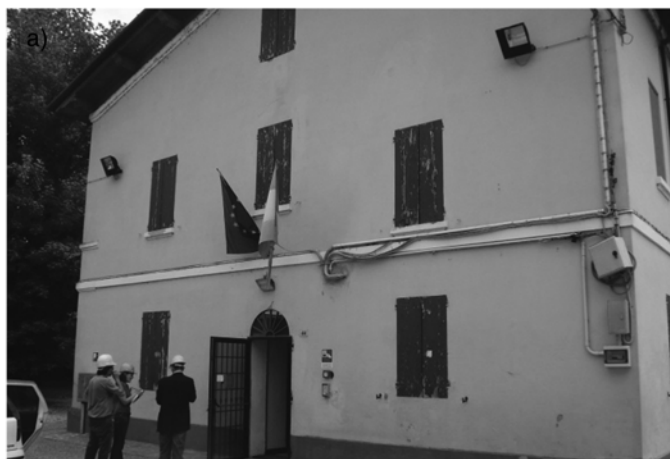
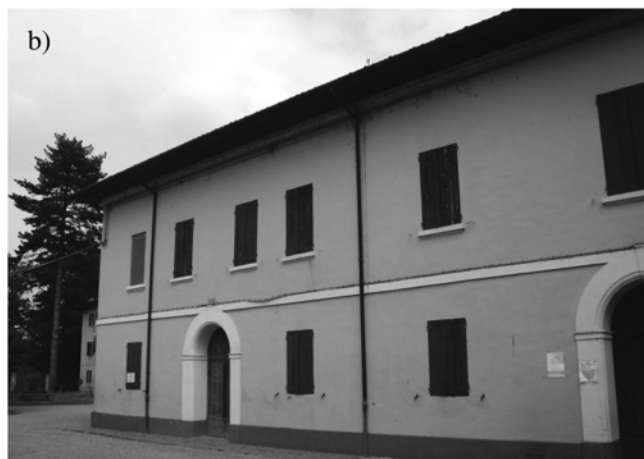
In the building few damages among walls and not significant floor-wall cracks have been recorded. Diagonal cracks into masonry piers and horizontal cracks in vaults are very diffused (Fig. 18).

Fig. 17. Front (a) and back (b) views of the “Sorelle Luppi” school building.
Fronte (a) e retro (b) dell’edificio scolastico «Sorelle Luppi».

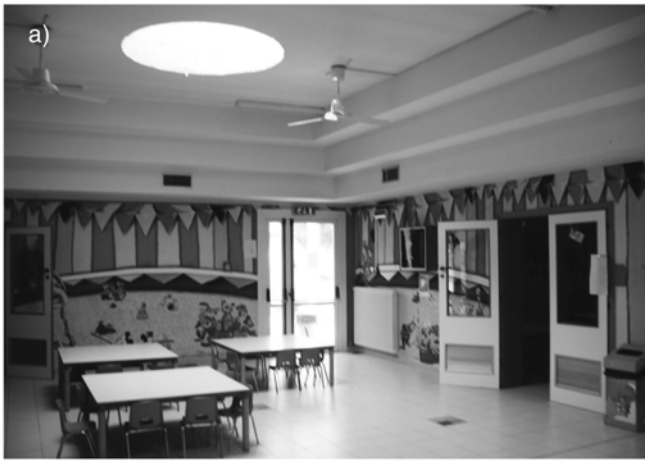
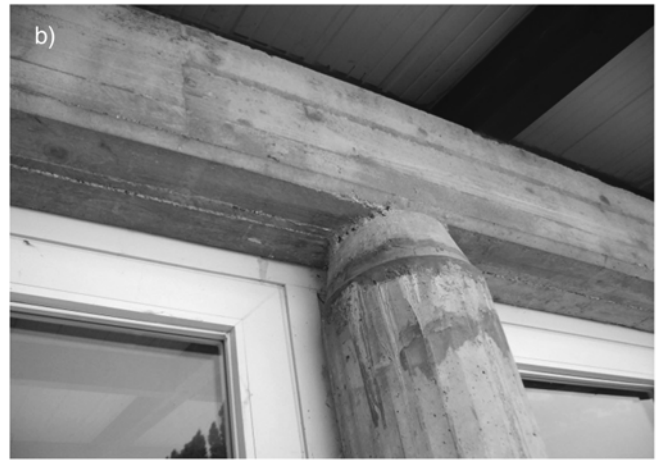
The second building of the block, erected in the last decade, has a vertical structure made of r.c. frames. It has exhibited a satisfactory seismic response, since no significant damage has been observed after earthquake (Fig. 26).

Fig. 26. The nursery of the “Margherita” school building block (a) and a view of the beam-to-column joint (b).
L’asilo dell’edificio scolastico «Margherita» (a) e una vista di un giunto trave-colonna (b).

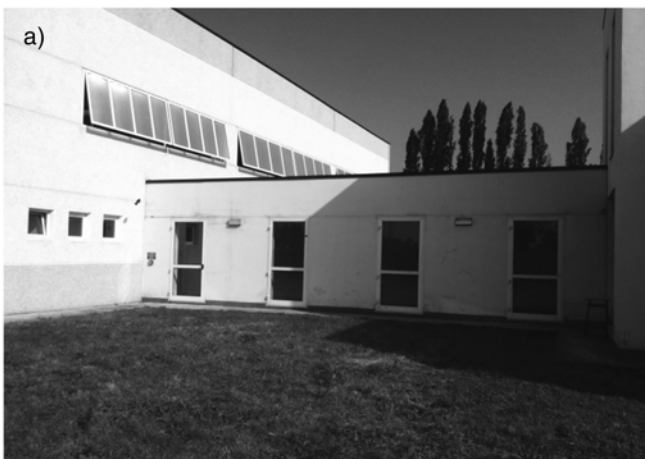
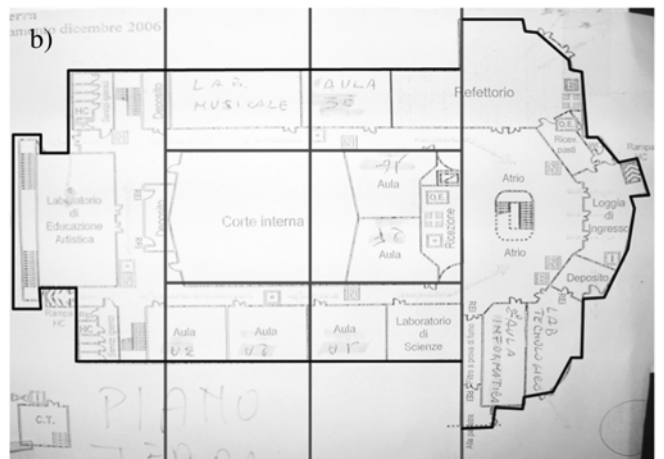
theless, since structural joints have not been made following the “rule of art”, that is leaving an appropriate

distance between two adjacent buildings, the main damages have been detected there. In fact, important plaster cracks have been observed both among adjacent col-

Fig. 28. The “Bonati” secondary school: connection construction between school and gym (a) and plan view with indication of structural joints (b).
La scuola media «Bonati»: collegamento tra scuola e palestra (a) e pianta dell’edificio con indicazione dei giunti strutturali (b).

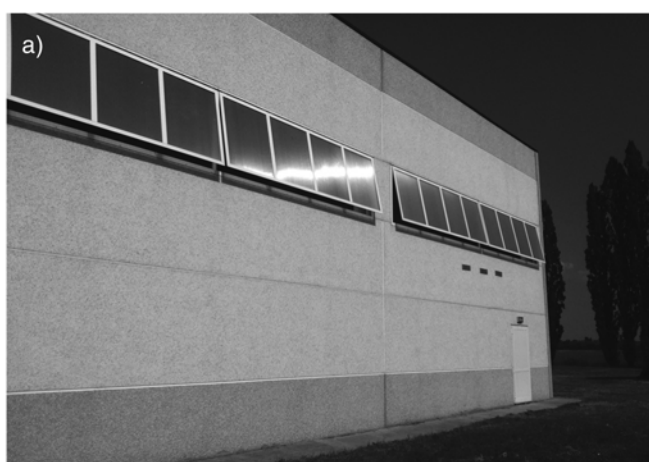
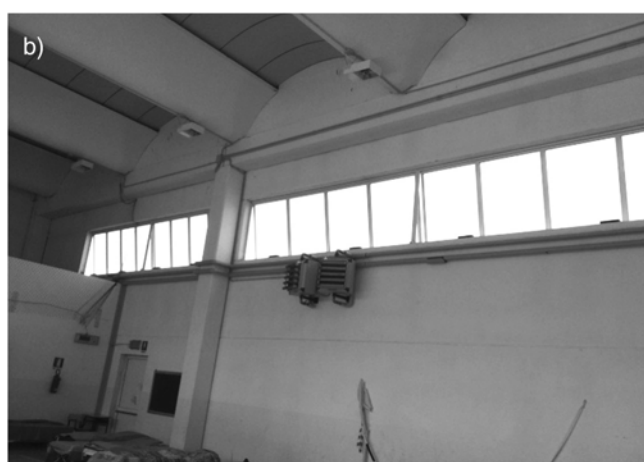
Fig. 31. External (a) and internal (b) views of the gym building of the "Bonati" secondary school.
Vista esterna (a) ed interna (b) della palestra della scuola «Bonati».

Considered as a strategic building, the gym has cladding panels significantly damaged. In fact, some

of them, badly connected to columns, have suffered an overturning out-of-plane mechanism which has produced detachment of panels from columns (Fig. 32a). In particular, a vertical crack developed along the entire building height at the panel-column interaction zone has been noticed. Also the hammering effect between gym and the connection structural body with the school building has been recorded (Fig. 32b).

As a whole, the observed damages, due to the absence of beam-column connections and the inefficiency of panel-column ones, make building susceptible to undergo severe damage under future earthquake, so to require appropriate seismic retrofitting interventions able to improve their global behaviour.

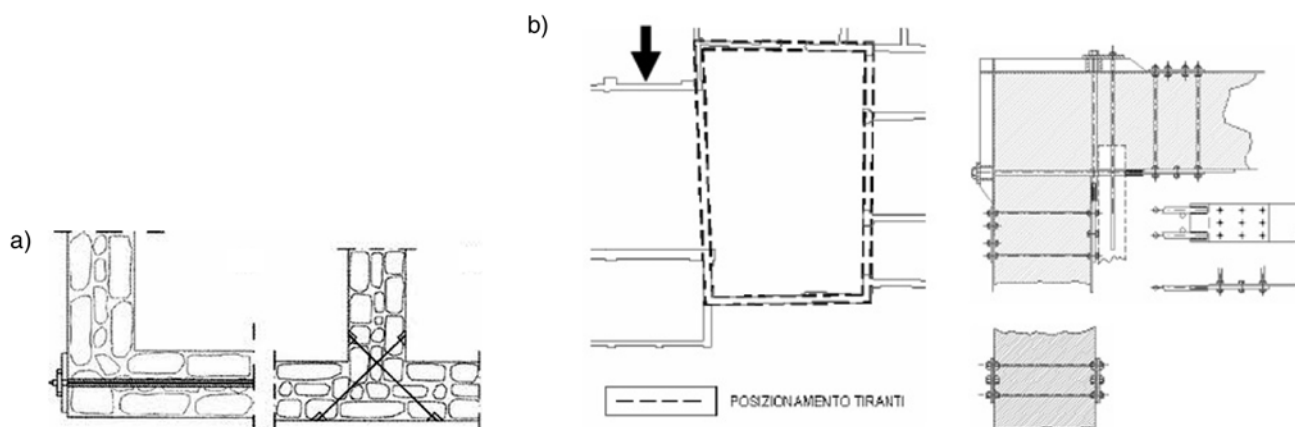
The damages observed within investigated school buildings have shown the typical deficiencies of such constructions: lack of wall-floor connections and high masonry wall slenderness for masonry buildings and

- Steel or r.c. tie-beams, in order to make effective wall-to-wall and wall-to-floor [Modena, 2007] connections (Fig. 33);
- Steel or r.c. jacketing of masonry walls, to be used when they are not able to sustain applied loads [Maz-zolani, 2008] (Fig. 34).

Fig. 33. Steel tie-beams for wall-to-wall (a) and wall-to-floor (b) (Modena, 2007). Collegamenti metallici tra muri (a) e muri-orizzontamenti (b) (Modena, 2007).
