Predictive maintenance for monitoring performance decay of plaster coverings according to the criteria of ISO 15686-7 code

Building in Naples (Italy) - Via Riviera di Chiaia, 270

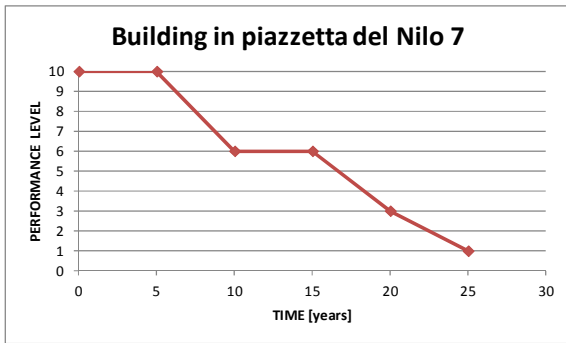
Fig. 6

In conclusion, thanks to the outputs of the thermographic inspections, it is possible to build performance/time curves like those in Figures 6, 7, 8, 9 (which respectively refer to the buildings in Piazzetta del Nilo 7, Via V. Colonna 4, Via V. Gemito 5 and Via G. Martucci 10), and then,

associating to the performances the related interventions, it is possible to realize reliable maintenance programs for each, after choosing the maintenance strategy to adopt.

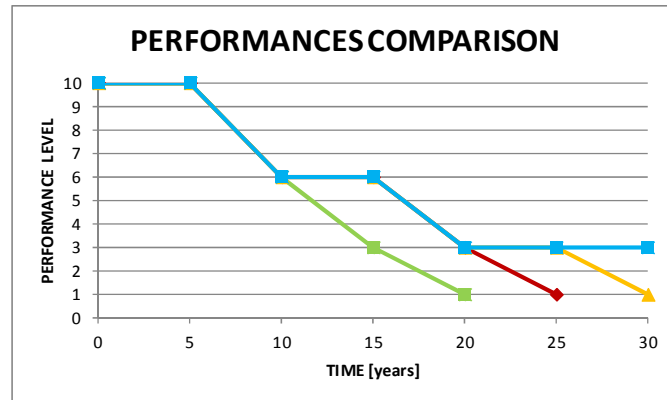
Fig. 10

Eventually, Figure 10 shows the four curves overlapped, highlighting a good convergence of the data, and therefore a sufficient reliability of the method.

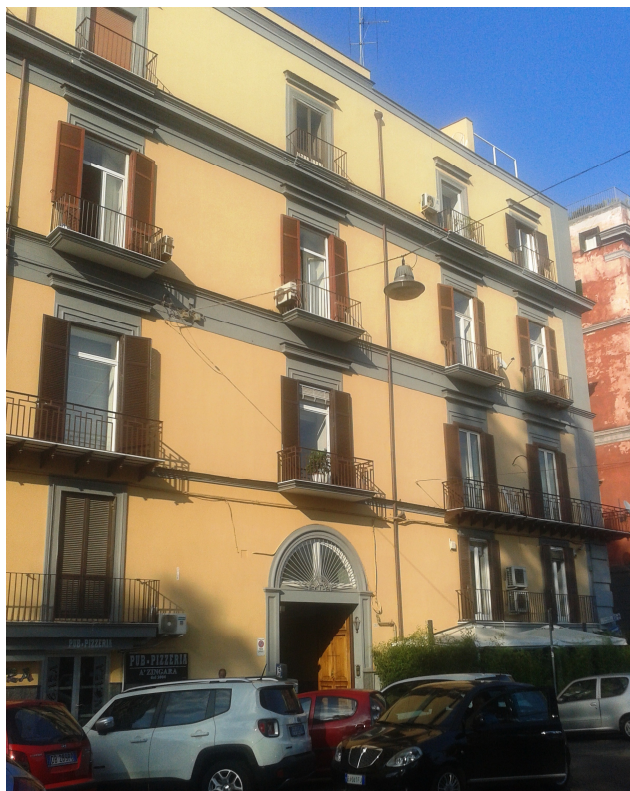
**B.1**

Building in Naples (Italy) - Via Riviera di Chiaia, 267

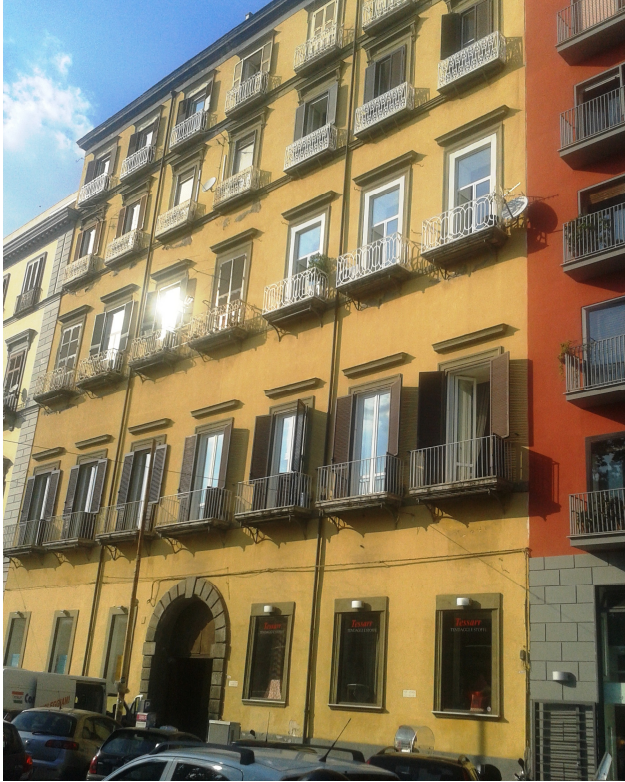
C.1

Building in Naples (Italy) - Via Riviera di Chiaia, 257

The building was subjected to maintenance interventions in 2010. Before these works, a slow and progressive worsening of the conditions of adhesion of the external plasters on the side of via Riviera di Chiaia, characterized by an aggressive climate (city environment with intense traffic and sea atmosphere) was noted. The thermographic frames refer, in particular, to the bottom of the prospect, which suffers the most from the vibrations caused by the passage of the vehicles.

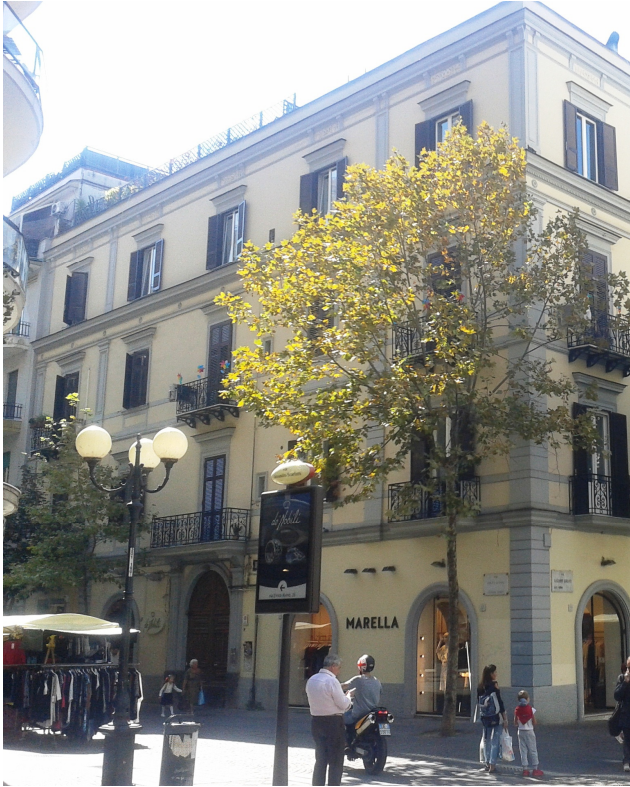
**D.1**

Building in Naples (Italy) - Via Enrico Alvino, 37
