Repairing of an Engine Block Through the Cold Gas Dynamic Spray Technology

Antonello Astarita^a, Fabrizio Coticelli^a, Umberto Prisco^{a*}

^a Dept. of Chemical, Materials and Industrial Production Engineering, University of Napoli Federico II, Piazzale Tecchio 80, 80100, Napoli, Italy

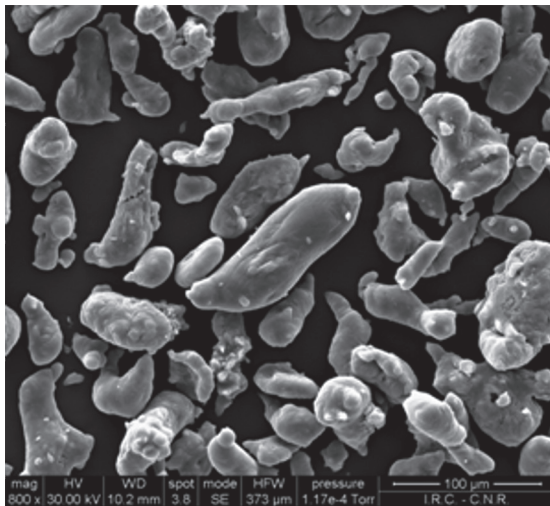
**Figure 4:** SEM micrograph of the powders used for the cold spray repairing.

A sample repaired by using CGDS is shown in Figure 3. Before the CGDS a grit-blasting was carried out on the sample to improve the adhesion of the coating on the substrate material. A commercial white corundum grit of 0.6-0.7-mm diameter was used. The blasting pressure was 0.6 MPa. An Al-12% Si powder, with a composition very similar to the same Al-Si alloy used in the TIG process, was chosen for the cold spray repair, see Table 1. The powder is characterized by a mean particle diameter of 40 microns. A SEM micrograph of the powder used is shown in Figure 4.

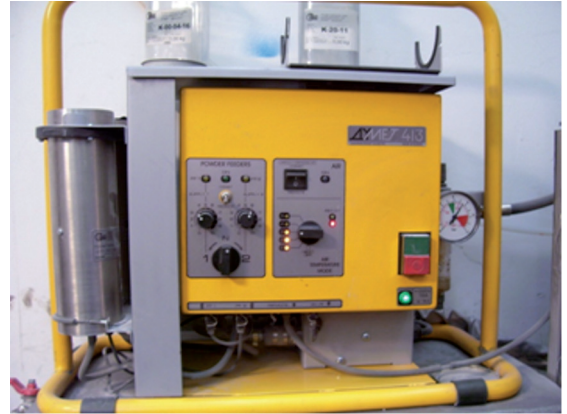
**Figure 5:** Low pressure Dymet equipment used for the spraying process.

The powder was deposited using a low pressure Dymet 413 equipment, Figure 5, with nitrogen as carrier gas. The spray conditions were the following: the propellant gas was preheated to about 1000 °C, the gas pressure was chosen equal to 2 MPa, the spray distance was fixed in 40 mm, the particles velocity was fixed at 600 m/s and the transverse speed of the gun was chosen equal to 0.01 m/s.

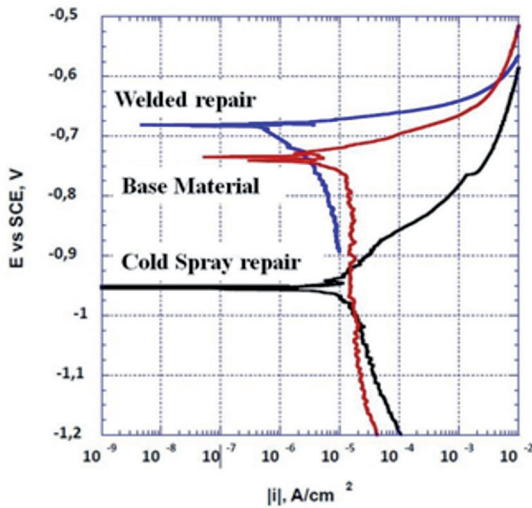
Figure 9: Results of the potentiodynamic polarization measurements.

The polarization curves are reported in Figure 9. It is clear that the corrosion potential value of the base material is more positive than that of cold spray repair. Thus, the corrosion of the cold spray repair can take place in preference to the corrosion of base material. Furthermore, it is possible to assess from Figure 9 that the welding repair showed an electrochemical behavior similar to the one of the base material while the OCP potential of the cold spray repair is noticeably lower than the previous ones. This result suggests an anodic behavior of the cold spray repaired zone with respect to the material of the engine block⁸. The general trend of the curve is similar for all the three samples under investigation.

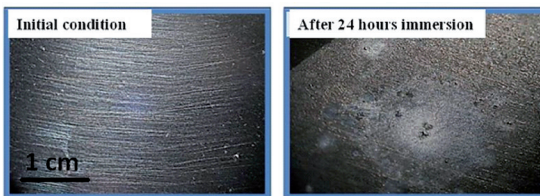
Figure 11: Macrograph of the top surface of the cold spray repair before and after the immersion test.

Photographs of the top surface of the specimens after the immersion test are reported in Figure 10 (welded repair) and 11 (cold spray repair). In particular, in both cases it is possible to observe the occurrence of classical pitting^{8,13}. The cold spray repair shows a better behavior with respect to the welded repair, in particular very few pits are appreciable.
