International Symposium on Dynamic Response and Failure of Composite Materials, DRAF 2016

Infrared thermography to an aluminium foam sandwich structure subjected to low velocity impact tests

C. Meola, S. Boccardi, G. Petrone, N.D. Boffa, F. Ricci, G.M. Carlomagno

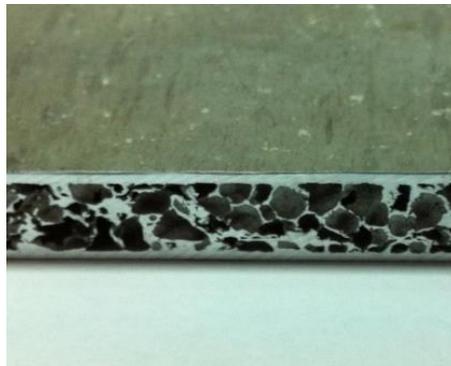
Fig. 1. Aluminium foam sandwich panel.

The Aluminium Foam Sandwich (AFS) panel under investigation has been manufactured by the Austrian company Mepura Metallpulver GmbH with the commercial name Alulight. As depicted in Fig. 1, the AFS panel consists of a three-layer composite: two external face sheets made of aluminium alloy and an internal core layer made of foamable aluminium alloy sheet (containing TiH₂ as a blowing agent).

The total thickness of AFS panel is 10mm: the foam thickness is 8mm, each of the two external layers is 1mm thick and the average cell size of the foam bubbles is about 2 mm.
