42<sup>nd</sup> IAHS WORLD CONGRESS  
The housing for the dignity of mankind  
10-13<sup>rd</sup> April 2018  
Naples, Italy

**THE HOLY MONUMENT ANNUNZIATA  
IN CAVA DE' TIRRENI (SA)  
HISTORICAL ANALYSIS OF THE BUILDING FOR A PROPOSAL  
OF A RELIGIOUS HOUSE OF HOSPITALITY**

**Abstract** *In this paper it is presented a research for the enhancement, the reuse and the architectural recovery of the holy monument Annunziata, located in Cava de Tirreni (SA).*

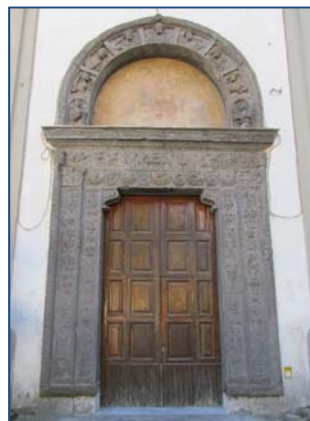
Outside, the facades have a traditional plaster based on sand and lime with white quartz paint. The main north-east front is punctuated by pilasters with a smooth trunk and stringcourses, characterized by the alternating strips and inverted gorges, and is crowned by a molded pediment: these elements are painted in gray. The façade also has a beautiful pipernoid portal. It has the classic trilithic shape: the upper bezel is considerably elongated and the jambs are decorated with festoons of flowers and fruit, cherub heads, candelabras and grotesques.

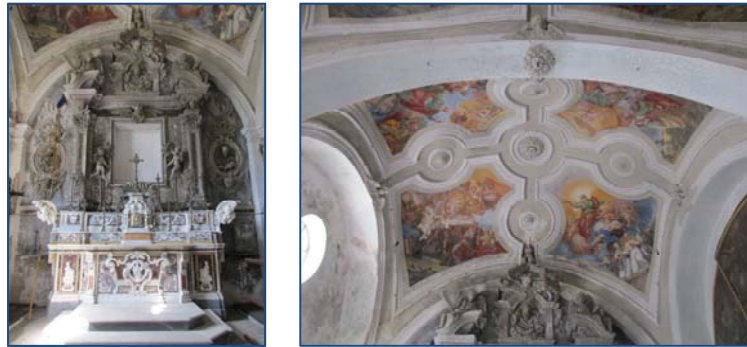
The oratory has a longitudinal plan, with a single nave divided into three bays. The presbytery is located in the innermost part of the last bay. The roofs are vaulted and there are pillars with doric capitals, leaning against the side walls and supporting the covering vaults. The intrados of the vaults are decorated with elaborate frames, which form geometric designs and partitions in quadrants, and with large frescoes.

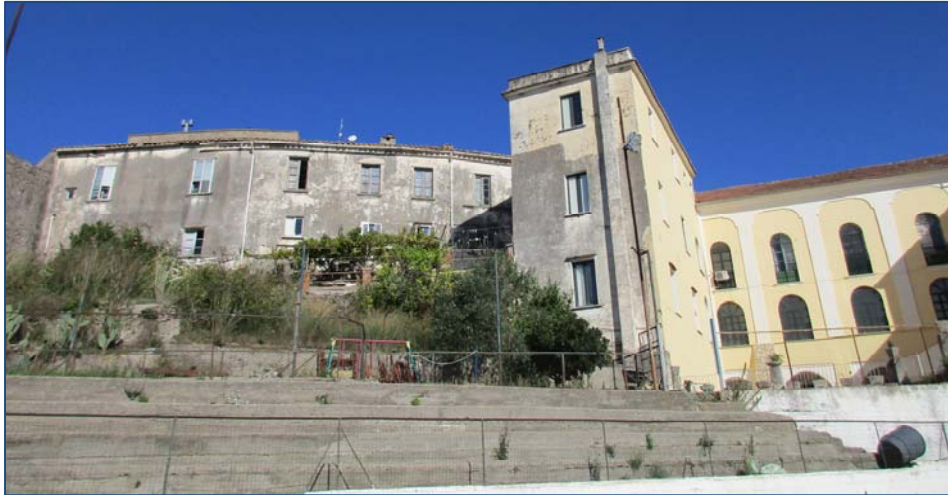
At present, the building has several rooms, distributed over five levels.

The ground floor, with entrance hall, includes a room used in recent times to the oratory and the cloister, open on one side and surrounded by two L-shaped corridors, covered with cross vaults in tuff walls, resting on pillars also masonry tufa, painted yellow, with coating on the basement in stone slabs. The court has recently been paved with prefabricated slabs of molded concrete.

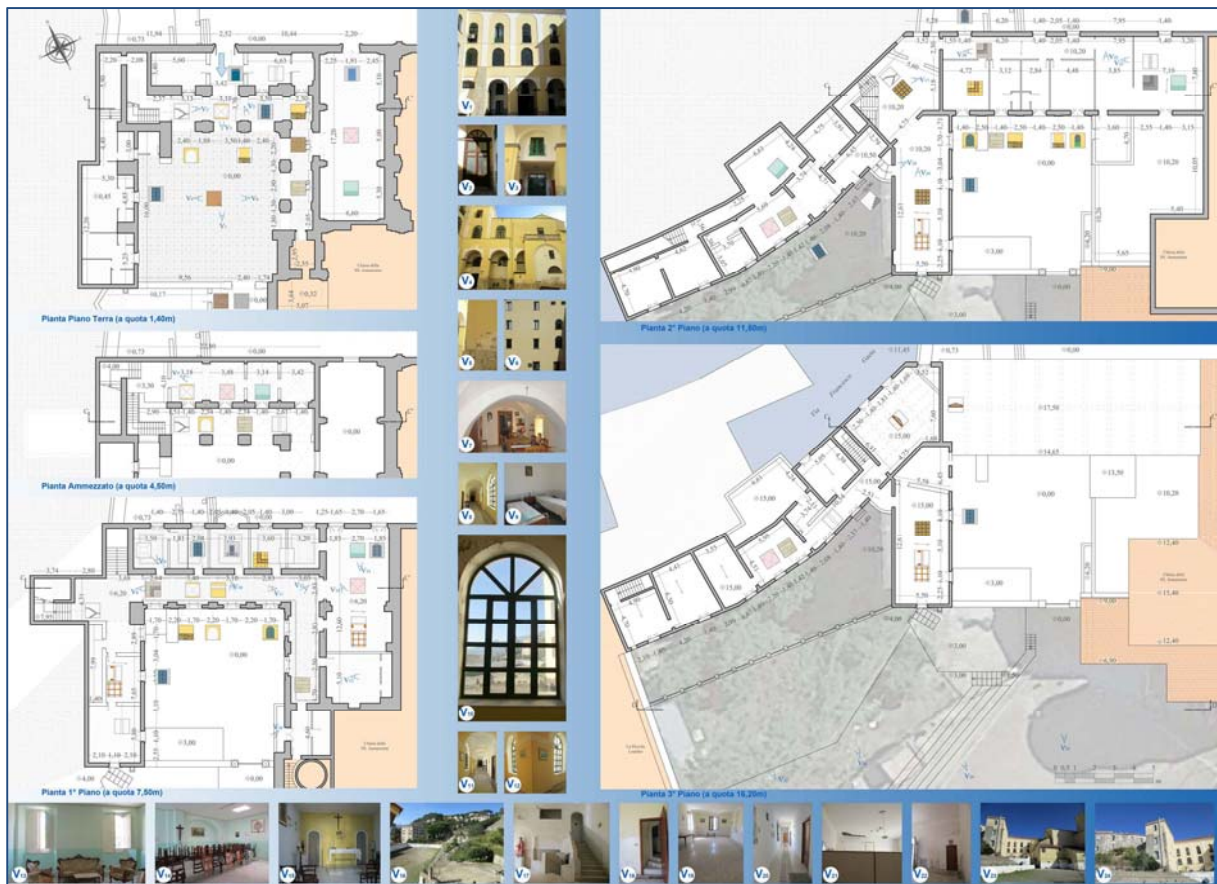
Compatibly with the architectural structure of the building, we have chosen the new functions that the various environments should have.

On the ground floor in the rooms that give onto the entrance hall the reception room and the bathrooms have been respectively arranged.
