Landslide-inventory of the Cinque Terre National Park (Italy) and quantitative interaction with the trail network

To cite this article: Emanuele Raso, Andrea Cevasco, Diego Di Martire, Giacomo Pepe, Patrizio Scarpellini, Domenico Calcaterra & Marco Firpo (2019) Landslide-inventory of the Cinque Terre National Park (Italy) and quantitative interaction with the trail network, Journal of Maps, 15:2, 818-830

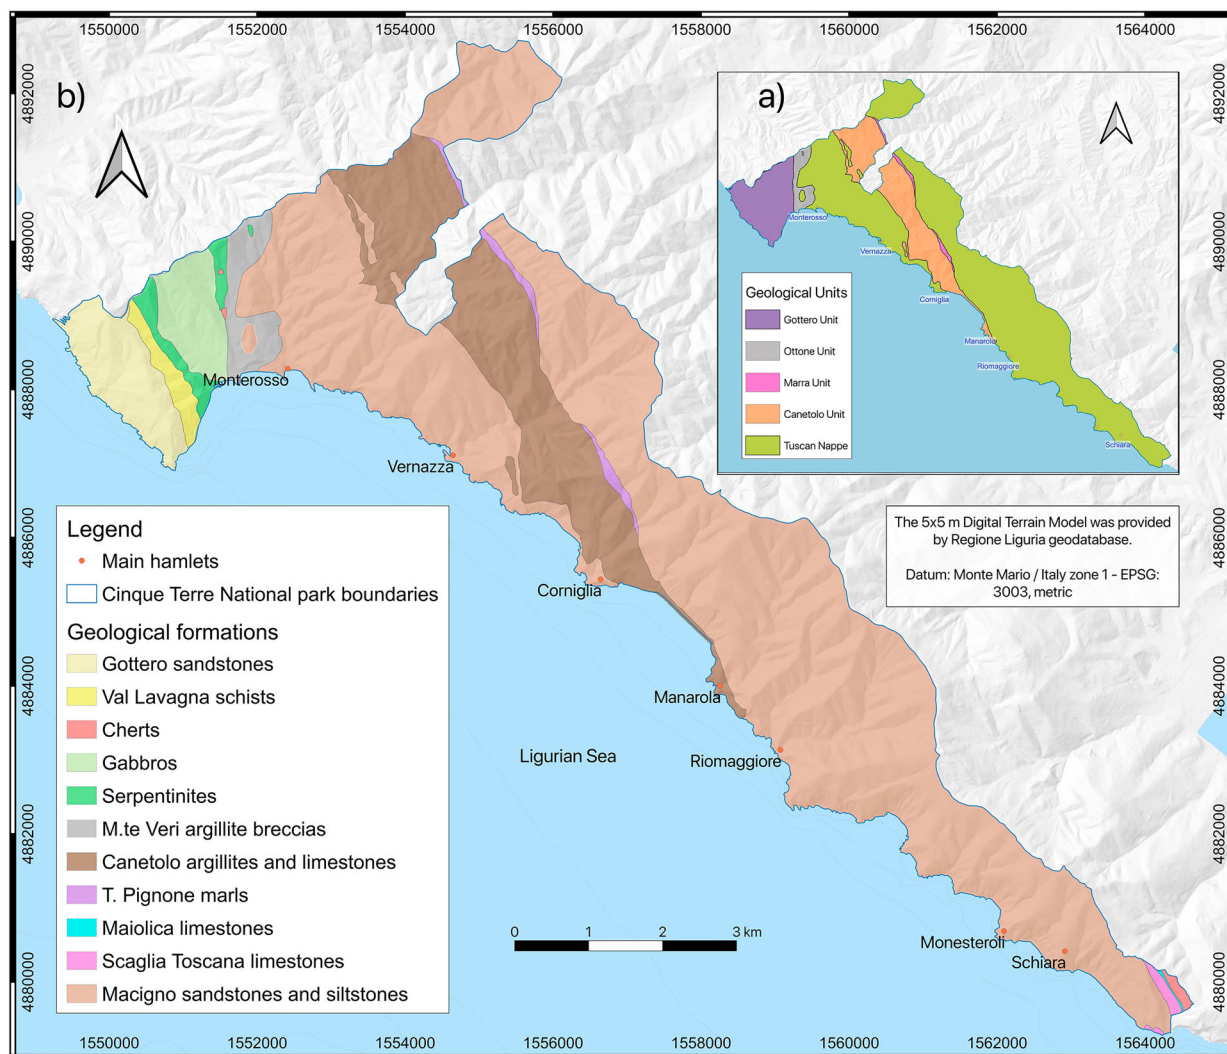
Figure 1 . Geology of the Cinque Terre National Park (modified after Raso et al., 2019): (a) tectonic sketch map, (b) geological map.

Geologically, the territory of the Cinque Terre National Park belongs to an NW–SE oriented segment of the Northern Apennine, an orogenic chain formed during Tertiary (Abbate, Bortolotti, Passerini, & Sagri, 1970). This sector of belt is made up of a nappe sequence that includes five overlapping tectonic units (top to bottom): Gottero Unit, Ottone Unit, Marra Unit, Canetolo Unit and Tuscan Nappe (Figure 1(a)). The Gottero Unit crops out in the westernmost sector of the study area, along the NE–SW trending headland of Punta Mesco, and mainly consists of ophiolite rocks (classically interpreted as the remnants of the Jurassic oceanic crust), followed by a turbidite sequence (Late Cretaceous). The Ottone, Canetolo and Marra units are localized in the western side of the Monterosso village and in the central sector of the national park (Figure 1(b)). The first one is prevalently composed by pelitic rocks (Monte Veri Complex Fm.). The other ones occupy a narrow NW–SE oriented stretch of land encompassing the coastal villages of Manarola and Corniglia and it includes claystones with limestones and silty sandstones turbiditic rocks (Figure 1(b)). The Tuscan Nappe occupies most of the Cinque Terre National Park as it outcrops on the eastern, central and

western sectors. This unit is almost entirely represented by thick sandstone-claystone turbidites (Macigno Fm.), largely cropping out along the coast, and secondly by limestones, only cropping out in the easternmost part of the national park (Figure 1(b)). The main structural setting of the study area is predominated by a wide overturned SW-verging antiform fold (Giammarino & Giglia, 1990) and by multiple sets of Plio-Quaternary tectonic discontinuities that in turn strongly influence the local morphology such as coastline, hydrographic network, main and secondary watersheds (Cevasco, 2007). The morphological features of the Cinque Terre area show a sequence of small coastal basins delimited from the inner Vara Valley by the main water divide approximately running parallel to the coast, which consists of sub-vertical rocky cliffs shaped by the wave action at the basal portion (Cevasco, 2007; Raso et al., 2017). Such basins are dominated by steep and very steep slopes (more than 50% of the slope gradient is greater than 30°) covered by thin and human-reworked eluvial-colluvial deposits (Cevasco, Pepe, & Brandolini, 2013b),

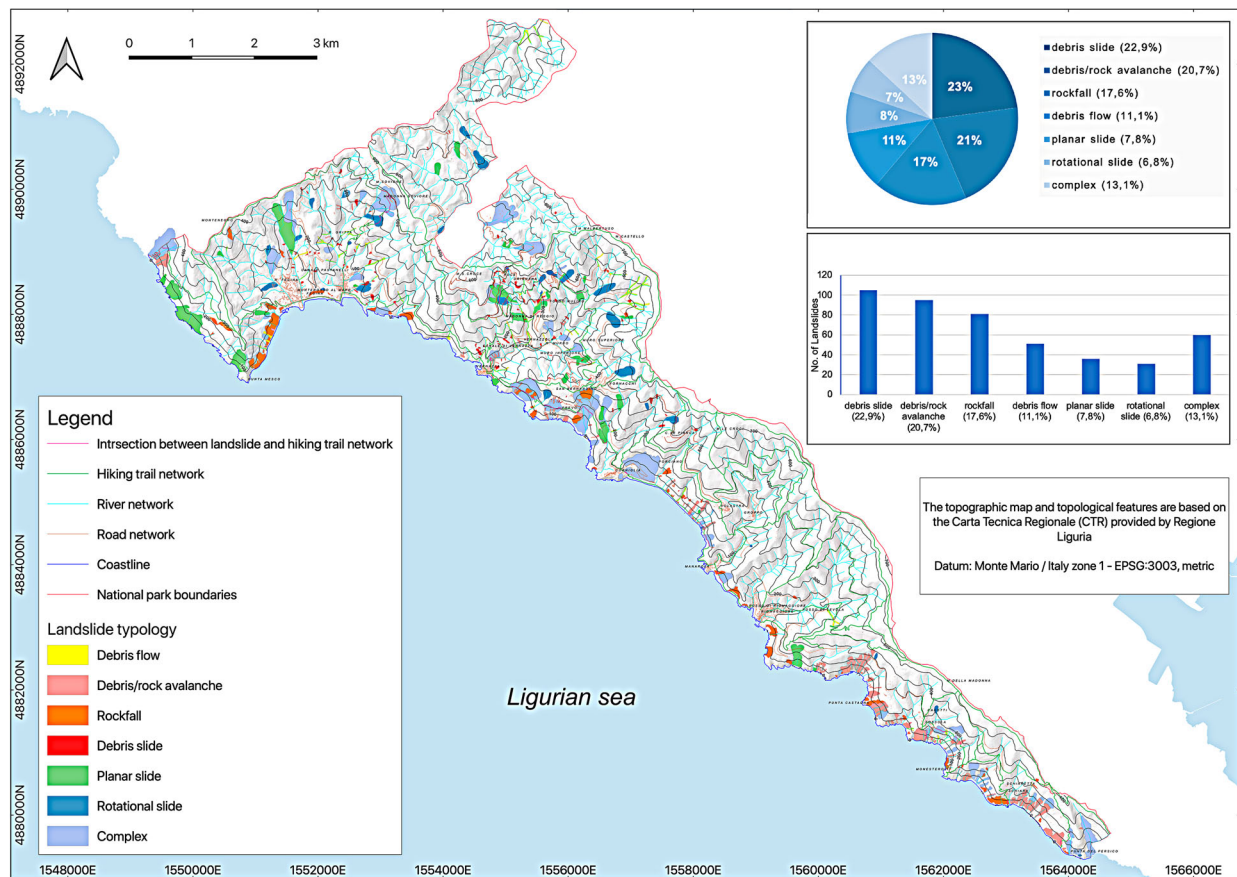
Figure 2. Landslide inventory of the Cinque Terre National Park and diagrams showing the percentage of catalogued landslides for each typology.

The produced LIM highlights how the landslides represent the main geomorphic processes within the Cinque Terre National Park territory and consequently as such phenomena play a leading role in the actual morpho-evolution of the landscape. A total number of 459 landslides (Table 1) were identified and mapped (Figure 2). It is relevant to note that an important number (about 170) of inventoried landslides, particularly of shallow-type, are related to the extreme rainfall event of 25 October 2011, when, in a few hours, approximately 450 mm of rainfall hit the western sector of Cinque Terre National Park belonging to the Monterosso al Mare and Vernazza municipalities (Brandolini & Cevasco, 2015; Cevasco, Pepe, & Brandolini, 2012; Galve, Cevasco, Brandolini, & Soldati, 2015, 2016). Moreover, some mass movements (about 5) were recently triggered on 30 October 2018, when cumulative daily rainfall magnitudes up to 128 mm in 3 h were measured at the Monterosso rain gauge (ARPAL-CFMI-PC, 2018).

The mapped landslides cover a total area of 4.19 km², corresponding to 10.9% of the total surveyed area and to a landslide density of 11.9 landslide/km². The size of the inventoried landslides ranges from a minimum value of 99 m² to a maximum one of 179,390 m² whereas the average area is 9140 m². Referring to the classification proposed by Cruden and Varnes (1996) and Hungr et al. (2014), inventoried landslides were grouped into seven main landslide types and a percentage distribution analysis was then performed (Figure 2). A high number of mass movements can be classified as debris slides (105–22.9%) and debris/rock avalanches (95–20.7%) which are typical phenomena affecting mountainous and hilly terraced areas, particularly in case of prolonged or intense rainfall events (Camera, Apuani, & Masetti, 2014; Cevasco et al., 2013a; Crosta, Dal Negro, & Frattini, 2003; Schilirò, Cevasco, Esposito, & Scarascia Mugnozza,

Debris flows are also widely distributed (51–11.1%), especially along the western sector of Cinque Terre, and are promoted by the steepness of first and second order channels (Figure 3(c)). They usually occur simultaneously with flash floods and are characterized by rapid and very rapid surging flows of saturated debris entrained from the flow path and of landsliding materials entered in the channels from the slopes (Cevasco et al., 2013a, 2014).

Finally, many landslides (60–13.1%) with complex evolution can be observed along the coastline between the Vernazza and Manarola municipalities (Figure 2). These phenomena (e.g. Guvano, Rodalabia, and Macereto landslides) are historically well-known and extensively described in literature (e.g. Cevasco, 2007; De Stefanis, Marini, Terranova, & De Luigi, 1978; Federici, Baldacci, Petresi, & Serani, 2001; Raggi, Raggi, & Pintus, 2010; Raso et al., 2017; Terranova, 1984, 1989) and usually consist of large relict landslide bodies closely related to stratigraphic/tectonic contacts between rock sequences characterized by different mechanical behavior (Figure 3(e)). Some of these landslides are characterized by localized residual movements and occasional

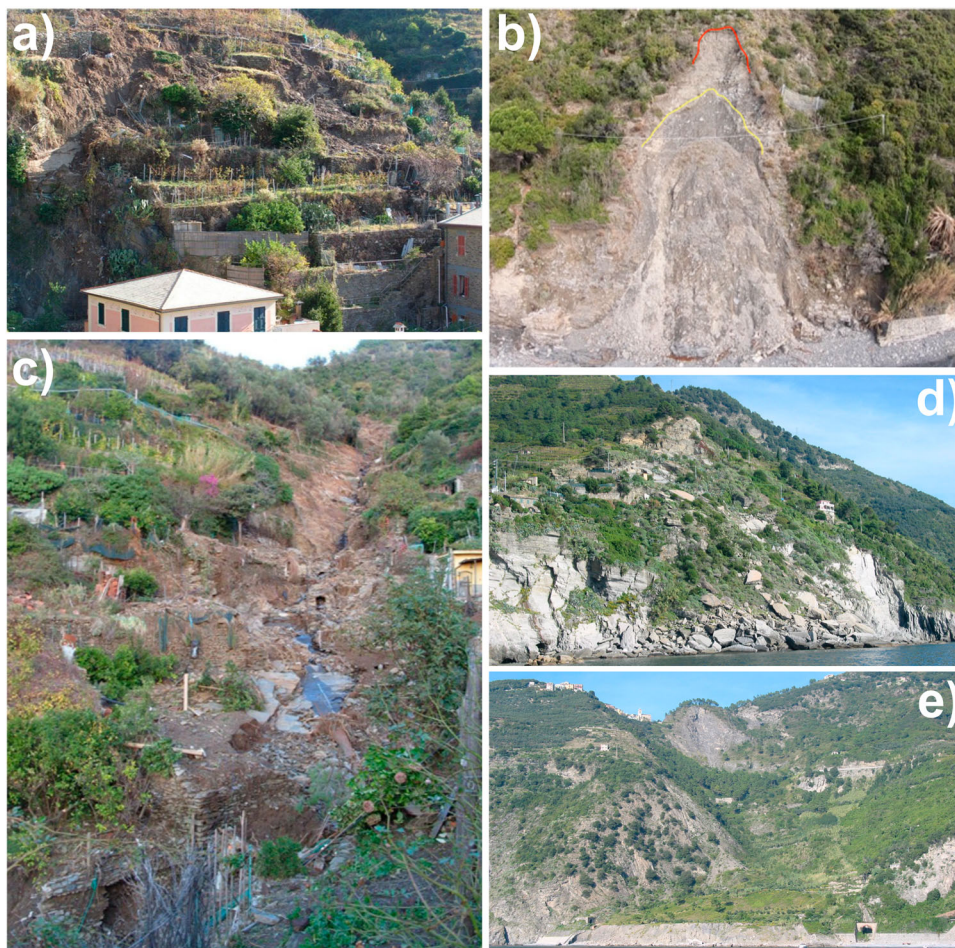
Figure 3. Five examples of different landslide typologies surveyed in the study area: (a) debris slide involving terraced slopes above the hamlet of Vernazza; (b) debris avalanche along the coastline between Corniglia and Manarola; (c) debris flow located in Vernazza, along the Vignaresca stream; (d) planar slide involving Macigno sandstone between Vernazza and Corniglia; (e) Guvano complex landslide.

Other landslide types are less numerous and include rotational (31–6.8%) and planar slides (36–7.8%) (Figure 3(d)).

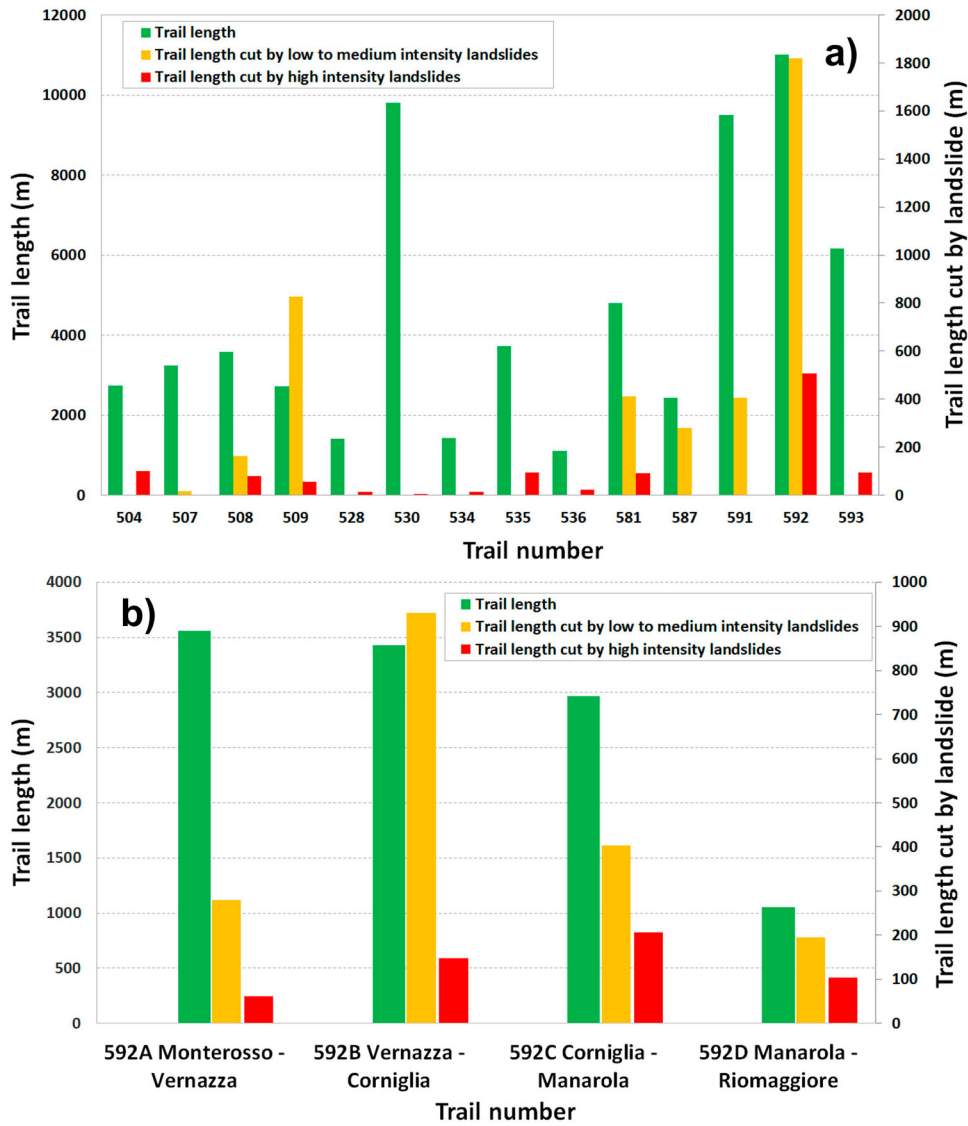
Figure 4 . (a) Trail lengths and landslide intersections in the Cinque Terre National park and (b) 592 trail sectors length and landslide intersection along the 'Sentiero Verde-Azzurro'.

On a total length of 104 km of the park's trail system, about 5 km were found to be cut by landslides (Figure 4 (a)). In detail, 3.9 km of the hiking trails resulted potentially intersected by low to medium-intensity landslides while 1.1 km by high-intensity landslides. Among the 14 inventoried hiking trails, only 4 paths (i.e. trails 507, 528, 530 and 534) resulted cut by landslides for very small lengths (ranging approximately between 4 and 16 m). It is worth highlighting the hiking trail number 592 (also known as *Verde-Azzurro* trail), which shows the highest number of visitors per year and that is also characterized by the highest length of path potentially subjected to the impact of landslides (Figure 4(a)). A further partition has been carried out on the 592 trail by distinguishing four main stretches (Figure 4(b)) which connect the five coastal villages of the national park (i.e. Monterosso, Vernazza,

Corniglia, Manarola and Riomaggiore). It is relevant to note that every considered stretch is potentially intersected by landslides (Figure 4(b)).

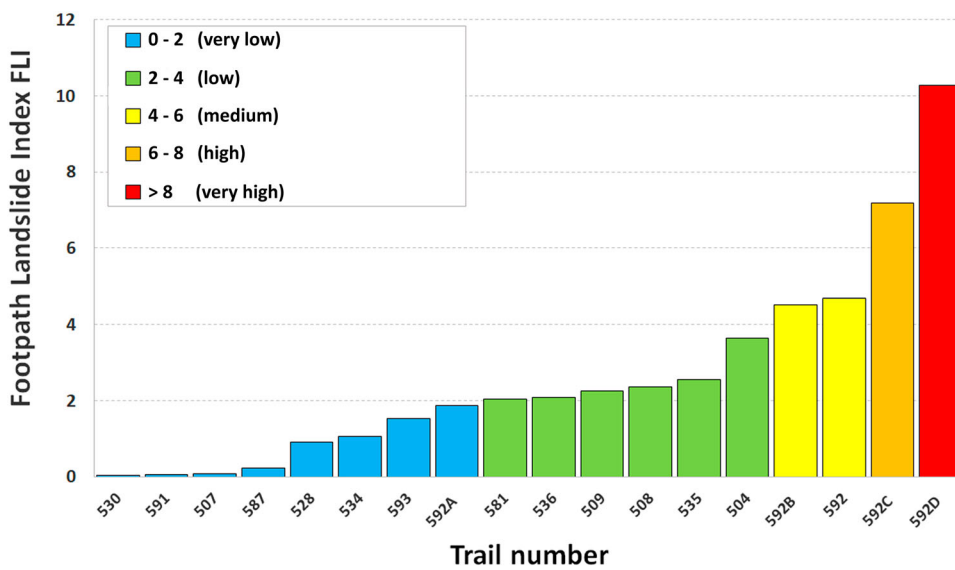
Figure 5 . FLI (Footpath Landslide Index) ranked in ascending order per each trail.

However, a better characterization of the potential for damage due to landslide impact for exposed elements, and more specifically for hikers walking along the footpaths, can be obtained through the computed Footpath Landslide Index. As can be observed by Figure 5, the FLI values vary between 0 and 10.3. The highest values of FLI are associated to the trails 592D and 592C (10.3 and 7.2, respectively) and highlight that the landslides intersecting these two stretches can cause significant damage to hikers. These results are in agreement with previous researches (Raso et al., 2016) that documented nine main rockfall events which affected the 592D trail stretch from 1990 to 2012. These landslide events lead to the closure of the path and in two cases they also involved the path users. Further interesting observations come from the mapping of the FLI values for the whole Cinque Terre National Park's hiking trail system (Figure 6). It is interesting to note how hiking trails showing values of FLI higher than 3 (high FLI) are usually

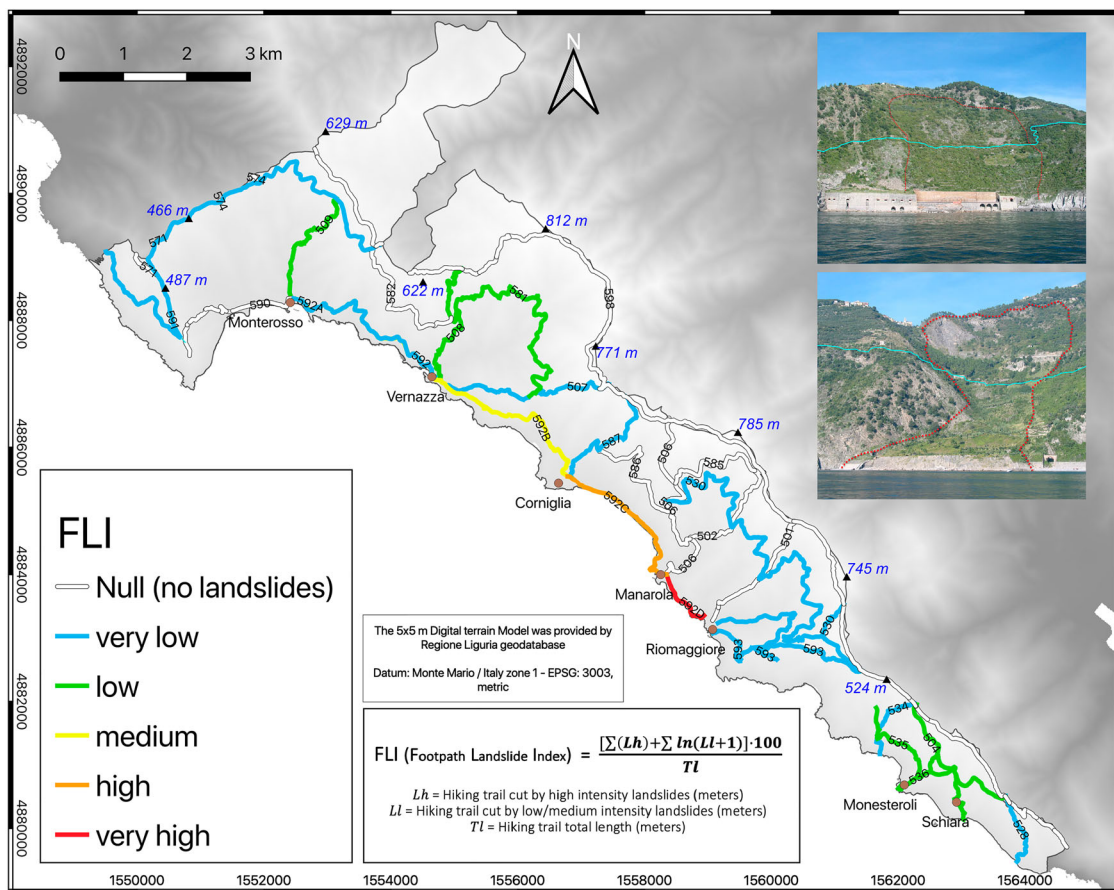
Figure 6. FLI (Footpath Landslide Index) extended to all the trails included in the Cinque Terre National Park and examples of side-hill trails.

side-hill trails (Leung & Marion, 1996), namely trails aligned perpendicular to slope gradient or approximately parallel to contour lines, which are often included, in part or completely, along the portion of slope comprised between the coast and the main edge of the erosional coastal scarp (Figure 6). Along such trails, hikers can be potentially impacted either by fast moving or flow-like landslides (e.g. rockfalls and debris/rock avalanches), which are slope instability mechanisms very frequent along the coastal strip comprised between 0 and 200 m a.s.l. (Cevasco, 2007; Raso et al., 2016, 2017). Conversely, the upper trails, such as the 530, 591 or 507, show very low values of FLI (less than 2). This is related to the fact that such trails are prevalently fall-aligned paths (i.e. aligned congruent to the slope gradient) that are often aligned with ridges, and therefore are less prone to be affected by landslides (Figure 6).
